# Utilizing the Taguchi Method to Optimize Slope Stability and Analyse Parameter Sensitivity in Road Cuts: Insights from Southern Ethiopia

Aklilu Shitu<sup>1,\*</sup>

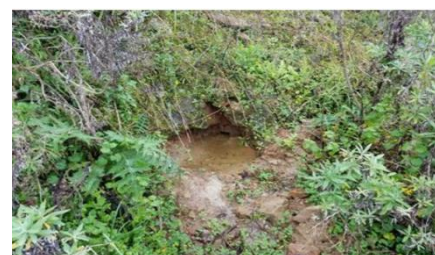
Landslides between Km 32+120 and Km 33+200 occurred at the interface of weathered rock and overlying fragmented soil. Boreholes indicate groundwater depths of 5–13 meters. Springs, visible at topographic breaks, flow year-round with variable discharge, contributing to pore pressure and slope instability in the affected zone. During heavy rainfall, the spring discharge increases, raising pore water pressure within the soil. Figure 5 shows spring water indication at km 32+130. The soil bulk is weakened by this high pressure, making it more prone to slide. Slope instability and mass movement in the region are

**Figure 5.** Groundwater/spring water indication at km 32+130.

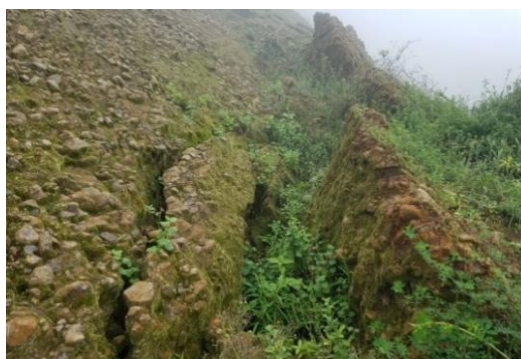
During a site visit, regressing tension cracks, vertical displacements, and movements were seen between km 32+275 and 32+280 as shown in Figure 14, Figure 15 and Figure 16.

**Figure 14.** Tension cracks seen between km 32+275 and 32+280.

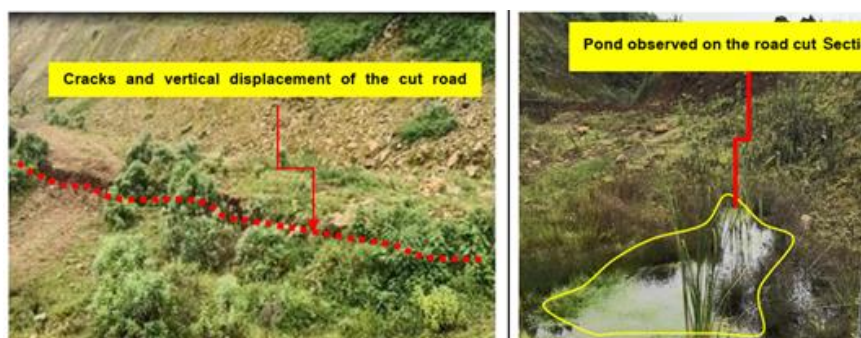
**Figure 15.** Cracks observed and water ponds in the given station.

During the wet season, these fissures could get worse and impact the local slope. Water infiltration from the LHS pond interacts with spoil materials put on the LHS between km 32+200 and 32+300, seeps into roadbed fissures, and exits on the RHS as seepage. The RHS becomes unstable because of the spoil being saturated by this surface and subsurface water.

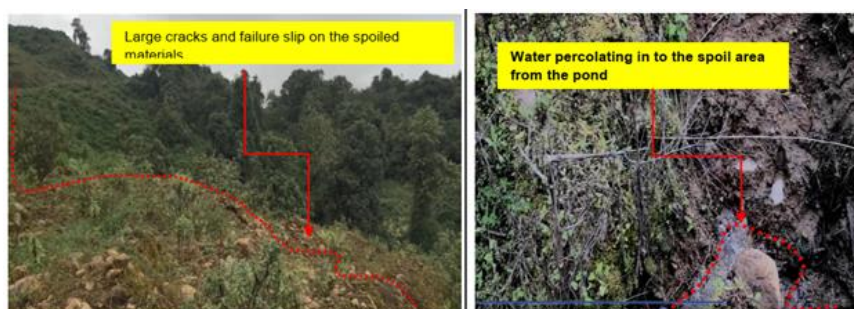
**Figure 16.** Cracks observed and water ponds in the given station.

The road failures were linked to unregulated spoil disposal, which was not noticed during the site visit, according to investigations. Particularly during the wet season, this condition may result in severe cracking and sliding. Table 3 shows the characteristics of each soil layer of the given location.

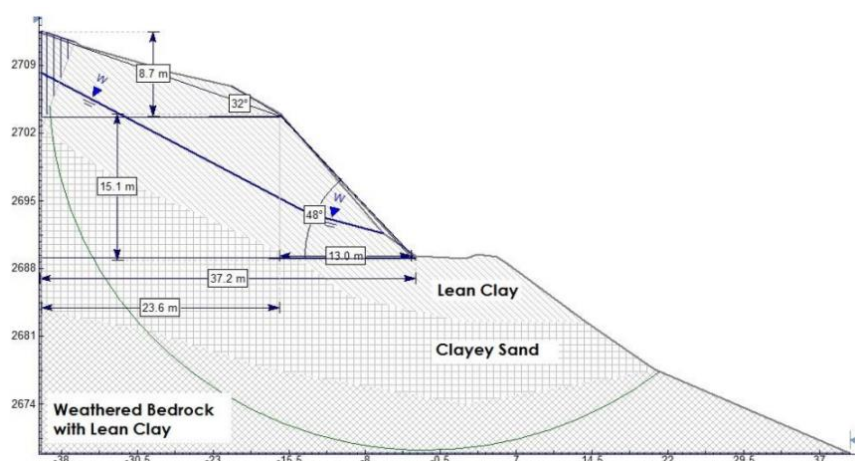
There is no discernible mass movement in this area, which shows indications of instability in the form of downslope creep and a sizable crack at the top of the cut portion that extends about three meters. Geophysical surveys and drilling studies verified the discovery of seepage signs at km 32+140 at the bottom portion. Additionally, the geometry, slope mass profile (for both the current and designed cuts), material properties, and groundwater conditions between km 32+120 and 32+225 are detailed illustrated in Table 6 and Figure 17.

**Figure 17.** Representative section of the current cut condition at Km 32+200.

The slope segment between Km 32+120 and Km 32+225 is unstable based on current and final cut evaluations. Recommended remedial measures include removing loose rock and soil from the lower bench to match the upper slope's angle, thereby stabilizing gradients, and reducing water infiltration. Surface re-grading is advised to eliminate depressions and reshape the landslide head scarp. A multi-layer gabion wall should be constructed at the toe, supported by rock backfill at a 1:2 batter slope as shown in Figure 27. Additional measures include installing crest drainage, vegetating the slope face, capturing subsurface water, and constructing a paved side ditch along the LHS.

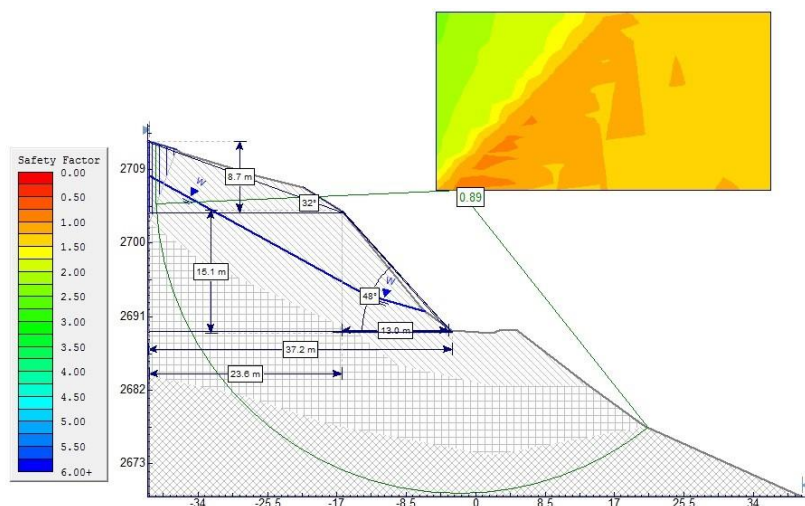
**Figure 18.** Slope stability status at the current cut condition shows instability.

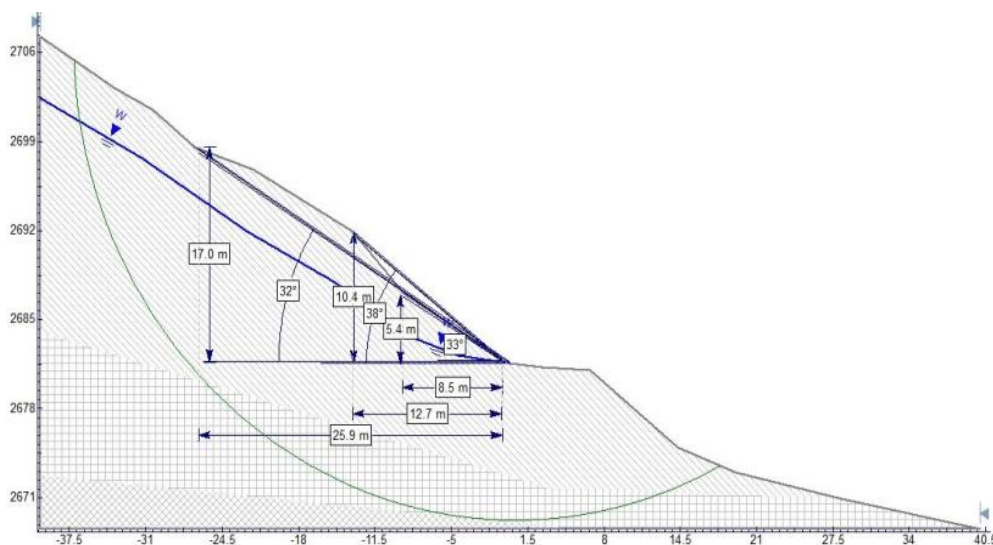
There is erratic vertical displacement and lateral movement in this portion of the cut slope, especially between the dumped spoil material and the road cut edge. During a site visit, these problems were noted between Km 32+355 and Km 32+380.

Significant fractures and slip failures were caused by water infiltration that was observed from the left-hand side (LHS) of a neighboring pond. Additionally, the geometry, slope mass profile, material properties, and groundwater conditions for the section between Km 32+355 and Km 32+380 are detailed in [Table 7](#) and [Figure 19](#).

**Figure 19.** Representative section of the current cut condition at Km 32+360.

The slope between Km 32+300 and 32+400 is unstable, with a factor of safety of 0.79. To stabilize it, landslide debris and weakened materials must be removed and replaced with

compacted rock fill and granular layers. A 1.5–2 meter retaining wall and underdrain on the LHS are also recommended. The slope stability study indicates an enhanced factor of safety of 2.19 with these precautions in place, as illustrated in Figure 26.

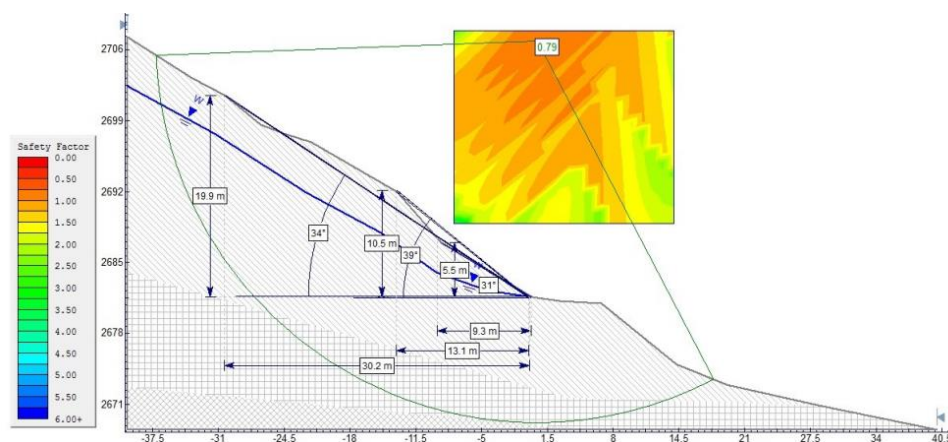
**Figure 20.** Slope stability status at the current cut condition at Km 32+360.

As seen in Figure 20 final design cut shows instability defined by 0.79 factor of safety indicating its potential to fail in full saturation.

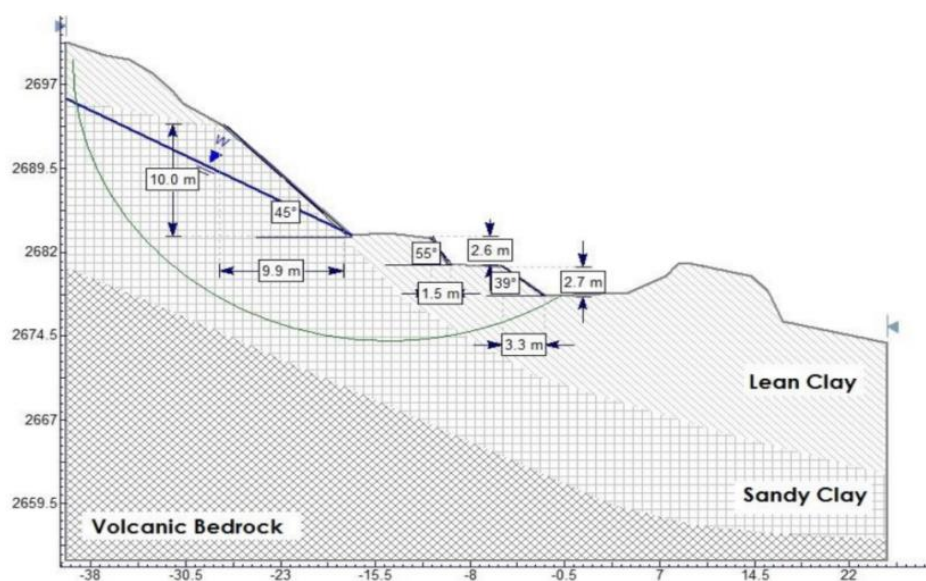
Significant sliding has occurred in this region, with motions

simulating an earth flow stretching about two hundred meters southwest near Km 33+000. According to field studies, the area's springs are mostly the result of topographic cracks and are frequently located where colluvial material meets the underlying rock. The geometry, slope mass profile, material properties, and groundwater conditions for the section between Km 32+400 and Km 32+900 are detailed [Table 8](#) and [Figure 21](#).

**Figure 21.** Representative section of the current cut condition at Km 32+400.

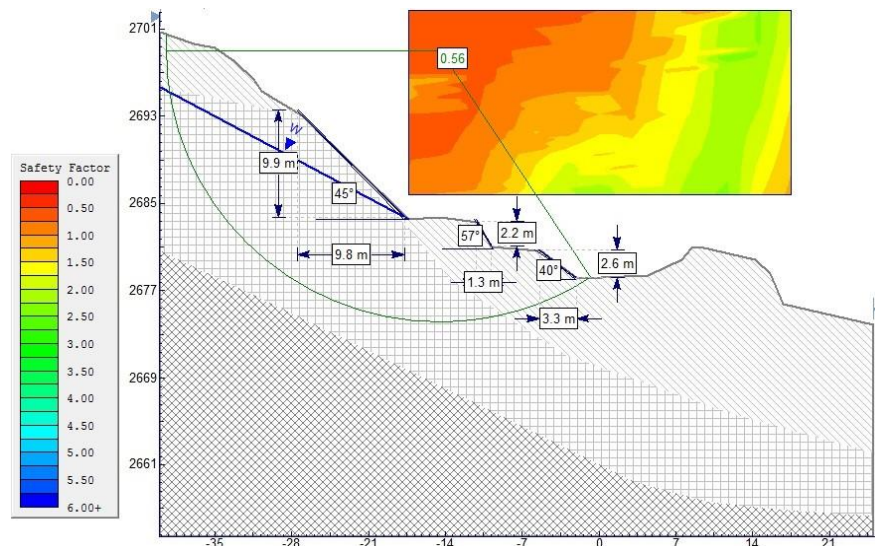
Figure 22. Slope stability status at the current cut condition at Km 32+400.

Slope stability status at the current cut condition and final design cut is showing a contrasting instability defined by 0.56 factor of safety as shown in Figure 22 indicating it's unstable

at current condition, but further cut might not induce further instability; rather it seems it is already exhausted.

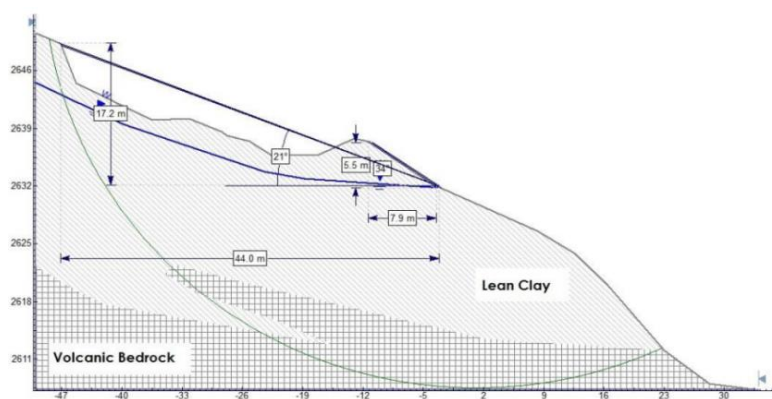
Figure 23. Representative section of the current cut condition at Km 33+140.

Only the left-hand side (LHS) slope is affected by the failure in this segment. A landslide can be caused by deep water infiltration into the transported and residual clays and gravel layers, which is made possible by colluvial deposits. On the LHS slope, seepage was noted near the junction of clay-mixed

Following the recommended foundation depth, a retaining wall should be built on competent and stable bedrock between km 33+100 and 33+200 on the LHS once the slide materials have been cleared. On the LHS of the road, behind the retaining wall, an underdrain should be placed to control subsurface water. It will divert water to the closest drainage structure. These measures are expected to improve slope stability, achieving a factor of safety of 1.93, as illustrated in Figure 28.

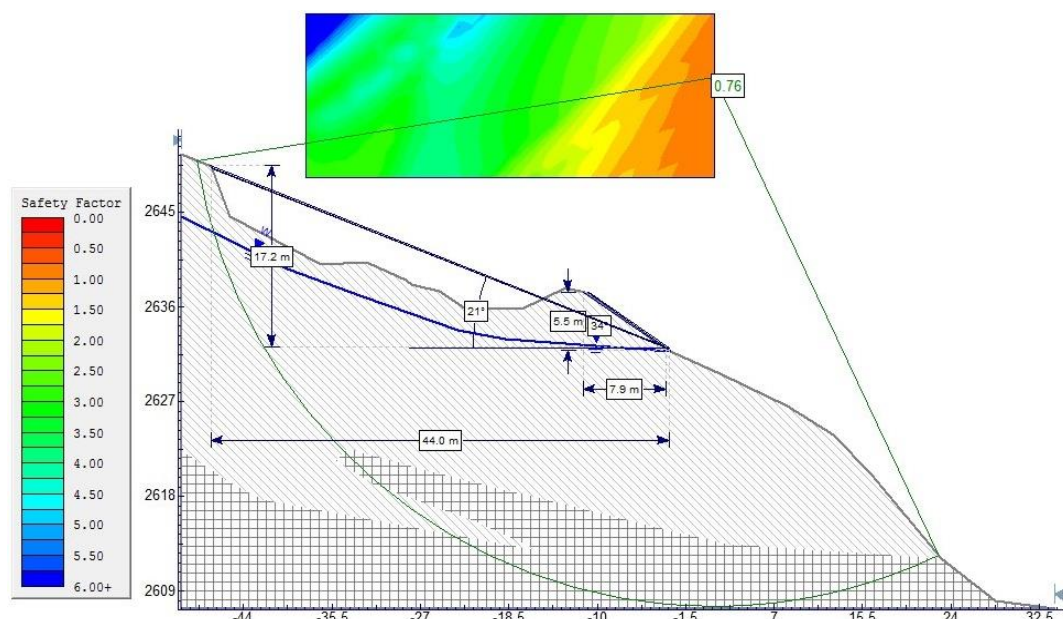
**Figure 24.** Slope stability status at the current cut condition at Km 33+140.

Additionally, the final design cut exhibits instability as indicated by the 0.76 factor of safety, meaning that it is unstable as it is and will become even more unstable with additional cuts.
