Premature Failure of Apedwa-Bunsu Junction Section of N6 in Ghana: Some Notes for Consideration

Yaw Adubofour Tuffour, Nana Kwesi Agyepong, Daniel Atuah Obeng. Premature Failure of Apedwa-Bunsu Junction Section of N6 in Ghana: Some Notes for Consideration. *American Journal of Civil Engineering*. Vol. 4, No. 3, 2016, pp. 84-91. doi: 10.11648/j.ajce.20160403.14

Abstract: This study investigated premature and continual failure of the Apedwa-Bunsu Junction section of Route N6 in Ghana despite an earlier maintenance intervention which included geotextile installation and placement of a new wearing course. It involved a condition survey, density, asphalt content, gradation, stiffness modulus and Falling Weight Deflectometer (FWD) tests on the section. The condition survey revealed cracking (alligator, transverse and longitudinal), ravelling, potholes, rutting and shoving as the predominant defects on the road. The density tests on the bituminous layers revealed relative compaction levels which, in most cases, did not meet the minimum required by the technical specifications despite the additional densification by traffic. The poor compaction was corroborated by high pavement deflectio

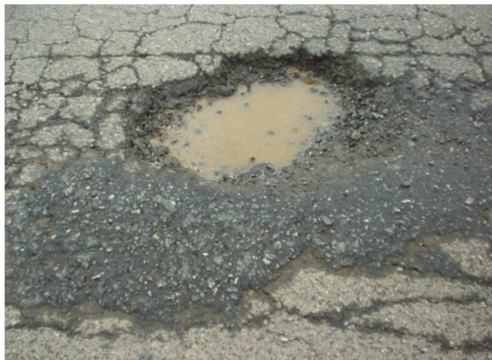
Figure 1. Alligator cracks with pothole development.

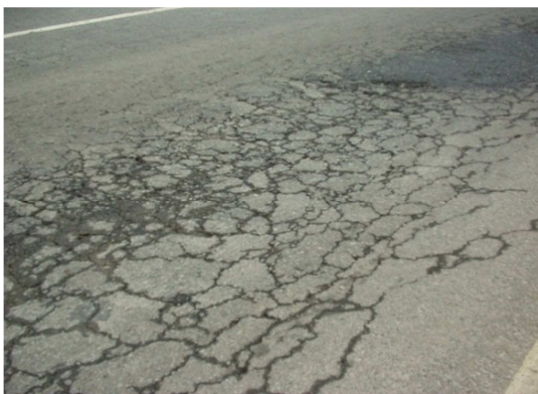
Figure 2. Extensive alligator cracks in wearing course.

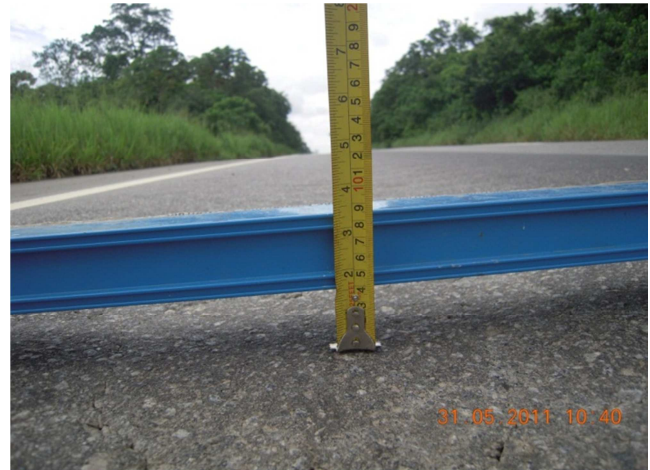
Figure 3. Rut in wearing course.

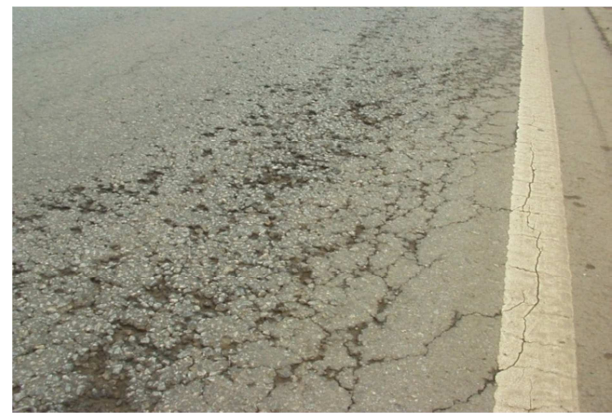
Figure 4. Ravelling with incipient pothole development.

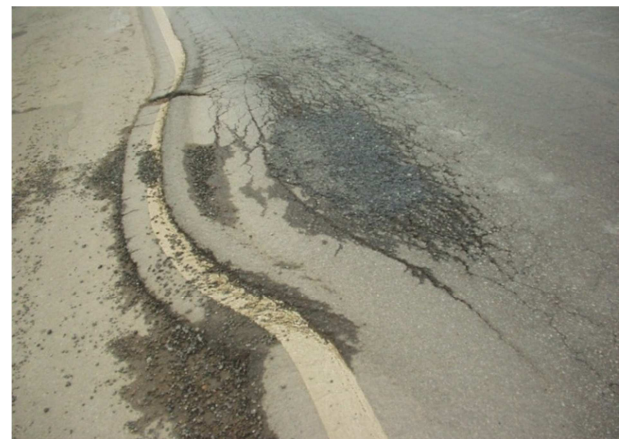
Figure 5. Structural failure and shoving of outer edge of surface course.

- Transverse and longitudinal cracking was very extensive in both travelled lanes and affected a greater length of the section.
- In terms of structural deformation, rutting dominated on both travelled lanes while shear failure and associated shoving tended to be confined to the outer edges of the wearing course.
- Alligator cracking was prevalent on both travelled lanes but affected a longer length of the north-bound lane than

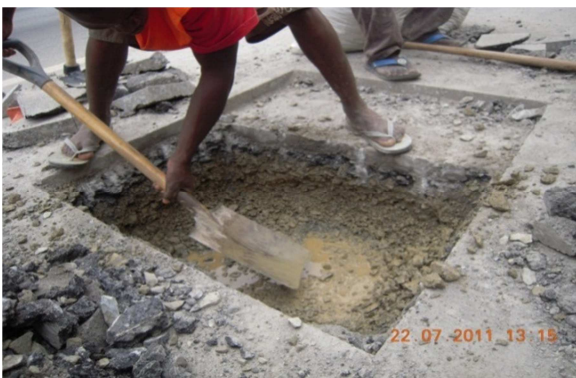
At some locations, the presence of ruts and cracks allowed run-off to seep into the pavement structure to saturate the underlying layers which became evident during the trial pitting (see Figure 6). Differences in prevalence of the distresses on the two travelled lanes could not be linked to differences in lane loading as this portion of N6 comes under heavy goods transport in both travelled directions almost equally. Besides, portions of N6 abutting the study section and constructed earlier under a different contract did not exhibit many of the observed defects on the study section, despite coming under the same loading regime.

Figure 6. Trial pit showing water-soaked crushed stone base.

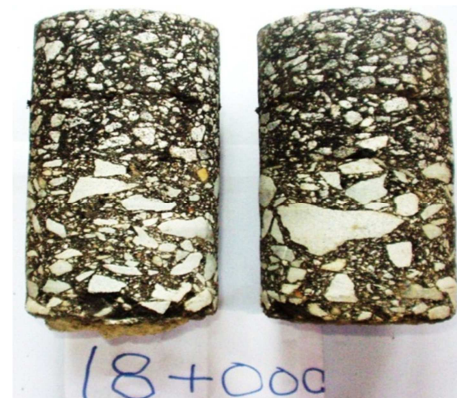
It was noted that the cored DBM layer tended to be friable with the mix hardly able to hold together. This suggested a lack of cohesion caused by stripping. There was also evidence of pitting on the cored surface suggesting material segregation and poor compaction during placement as well as stripping (see Fig. 7).

Figure 7. Asphalt cores with pitted surfaces.

The low relative compaction values associated with the bituminous layers are indicative of inadequate compaction during construction. It is believed that the poor compaction rendered the DBM layer permeable and probably made it easy for water to penetrate the pavement structure to cause stripping damage. Even though Chen [12] has cautioned that density alone may not engender quality construction, nevertheless, dense gradation and high density are important for achieving minimum permeability [2]. It is believed that moisture damage may have led to loss of inter-particle cohesion within the DBM layer causing it to behave essentially like a compacted granular layer.

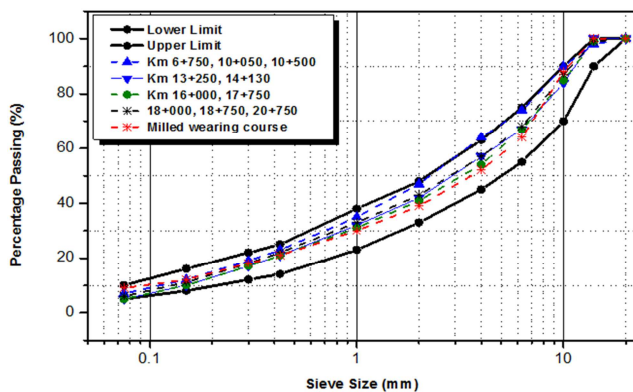
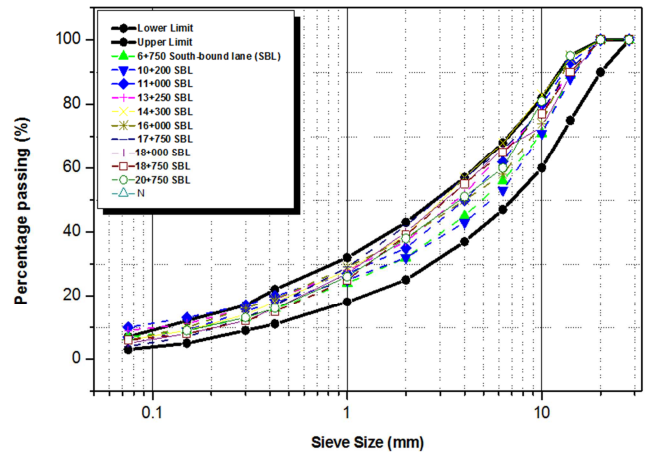
Figures 8 and 9 show the particle size distribution curves for samples of the wearing course and binder course materials, respectively, after bitumen extraction. The curves have been superimposed on the corresponding gradation envelope per the Ministry of Roads and Highways Specification (MRH) [13]. It is seen that all the curves essentially fell within the gradation envelope, although in the case of the binder course material, there was slight violation for some of the samples in the fine fraction content. In addition, most of the sample curves tended to gravitate a bit more toward the upper limits of the specification size ranges.

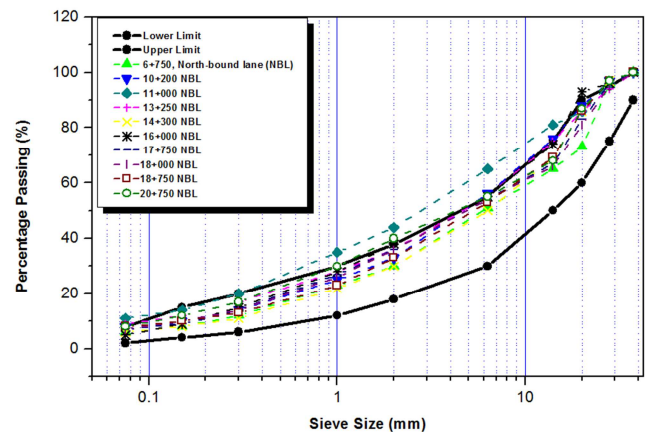
Figure 10 shows the particle size distribution of the residual aggregates of the DBM layer after bitumen extraction. While most of the samples had the particle size falling within the specification envelope, a few fell outside. Also, most of the samples with size distribution falling within the envelope tended to gravitate toward the upper limit of the size ranges.

Hence, on the whole, compliance of the DBM material with the particle size distribution requirement of the MRH Specification was not total.

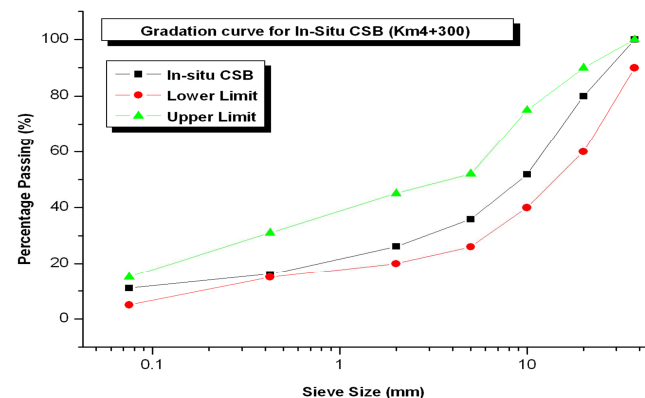
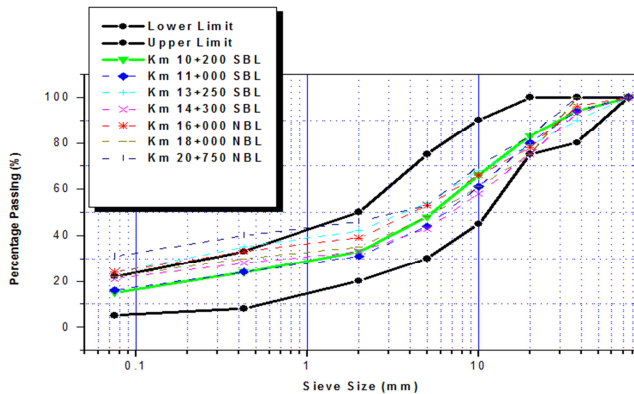
Figures 11 and 12 show the particle size distribution curves of the CSB material and the sub-base, respectively. It is seen from the curves that whereas compliance with the MRH specification for the base material was total, it was not so for the sub-base material. The fines fraction of some of the samples went above the upper limits of the specification.

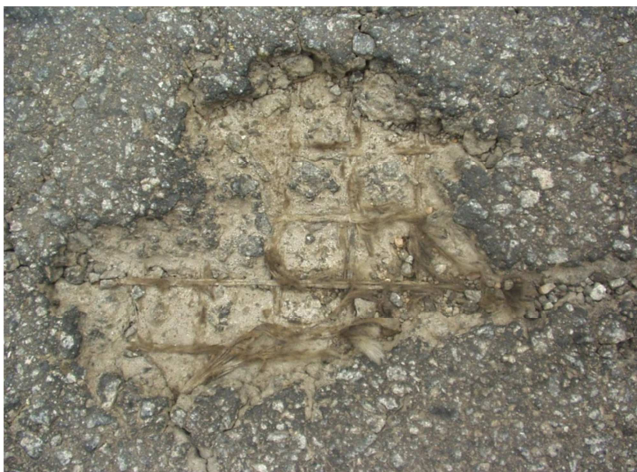
In the course of the fieldwork, a geotextile material placed in an earlier intervention work was established to have been placed at a depth with only about 15-20mm asphalt concrete cover (see Fig. 13). Literature on geotextile placement in asphalt overlays recommends a minimum compacted cover of 38mm (1.5inches) as first lift [2] to make it effective. This suggests that the placement of the geotextile did not meet this minimum requirement and probably partly explains why the material had not been effective in arresting cracks.

Figure 13. Exposed geotextile placed in an earlier maintenance intervention with thin cover.
