The Investigation of Negative Effects of Salt Dome on the Quality of Water in Gotvand Olya Dam and the Use of Cut-off Wall as Treatment

Mahmood Mansournejad, Behzad Kalantari, Mehdi Mahdavi Adeli. The Investigation of Negative Effects of Salt Dome on the Quality of Water in Gotvand Olya Dam and the Use of Cut-off Wall as Treatment. *American Journal of Civil Engineering*. Special Issue: Research and Practices of Civil Engineering in Developing Countries. Vol. 3, No. 2-2, 2015, pp. 53-56. doi: 10.11648/j.ajce.s.2015030202.20

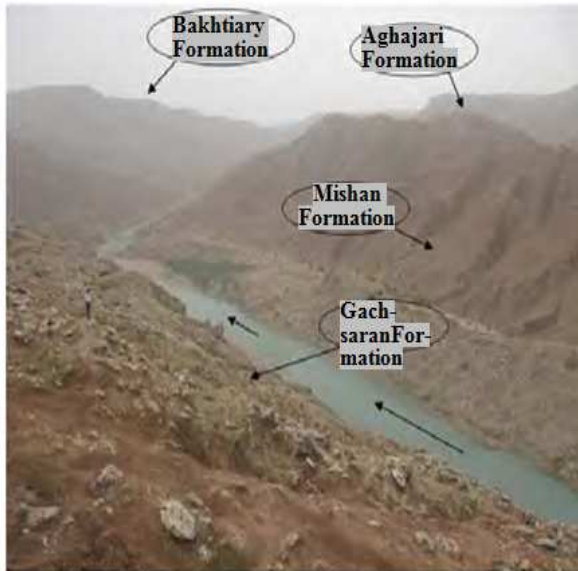
The dam reservoir, being longer than 90 km, is surrounded by Aghajari, Mishan, Lahbari, Bakhtiyari (conglomerate, Figure 1)

Fig. 1. Location of dam's reservoir foundations.

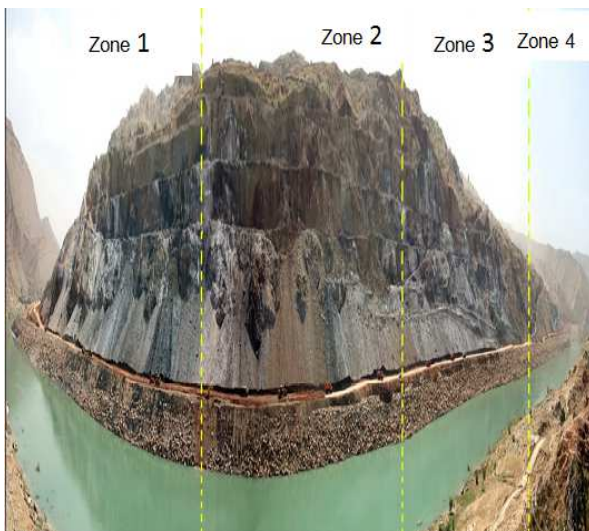
The scope of operation include four zones, zone one and two have been assigned to the first contractor and zones three and four, covering 1150 m, were assigned to second contractor on 22 April 2011 (figure 2). First, after cleaning the excavated trenches and debris, first seven meter from the edge of the trenches of clay material with proper thickness and density of more than 92% were executed (density testing method for clay is TM1556 and for pebbles is TM5030). Then, close to clay material, trenches materials were implemented without any contraction and for 2 meters. At the end, rip rap materials have been used to cover the material with more than 1.5 meter width. Treatment operation has been done by two procedures; the first one has been done before and after impounding [6].

Fig. 2. The zoning area of Gachsaran formation.

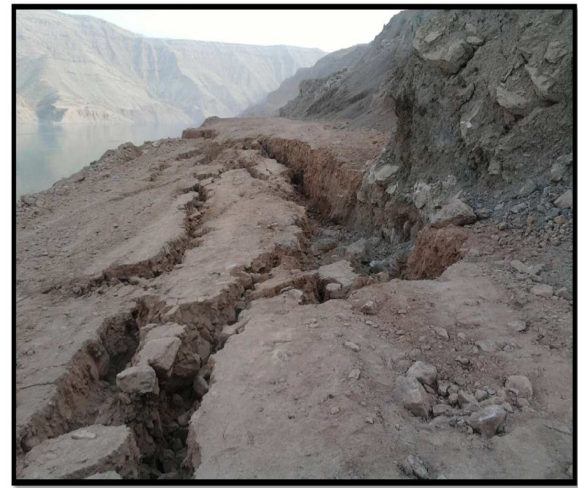
After the first step in Gotvand Olya dam impounding, due to rapid impounding of the reservoir, some tracks and holes were created in embankment area, so based on the design consultant some changes were applied in the implementation method of the band, the most important of which are as follow:

- Cancelling the transition later implementation: due to sinking of the only mine of these materials SB
- Change in the implementation method of materials: after impounding, for stability and filling of the hole, clay and riprap materials were evacuated in form of damp on the band and the contraction of material was done by the traffic of road construction machineries (figure3).
- After impounding, due to safety concerns, the consultant

Concerning the results obtained, reviewing the prepared photos and according to the opinion of experts engaged in the project, the quality of soil was evaluated as somehow mid to low.

Fig. 3. cracking in the embankment after dam impounding.
