# Analysis of Partial Discharge Patterns for Generator Stator Windings

Korea Electric Power Corporation (KEPCO) Research Institute, Daejeon, South Korea

Tae-Sik Kong, Hee-Dong Kim, Tae-Sung Park, Kyeong-Yeol Kim, Ho-Yol Kim. Analysis of Partial Discharge Patterns for Generator Stator Windings. *American Journal of Electrical Power and Energy Systems*. Vol. 4, No. 2, 2015, pp. 17-22. doi: 10.11648/j.epes.20150402.11

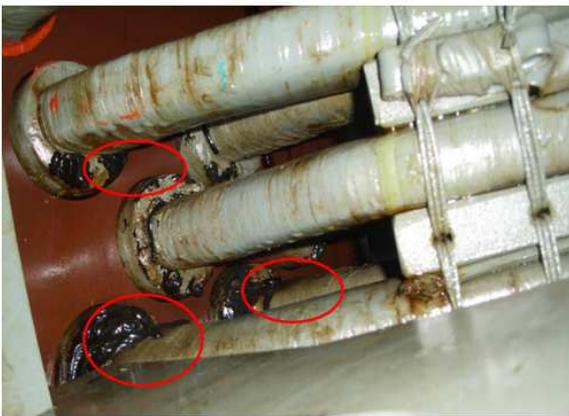
This is a case where a large-scale water cooling steam turbine generator was tripped because of the destruction of the main insulation of the stator winding caused by cooling water supply discontinuance. The generator, which was manufactured with thermal class B insulation material with a maximum allowable temperature of 130 °C, experienced a discontinuance of the cooling water supply. The discontinuance was caused by an error in the coolant supply system for approximately 10 min during normal operation, and the temperature of the stator windings increased rapidly to approximately 200 °C. This caused the main insulation of the stator winding to fail, and a ground fault eventually tripped the generator. The melted compound of the connecting joint between the cooling water box and the stator winding caused by overheating is shown in Figure 1, and the failed insulation of the stator winding is shown in Figure 2.

Figure 1. Compound melting due to overheating.

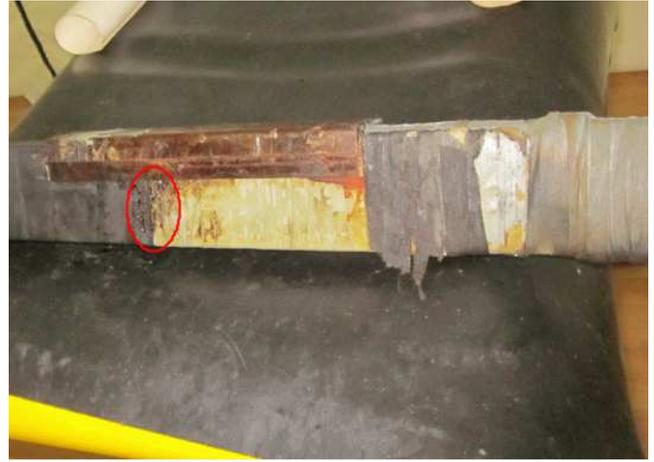
Figure 2. Stator winding insulation failure.

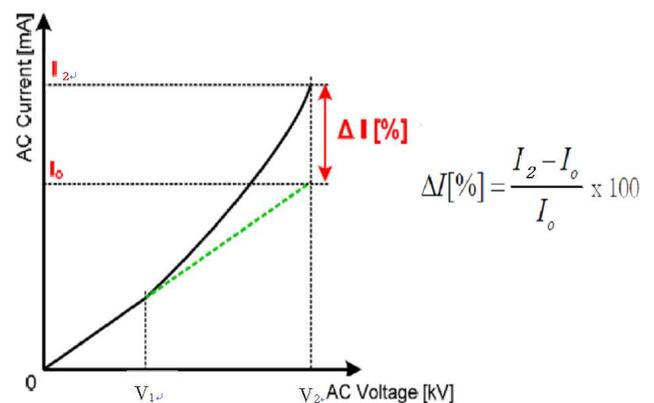
Figure 3. Voltage vs. AC current.

The AC current and DF measurement results at 15kV (phase voltage) were measured in two years prior to the failure. The same voltage of 15 kV was applied to measure the values of  $\Delta I$  and  $\Delta \tan \delta$  in order to compare the test results. The results show that both  $\Delta I$  and  $\Delta \tan \delta$  increased after the failure, as shown in Table 1. This implies that PD started to occur more than two years prior to the failure, and also implies that the number of voids, which cause discharging within the insulation system, increased because of stator winding thermal overheating.

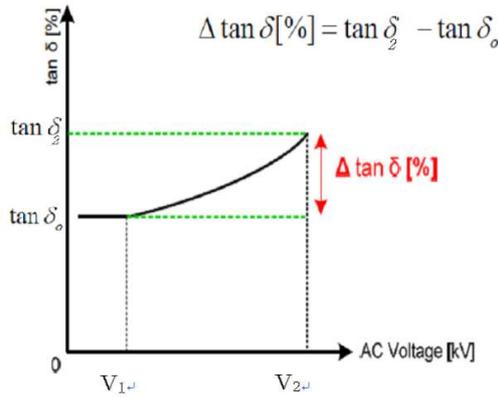
Figure 4. Voltage vs. Dissipation factor.

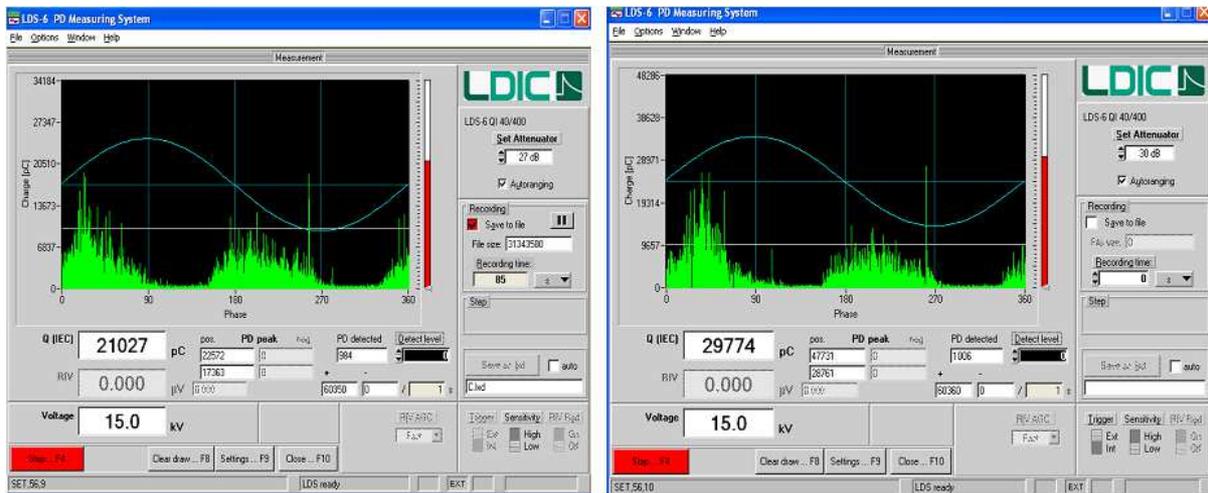
Figure 5. PD pattern for copper conductor overheating.

results show that the level of PD increased significantly after the failure and that there was also a change in the discharge pattern. Before the failure, the size and number of the negative discharge pulses, which appeared when the test voltage is positive, were similar to those of the positive discharge pulses, which appeared when the test voltage is negative. However, negative pulses were larger than the

positive pulses after the failure due to thermal overheating, as shown in Figure 5. This pattern appears mainly in the gap between the copper conductor and strand insulation [10]. Furthermore, it was found that the insulation was not in good condition because the PD size was close to 30,000 pC or greater [11].

This pattern is produced because of delamination between the copper conductor and the insulation because of the differential thermal expansion between the copper conductor and stator winding insulation as a result of rapid thermal overheating.

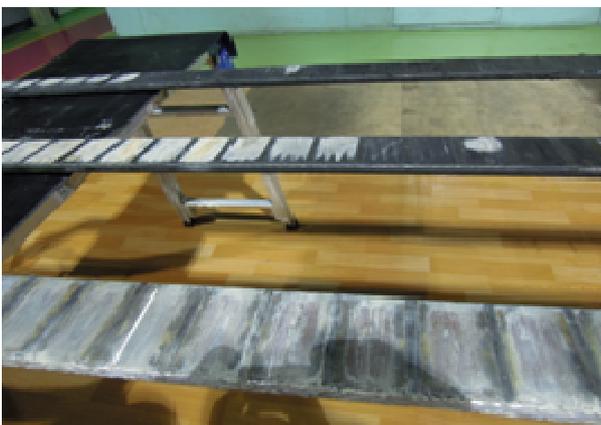
However, when the generator is started and stopped, the winding insulation is subject to thermal expansion and contraction because of Joule heating, and the resin that holds the stator winding in its position within the slots is separated. This creates a gap between the winding and the slot, and the stator winding starts to vibrate at 120 Hz because of the electromagnetic force of the rotor, further reducing the thickness of the insulation. This increases the length subject to vibration, accelerating the wear process and eventually causing dielectric breakdown. In Figure 6, it can be observed how the semiconducting layer is almost eliminated because of the slot vibration-induced wear on the surface of the stator winding. The semi-conductive layer is used to reduce the partial discharge between the stator winding and the slot [12].

Figure 6. Wear in stator winding surface.

Insulation diagnosis tests were performed on the remaining stator windings except for those that experienced dielectric breakdown. The PD measurement was carried out at rated phase voltage, and the measured PD magnitude and phase pattern is shown in Figure 7. The results show that the PD value was relatively high (38,000 pC), and the PD pattern showed that the positive discharge pulses, which occurred at a test voltage phase angle of 225 °, were produced more than negative discharge pulses, which occurred at 45 °, forming a slot discharge pattern [8, 9]. Most PDs are considered to occur at a gap between the stator winding and the slot, and it was also confirmed that the surface of the stator winding drawn from the slot was also significantly worn, as shown in Figure 6.

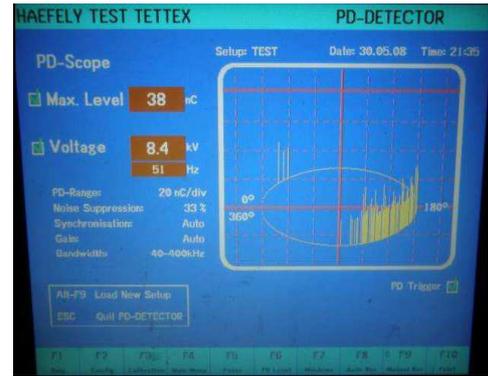
Figure 7. PD pattern for slot discharge.

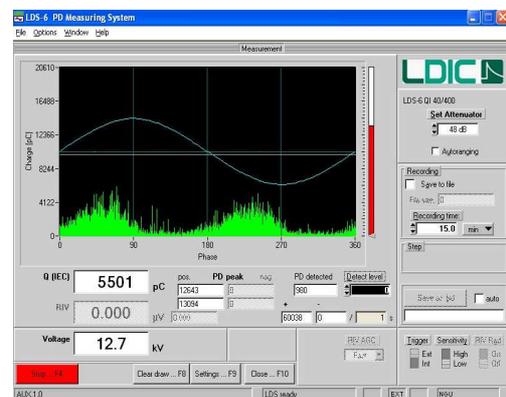
Figure 8 shows the PD measurements on a 22 kV steam turbine generator, which has been operating for approximately 20 years. According to the test results, the location of the main discharge is considered to be in the void inside the ground-wall insulation because the positive and negative PDs occur almost similarly. This is because the voids within the ground-wall insulation were not completely removed during the vacuum pressure impregnation process of the winding manufacturing or because voids were created inside the ground-wall insulation as a result of thermal deterioration. This discharge pattern due to the internal voids of the insulation material occurs during normal deterioration and is a frequent form of partial discharge pattern.

Figure 8. PD pattern for internal discharge.

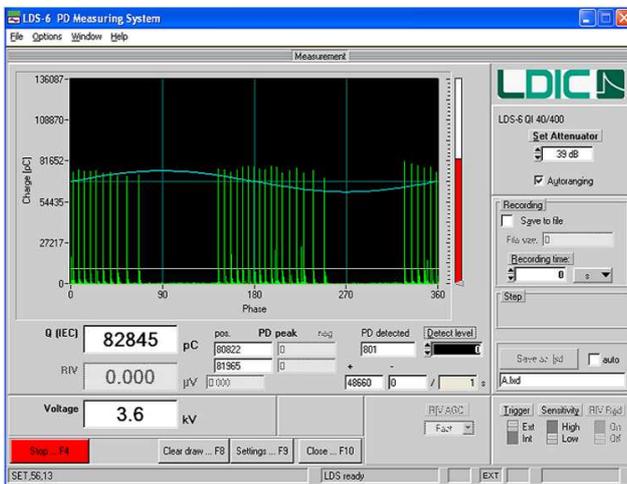
The screen of the PD measurement during a PD test on a generator that failed because of overheating in the copper conductor is shown in Figure 9. The location of the preliminary pulses are near  $0^\circ$  and  $180^\circ$ , and the size of the discharged pulses are almost identical. This pulse had a completely different shape with respect to the discharge pattern on insulation systems. This discharge pulse sizes being similar implies that the pulses occurred between particular electrodes. Because external noise pulses were detected in addition to the PD occurring at the electrical insulation, a visual inspection was performed to check the location that produced the noise. As a result, it was found that the contact between two isolated phase bus (IPB) bars, through which the generator output flowed for each phase, and the clip, which connected the two IPB bars to the common plate, was defective resulting in a discharge. This problem was rectified, and a test was conducted.

Figure 9. PD pattern for gap discharge noise.

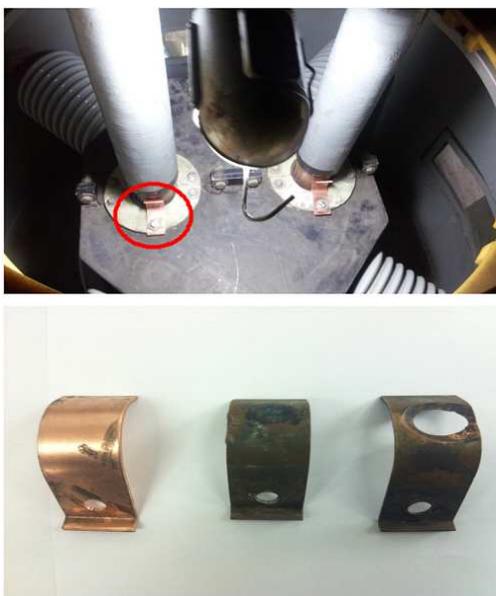
Figure 10. Gap discharge location.
