Electrical Power Transformer Damage on the Power Grid in Benin: Causes, Consequences and Solution Approaches

Oswald Gbetondji Acclassato^{1,2}, Mathias Adjimon Houekpoheha^{1,3,*}, Basile Bruno Kounouhewa^{1,2}

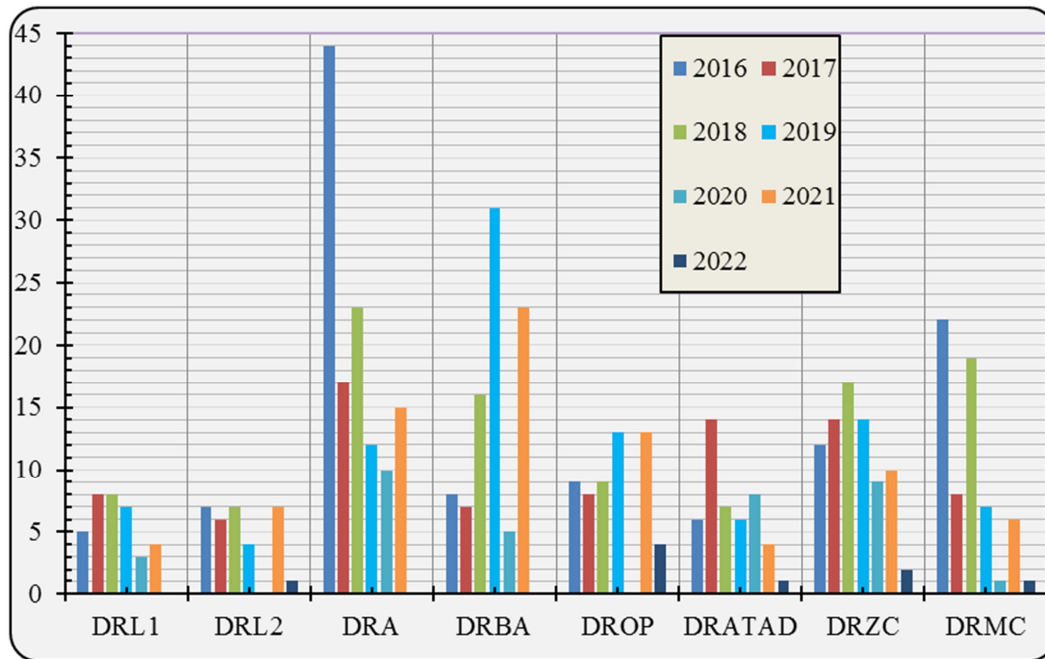
Figure 1. Point of defective transformers by region and by year.

From 2016 to January 2022, the evolution of the diagrams in Figures 1 and 2 show that the DRA is the region which recorded the highest rate of damage with 21.18% compared to the total number of damage on the electricity network. of Benin, followed respectively by the DRBA (17.24%), the DRZC (14.94%), the DRMC (12.26%) and the DROP with a rate of 10.73%. These regions are globally high charge density regions As for the rest of the regions, areas with low load density, they recorded a damage rate of less than 10%. From the above, the high density of charges is therefore a limiting factor for the normal operation of transformers and contributes significantly to their defect.

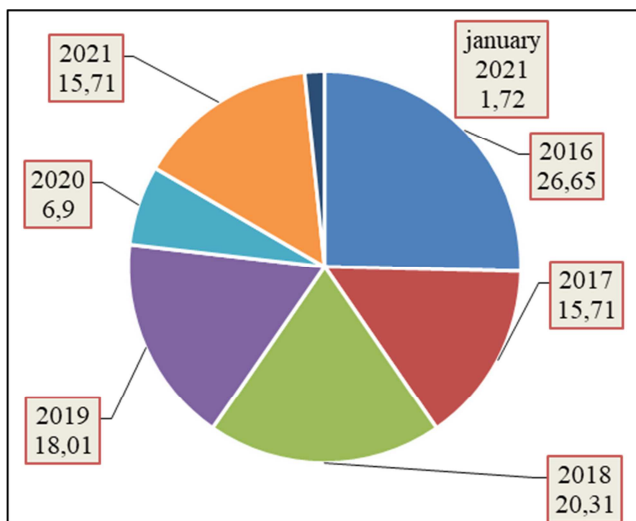
Figure 2. Proportions of defective transformers by year.

The diagram in figure 2 reveals that the transformer damage rate decreases from 2016 to 2020 and goes from 20.31 to 6.9%. But in 2021, we are witnessing a significant increase in this rate. This observation is justified by the fact that during this year, apart from atmospheric and anthropological disturbances, there is an increase in the connection of users to the electricity grid.

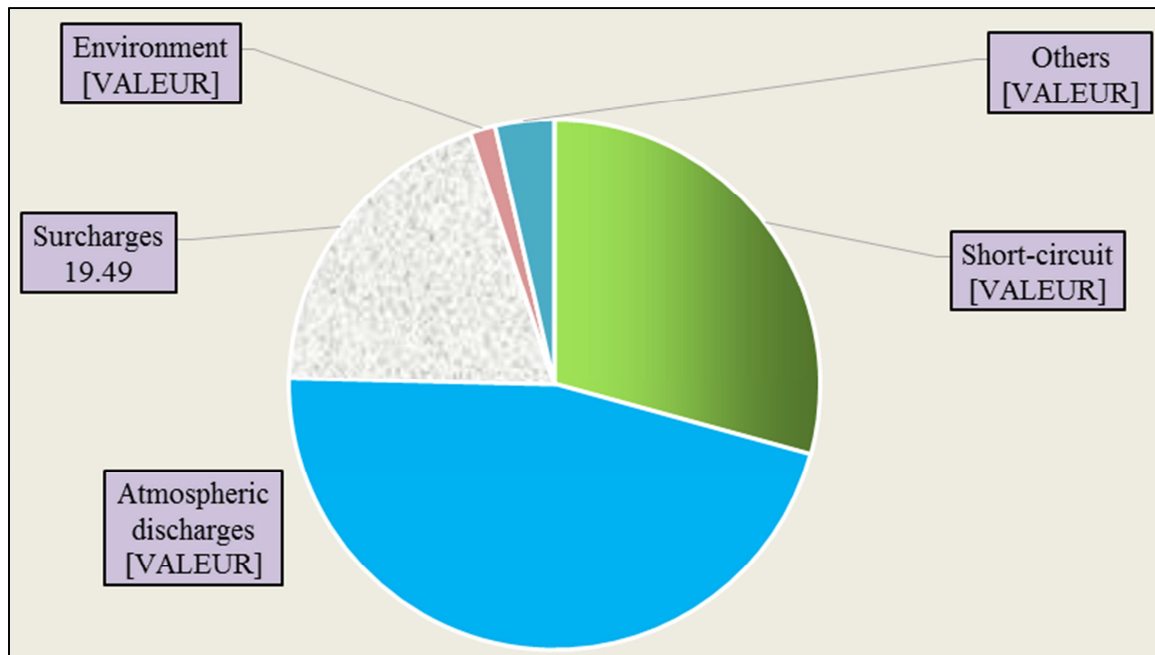
Figure 4. Causes of damage to transformers in 2016 and 2017.

The diagram in Figure 4 shows the proportions of causes of damage to transformers in the years 2016 and 2017.

From the analysis of the damage sheets, it emerged that most defects are due to overvoltage from discharges (46.15%), overloads (19.49%) and short circuits (29.23%) (Figure 4). In fact, overvoltage subject the insulators to stresses that exceed the insulation voltage of the transformers. Nowadays, keraunic levels are very high and atmospheric discharges are therefore very severe on electrical installations. Appropriate measures must then be taken to protect them effectively against this

phenomenon. Also the earth circuits of some transformers have been vandalized by social divorcees. Very high discharge currents are not efficiently drained to the ground and thus create floating potentials which are very dangerous for

equipment and third parties. The regional authorities will then have to identify all these scenarios and rehabilitate them with 95mm² Almelec Alu cable that can efficiently carry currents of 100kA to the ground.

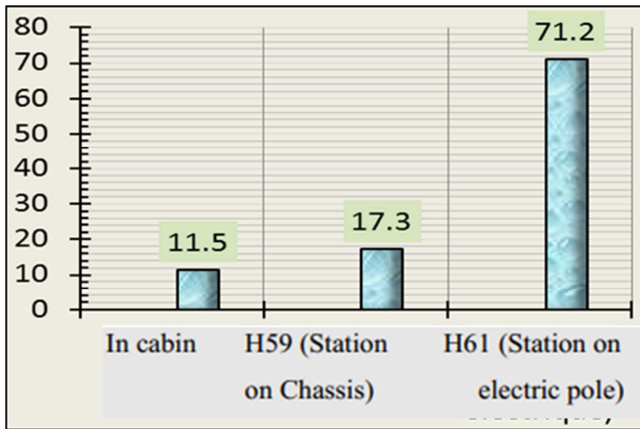
Figure 6. Rate of employment varies by type of post.

The posts most affected are those on poles (H61) with a rate of 71.2% and then posts on frames with a proportion of 17.3%. The PMD ends often used on networks and which equip frame-mounted transformers are exposed to bad weather and over time water infiltrates them: they do not have the characteristics corresponding to this mode of operation. This constitutes a weak point on chassis-mounted substations and can contribute to their failure.

H61 transformers are exposed to atmospheric, electrostatic and sometimes switching overvoltage. Lightning generates currents of up to several kA. Spark gaps and surge arresters
