Conveyance Efficiency and Maintenance Performance Evaluation of Canals at Serenta Irrigation Scheme, Northern Ethiopia

Gebre Gidey*, Husen Siri

Department of Natural Resource Management, Dambi Dollo University, Dambi Dollo, Ethiopia

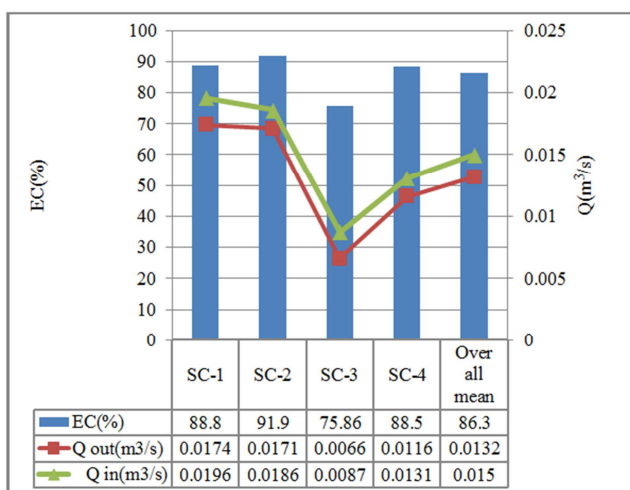
canals of the irrigation scheme, the average conveyance efficiency ranged from 75.86% (SC-3) to 91.9% (SC-2) with an overall mean efficiency of 86.3%. The lowest conveyance efficiency (75.86%) was observed in secondary canal 3 (SC-3). This reflected that the high amount of water loss, due to broken and cracked condition of the structure at this particular canal (Figure 5), which contributed for deep and off farm loss.

Figure 4. Average conveyance efficiency of secondary canals.

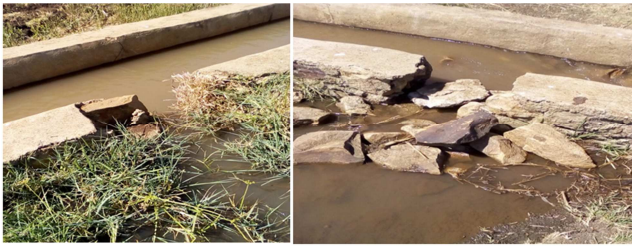
This low performance of the canals was also confirmed by the respondents interviewed. Of the total respondents, 46.6% of them responded that the canals cleaning and maintenance performance were in poor condition. And also, at the time of water flow measurement and field visiting a lot of broken secondary canal structures were observed (Figure 5). This breaching canals problem was also confirmed by the respondents' interview. 50% of the respondents stated that, the major cause for the poor conditions of the canals was breaching of canals by illegal water users. The siltation, animals' damage (animal's movement) and improper management of weeds (Farmers were thronging weeds to the canals and poor cleaning weeds which grows in the canals) were the other problems in the secondary canals.

Figure 5. Broken secondary canals and water wastage (losses) in the irrigation scheme.

scheme was with acceptable value. However, the majority of the secondary and tertiary canals were broken, cracked and silted by weeds and soils contributing to high water loss. As a result, the conveyance efficiencies were very low and under recommended values. So to reduce water loss and improve the performance the irrigation scheme, the conveyance efficiency of the irrigation scheme should be improved through regular canal cleaning and maintenance of the broken structures by mobilizing farmers to participate on the activities.

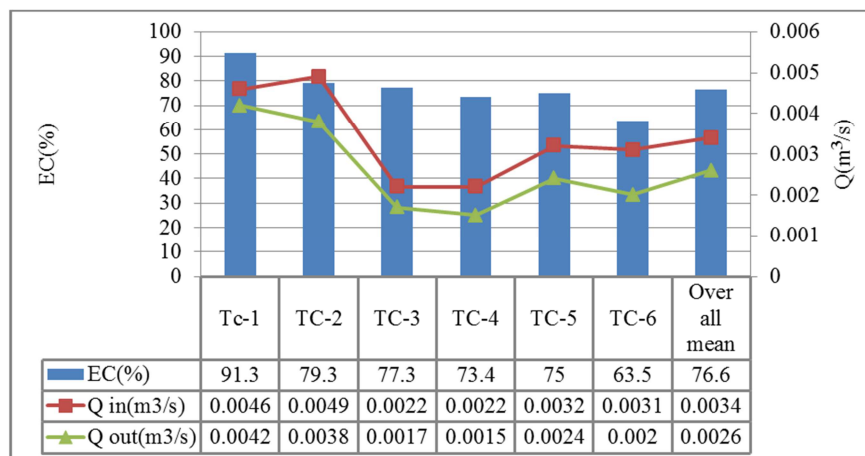
As indicated in Figure 6, the average conveyance efficiencies ranged from, 63.5% (TC-6) to 91.3% (TC-1), with the overall mean value of 76.6%. The low conveyance efficiency observed in tertiary canal 6 (TC-6), implied for high amount of loss, due to the weak earth work canal (small

width), a lot of water was flowing over the canal, and improper management (it was covered by grasses).

Figure 6. Conveyance efficiency of tertiary canals.
