Status of Public Water Supply Facilities in Port Harcourt Metropolis

Geraldine Okwy Ojukwu, Hycienth Ogunka Nwankwoala. Status of Public Water Supply Facilities in Port Harcourt Metropolis.

International Journal of Environmental Protection and Policy. Vol. 10, No. 2, 2022, pp. 31-38. doi: 10.11648/j.ijepp.20221002.13

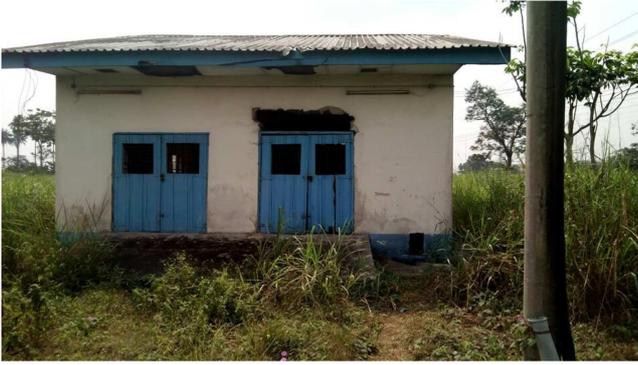
Table 2 shows operational capacities of the PHWC water stations and their status as at the time of assessment. The facilities are generally underutilized and in poor working conditions. The status of the Rumuola Water Station facilities is presented in Table 3. It was observed the facilities were poorly maintained, working below capacity, armored cable vandalized by hoodlums at the transformer powering one of the 3 wells that are functional, collapsed fence at the back of the facility granting hoodlums access into the facility; and bushy fields covered most of the facility (Figure 1).

Figure 1. Dilapidated generator house showing vandalized armored cable at Rumuola water station.

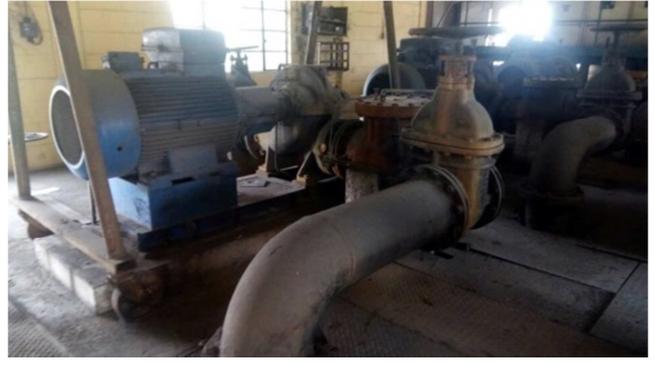
Table 4 shows the status of facilities at Diobu water station. As observed, booster pumps no. 3 and 6 are functioning, but their faults are mainly mechanical; booster panel no: 3 and 6 are functioning; with a capacity of 864 cubic meters each; generator sets (2No), 725KVA and 875KVA, 725KVA functioning with minor issues (battery); poor drainage system, experiences floods during rainfall inside the powerhouse; overhead tanks (2) cylindrical and funnel, the cylindrical tank has a faulty valve; and the surroundings were bushy (Figures 4 and 5).

Figure 4. Fairly maintained engine room and an overhead tank at Diobu Water Station.

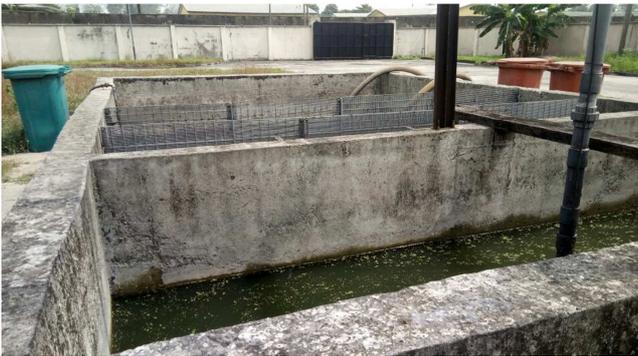
At Eagle Island water pumping station, not much activity was going on in this facility as equipment have been vandalized (Figure 2).

Figure 2. Non-functional treatment tank at Eagle Island Treatment Plant.

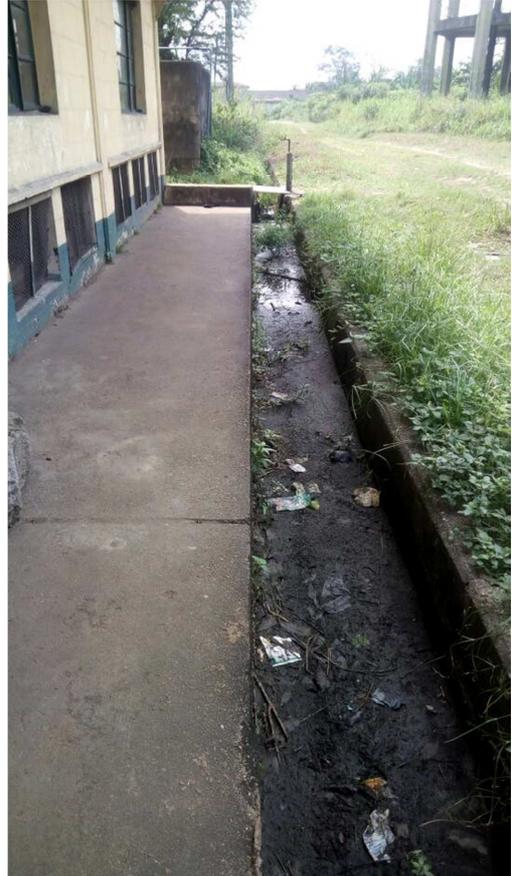
Figure 5. Poorly maintained drainage and surroundings at Diobu Water Station.

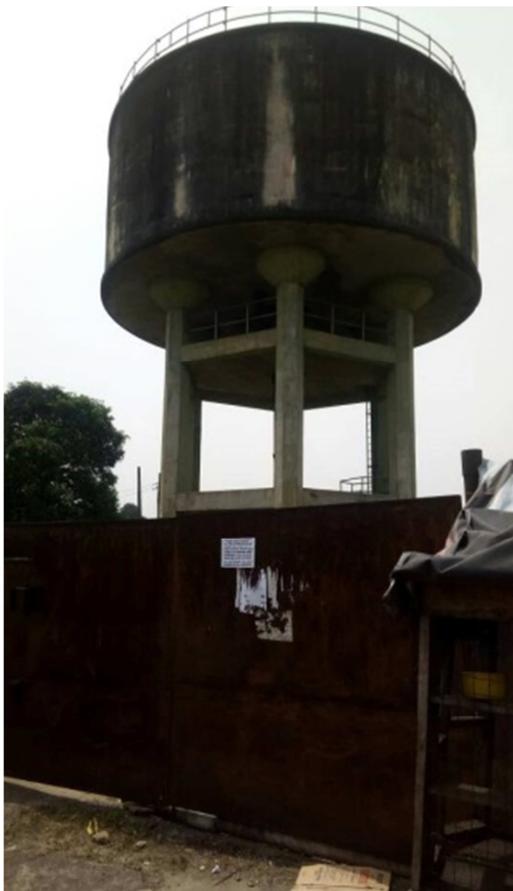
For Borokiri Water Station, at the time of visit the station was locked and access could not be gained to this facility. However, observations made showed that no activity has been going on in the facility for some time and the structures therein are under neglect (Figure 3).

Figure 3. An overhead tank at Borokiri Station.

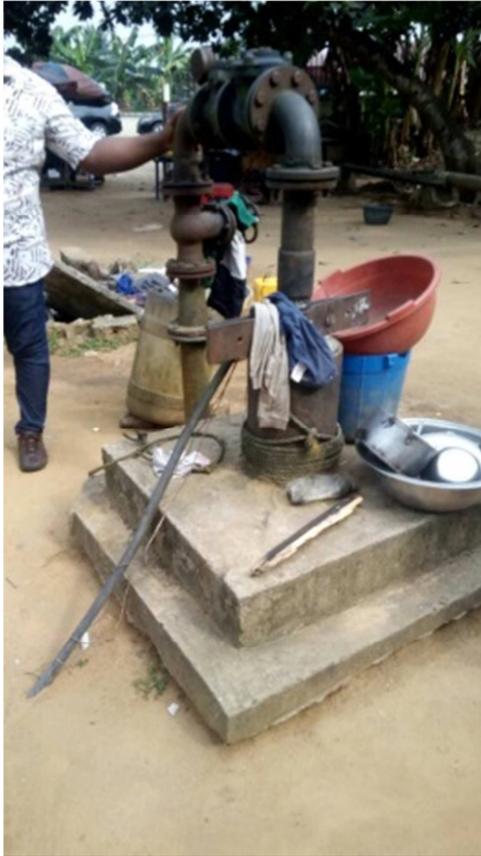
At Ernest Ikoli Water Station, generally, this facility looks abandoned as no activity was observed going there (Figure 6).

Figure 6. Abandoned structures at the Ernest Ikoli water station.

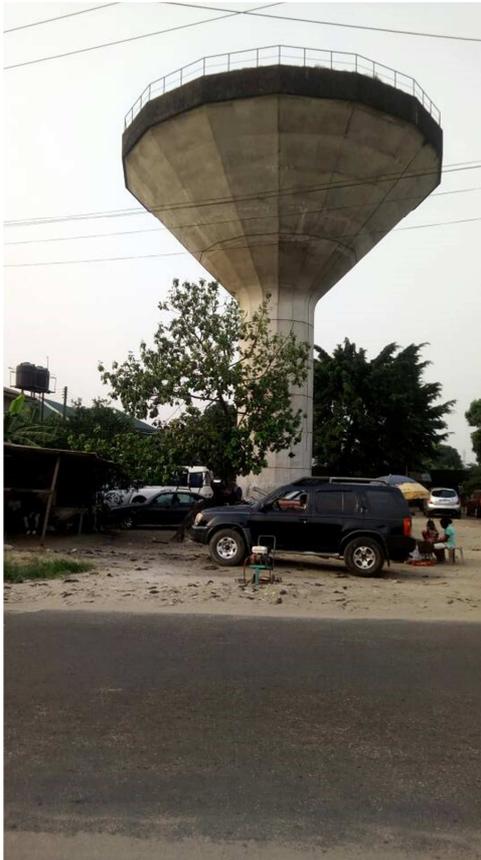
At Omerelu Street, GRA Phase 2 water station, the compound is presently used as a mechanic yard and waste litter the environment (Figures 7 and 8).

Figure 7. Overhead tank at Omerelu Street, GRA Phase 2.

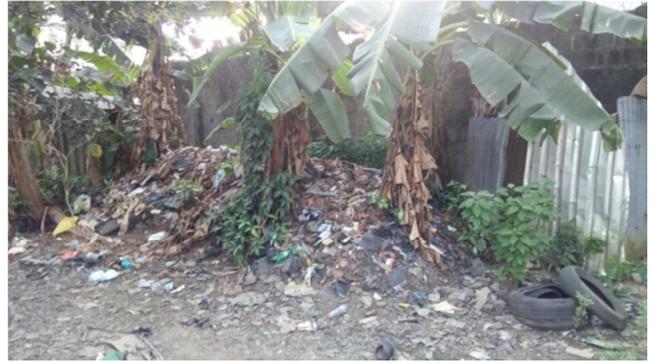
Figure 8. Waste dump surrounding Omerelu Street overhead tank, GRA Phase 2.

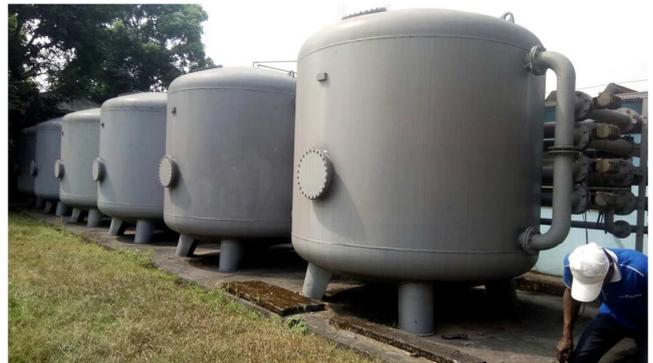
Reclamation (Macoba) Road, NPA axis etc. The water tank is normally washed once in a year. Figure 9 shows properly maintained water tanks and pumping station at Moscow Road water station. water leakages were observed along Aggrey road at the following locations and coordinates First Bank, Aggrey Road and 9, Aggrey Road, by Young Model Supermarket (Figure 10).

Figure 9. Properly maintained water tanks and pumping station at Moscow Road.

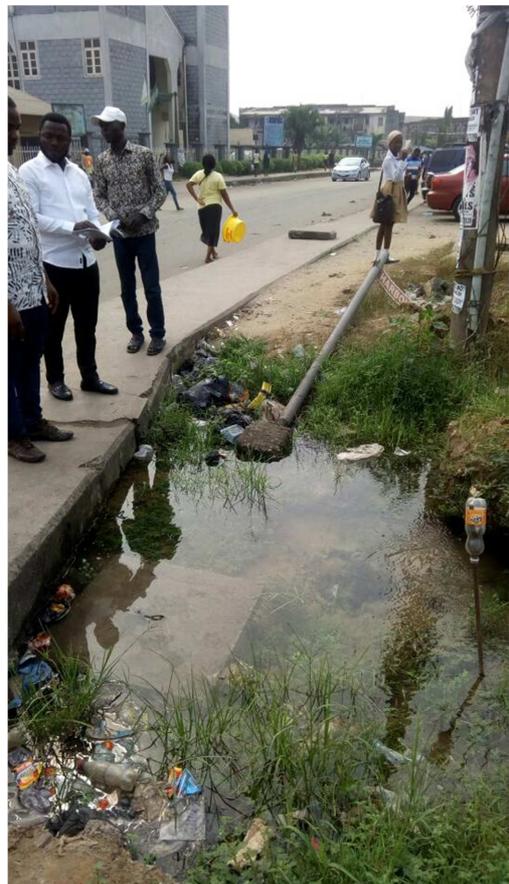
Figure 10. Lines from Moscow station showing leakages and refuse.

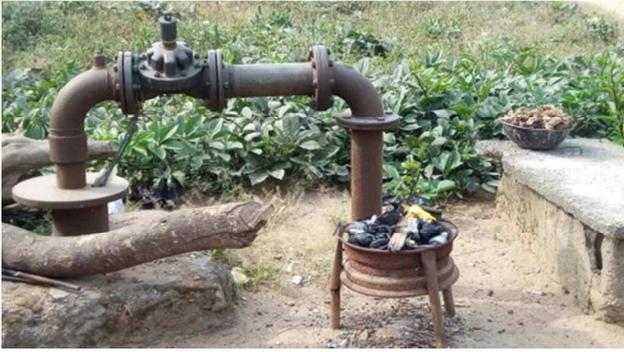
For Elemenwo Water Station, observations within this facility include: a borehole which is also not well maintained; abandoned generator set, two overhead tanks (one, in a bad state presently); and an open burning of waste close to fence

Figure 11. Dilapidated overhead tanks and abandoned borehole at Elemenwo Water Station.

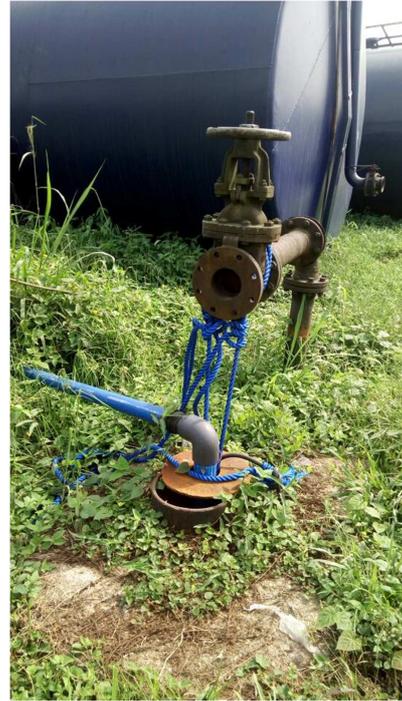
At Trans Amadi Water Station, the facilities observed include four Boreholes (1 abandoned but converted into use by a Gas Company operating within the premises); one cylindrical overhead tank; and one contact tank. Open waste dumps also litter the surroundings of this station and some waste dumps have been burnt closed to the fence (Figures 14 and 15).

Figure 14. Borehole converted and put into use by a Gas Company operating within the premises.

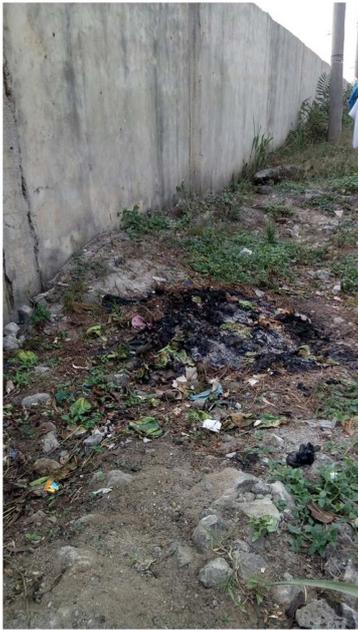
Figure 12. Waste litter the surroundings of Elemenwo Water Station and burning of waste close to the fence.

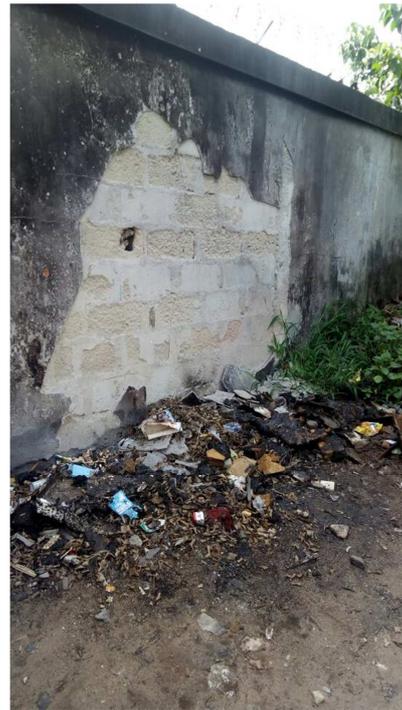
Figure 15. Open burning of waste close to fence wall at Trans Amadi water station.

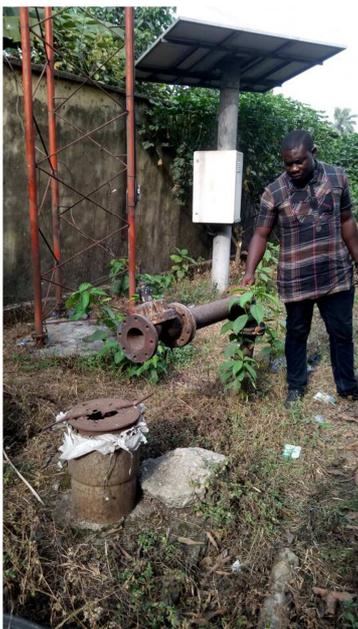
At Rumuokwurushi Water Station, observations showed that the station is not functioning as most of the equipment have broken down and require major repairs (Figure 13).

Figure 13. The facilities at Rumuokwurushi Water Station under disrepair.
