Research Article

Hydraulic Performance Evaluation of Irrigation and Drainage Infrastructure Serving Ahero Irrigation Scheme in Kenya

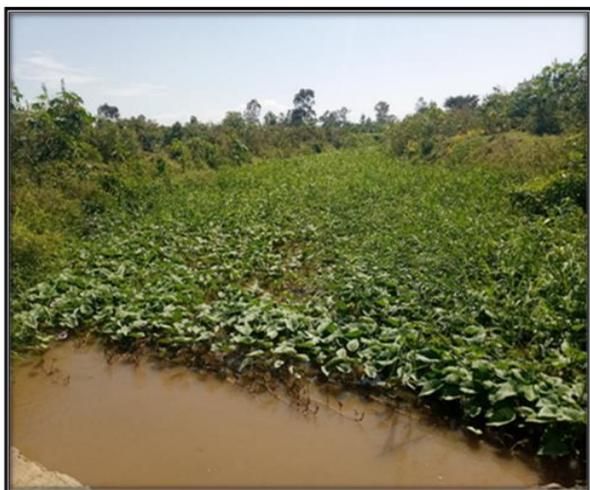
During the research period it was observed that the earthen main canal was invaded by aquatic weeds, see Figure 3. The aquatic weeds hindered conveyance of irrigation water in the canal, promoted irrigation water loss through infiltration from the canal's bed and the deposition of sediments onto the canal's bed [10]. The aquatic weeds in the canals were opportunistic because they used the water intended to irrigate the rice crop for their own transpiration. The aquatic weeds also caused blockages in the canals [9]. The invasion of aquatic weeds in the canal was attributed to poor maintenance or lack of it.

Figure 3. Poorly maintained irrigation canal invaded with aquatic weeds.

Based on the findings of this research study, the conveyance efficiency of the earthen main canal will improve if the earthen main canal's bed is lined with impermeable

lining. The preferable lining is concrete. The concrete will limit infiltration losses and growth of aquatic weeds. The geometric design of the proposed lined canal should have a trapezoidal cross-section for efficient water conveyance [16]. As a cheaper alternative before lining the earthen main canal with concrete, regular maintenance activities should be done on the earthen main canal such as desilting, reshaping of the canal's embankment, and removal of aquatic weeds to improve the conveyance efficiency of the earthen main canal. The failing water control structures should be rehabilitated to prevent losses of irrigation water in the earthen main canal.

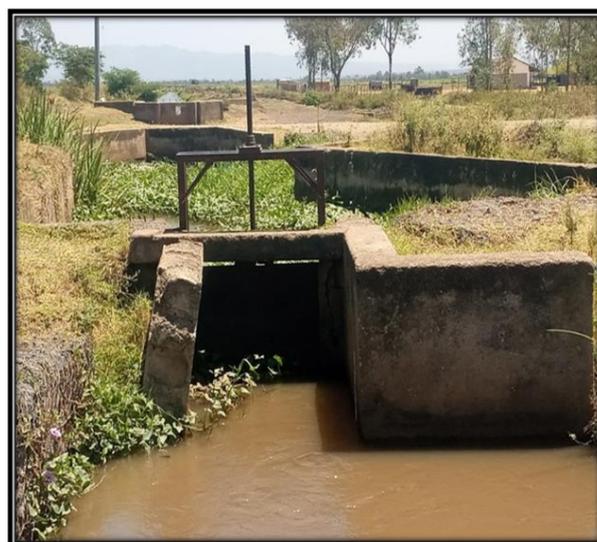
During the research period it was observed that some of the water control structures along the earthen main canal were not functioning properly. Figure 4 is a picture of a failing division box that has its wing wall leaning and collapsing towards the earthen main canal hindering the operation of the sluice gate. Figure 5 is a picture of a faulty sluice gate. The sluice gate is fully closed but still water passes downstream of the gate. The failing water control structures affected the ability to manage the canal water effectively. The inadequate provision of maintenance and vandalism caused by water users promoted deterioration of hydraulic structures along the earthen main canal [14]

Figure 4. Failing water control structure – Division box.

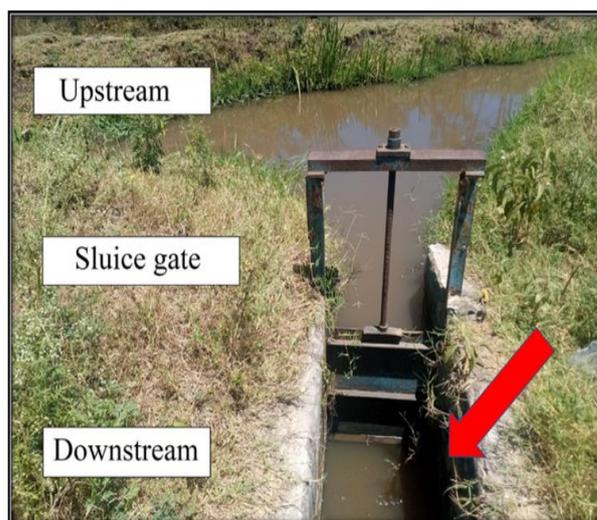
Figure 5. Failing water control structure – Sluice gate.
