# Geo-environmental Study of Soils Within the Double Landslide Area of Foreke-Dschang (Cameroon Western Highlands)

Landslide, Foreke-Dschang, Slope Stability, Granite-gneiss, Cameroon Western Highland

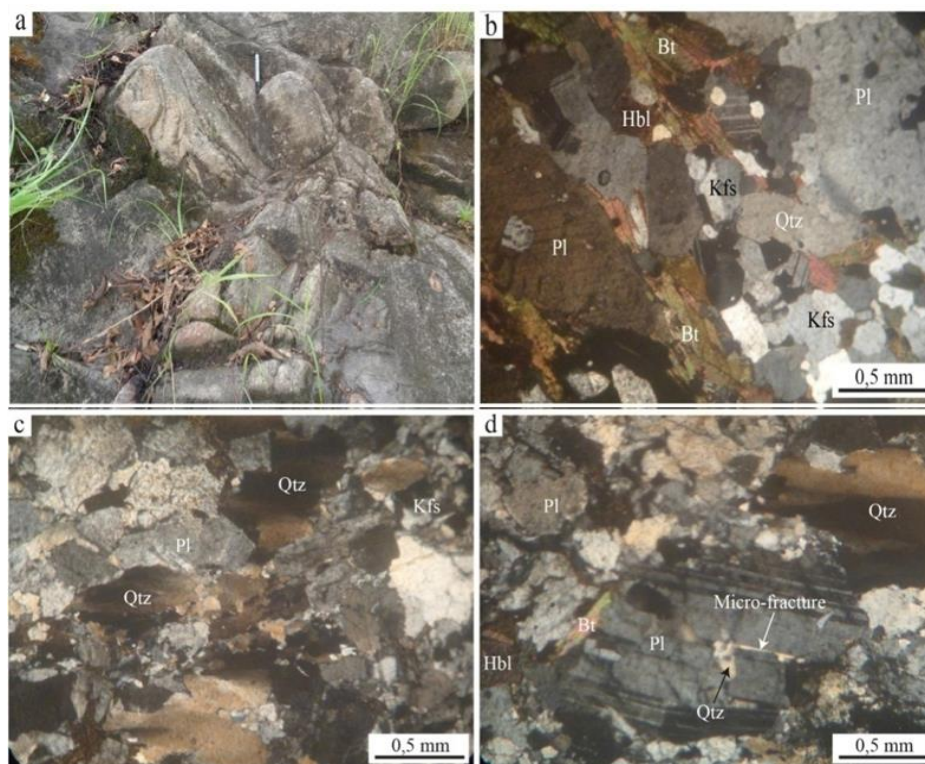
**Figure 3.** Outcrop mode (a) and microphotographs (b, c and d) of biotite and amphibole granite in the Foreke-Dschang locality.

The biotite and amphibole granite outcrops in the form of balls, blocks or slabs (Figure 3a). In places, the latter is in a vein in the biotite-amphibole gneiss. At the outcrop, the biotite-amphibole granite is dark gray in color, medium-grained with millimeter-sized minerals.

Under the microscope, the rock shows a porphyroidal grainy texture (Figure 3b).

It is composed of quartz, alkali feldspar, plagioclase, biotite, and amphibole. Apatite, zircon, sphene, and opaque minerals are also found. Quartz (35%) is colorless with sinuous contours and generally in xenomorphic crystals, less than 0.8 mm in size. It occurs in sub-grains or in flattened

sections with rolling extinction, thus forming polycrystalline ribbons (Figure 3c). Quartz contains plagioclase and biotite as inclusions. Plagioclase (25%) occurs in the form of large sub-automorphic patches. Its size is between 0.5 and 1.2 mm. The plagioclase sections are colorless and are identified by the presence of the polysynthetic twin of albite. Locally, this twin is flexuous. The plagioclase crystals are in places affected by micro-fractures filled with quartz (Figure 3b) or biotite flakes. Alkali feldspar (20%) is automorphic to sub-automorphic, up to 1mm in size. It has fractures perpendicular to the long axis of the mineral. It contains biotite, plagioclase, and opaque minerals as inclusions. (Figure 3b).

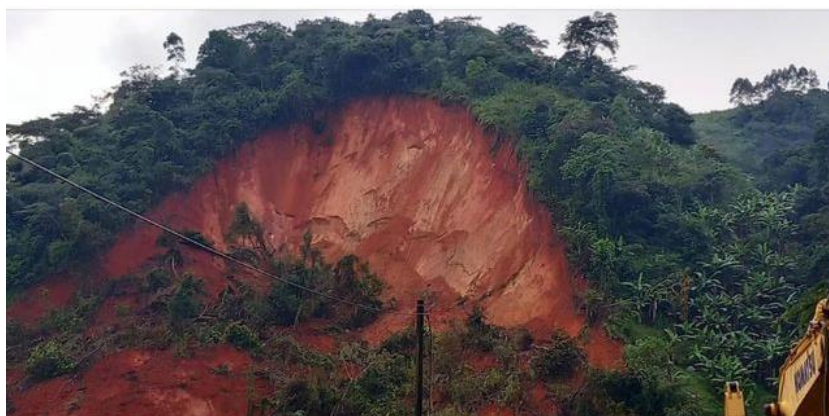
**Figure 4.** Morpho-structural view of the soils of the Foreke-Dschang cliff.

In situ descriptions indicate the humid tropical climate has led to intense weathering of the granito-gneissic basement forming a mantle of saprolite-type alterites up to 8 m thick. This weathering mantle constitutes a friable, fragile complex that is very sensitive to water input. The weathering set are topped by medium-thick size soils with a sandy-clay texture on which the presence of sandy colluvium and coarse scree is often possible. In conditions of steep slope, the rupture of the terrain can occur at the scale of a slope. The very thick profiles in the locality illustrate the extent of this phenomenon. Indeed, the soil profiles are 2 to 18 m thick in places from the A horizon to the BC horizons (Figure 4). Also, the weathering mantle rests on granular rocks such as gneisses and granites which release abundant in the BC horizons.
