# Delineation of Leachate Plume and Subsurface Characterization Using Geophysical Method of Sisdol Landfill Site, Nepal

Suraj Belbase<sup>1,\*</sup>, Khomendra Bhandari<sup>2,\*</sup>, Dinesh Pathak<sup>2</sup>, Umesh Chandra Bhusal<sup>2</sup>

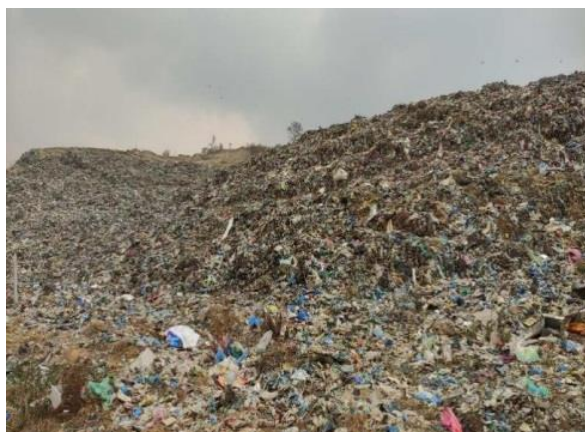
Figure 2. Landfill site.

The study area is easily accessible via Balaju Bypass- Tinpi-Sisdol landfill site road. Public transport is available from Balaju Bypass to Tinpi. A motorable road is connected from Tinpi to the study area. Many tracks are connecting local villages that make the area accessible by motorbike and jeep. Figure 1. Figure 2 show the thickness of solid waste material.

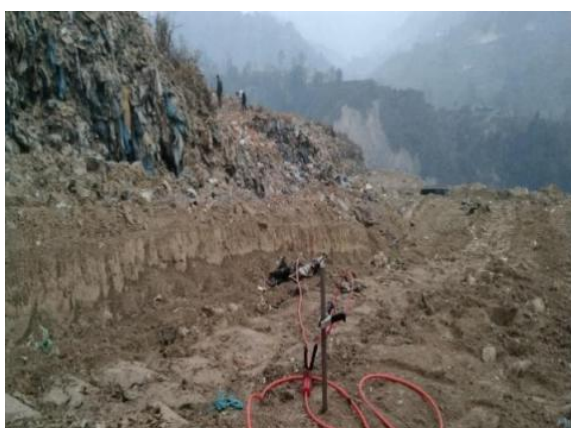
The resistivity measurements are obtained by injecting a known value of Direct Current (DC) into the subsurface with the help of two current electrodes “transmitter” and the resulting voltage difference is measured with the help of two potential electrodes “receiver”. In this two-dimensional electrical resistivity survey, an array of stainless-steel electrodes spaced in a defined interval is placed in the ground where different combinations or arrays of transmitting and receiving electrodes are used Figure 5.

**Figure 5.** Resistivity data acquisition arrangement.
