Research Article

# The Seismic Performance of RC Frame Structures with Exterior-Hanging Green Self-Insulating Wall

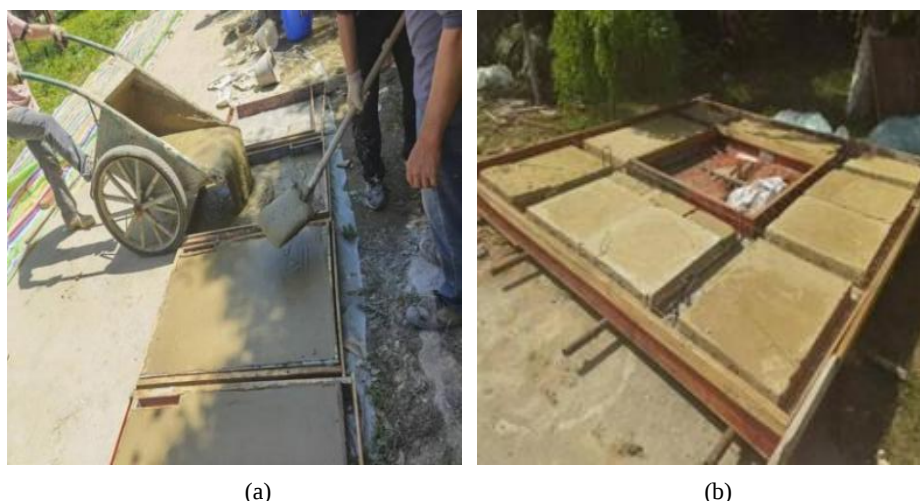
**Figure 4.** The cement-based porous thermal insulation soil core (a) Production, (b) Installation.

The production and placement of the cement-based porous thermal insulation soil core material for the wall panels are shown in Figure 4.

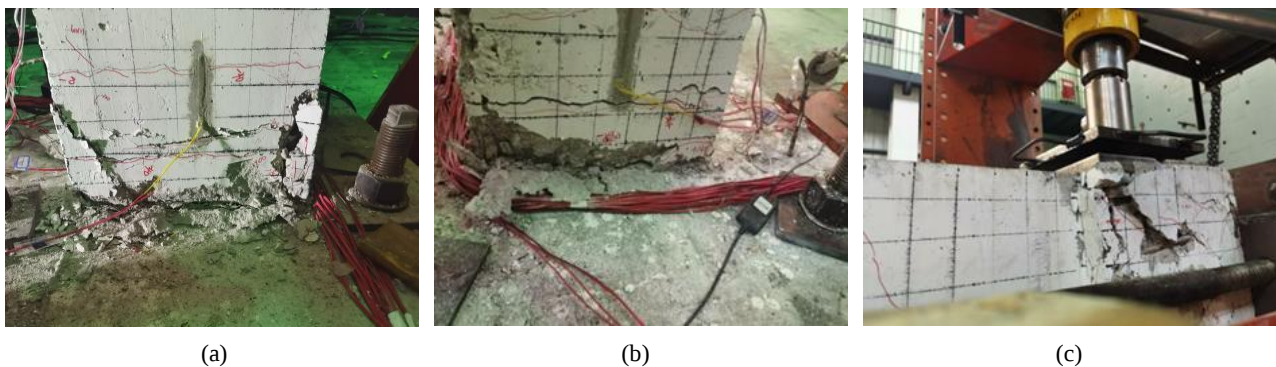
**Figure 7.** Crack patterns of specimen K1. (a) Low-ends of the left column, (b) Low-ends of the right column, (c) Beam-column joint.

For the K1 specimen, when the loading drift was less than 8 mm, the specimen borne relatively small loads, with no crack occurred, and the structure was in the elastic stage. When the loading drift was between 8 mm and 40 mm, cracks developed progressively at the low-ends of the RC columns and at the beam-column connection joints. The concrete at the cracked locations no longer borne tensile stress, while the stress in the steel reinforcement increased. As the loading drift increased, the stress in the steel reinforcement reached its yield strength. After the loading drift exceeded 40 mm, cracks developed rapidly, with longitudinal cracks appeared in the compressed concrete area, resulted in a chaotic crack network. As the loading drift completely increased, the concrete is completely crushed, and a plastic hinge forms at the low-ends of the RC columns, with shear failure occurred at the beam-column connection joint, as shown in Figure 7(b).

Specimens K1, K2 and K3 all formed plastic hinges at low-ends of the column. Before micro-cracks appear in the beam, there are micro-cracks at the joints, but the presence of stirrups can limit the development of micro-cracks.
