Use of Debris Program of Civil Construction Waste Management in Containment Residential Erosion Geovanni Braga in Anapolis in the State of Goiás

Welvis Furtado da Silva, Ernane Rosa Martins. Use of Debris Program of Civil Construction Waste Management in Containment Residential Erosion Geovanni Braga in Anapolis in the State of Goiás. *American Journal of Civil Engineering*. Vol. 3, No. 6, 2015, pp. 207-216.

Thus, this research aims to present the use of debris Construction in curbing the environmental impact of erosion Residential Geovanni Braga by the Municipal Works, Urban Services and Property Anapolis City Hall in the State of Goiás in 2015.

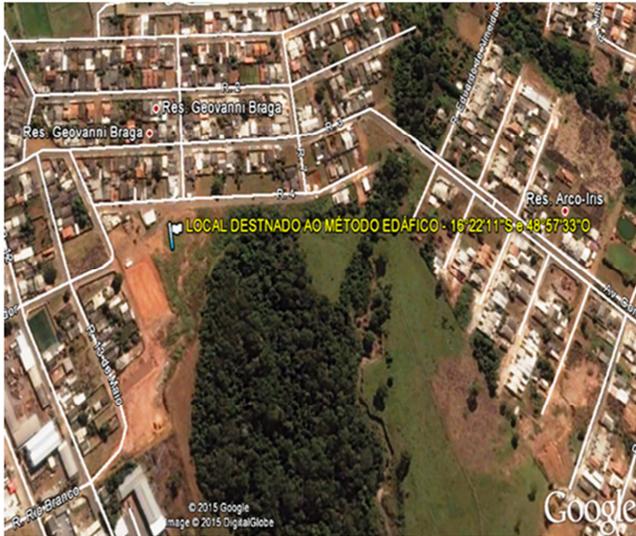
Figure 1. Local intended to edáfico Method.

bank by the Ombudsman Street and 4th Street, at coordinates 717928 E / 8189088 N. This process voçorocamento settled perpendicular to the slope Goes Stream, a tributary of the Antas River, as shown in Figure 1 Goggle Earth date of 05/31/2015.

The erosion was arranged in the direction North West / East, it has a linear shape with a length of approximately 550 meters, the average width of approximately 25 meters and an average depth of approximately 12 meters.

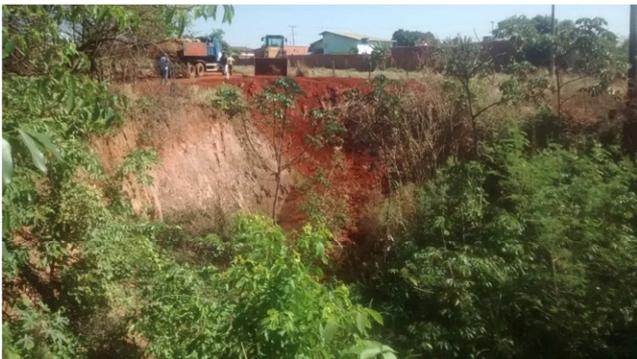
Figure 2. Erosion.

The recovery of the area was carried out by edáfico method, which includes the recovery of all battered area in the primitive land containing approximately 8214 m², the more the soil profile (slope) on the edge of the forest, as shown in Figure 2.

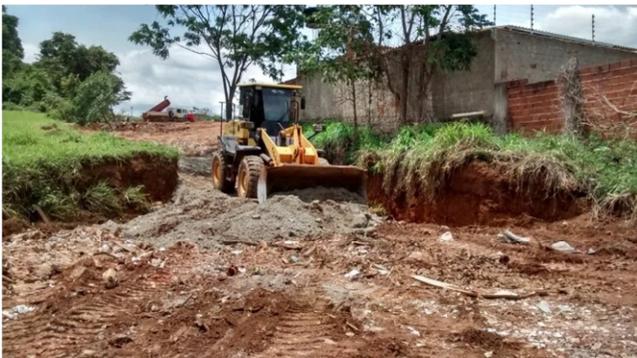
Figure 3. Use of machinery.

This operation consists of removing all loose sediment and also those who were in unstable conditions. The removal was done manually and with the use of machines as shown in Figure 3.

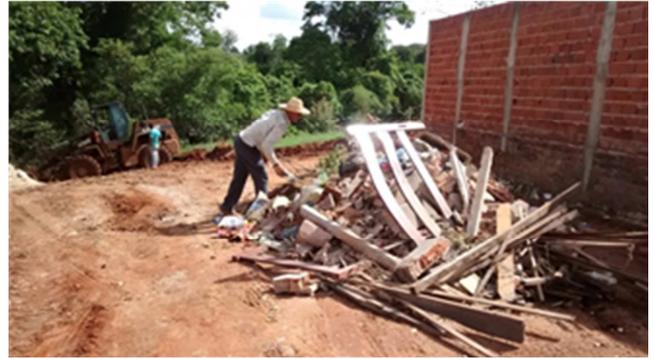
Figure 4. Waste Segregation manually.

It was allowed to waste pickers perform the collection, as shown in Figure 4.

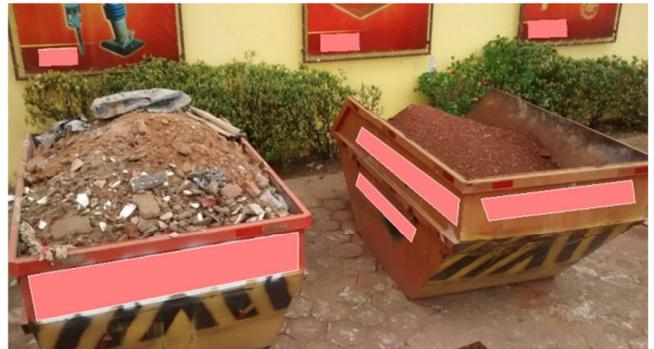
Figure 5. Buckets with segregated rubbish.

The local government allowed the population had free access to the site, however, was allowed only the disposal of rubble. Companies (disk-rubble) responsible for collecting this type of material were asked to sift through and gather their buckets, any other kind of material between them, such as soda cans, water bottles, candy wrappers and ice cream, as shown in Figure 5.

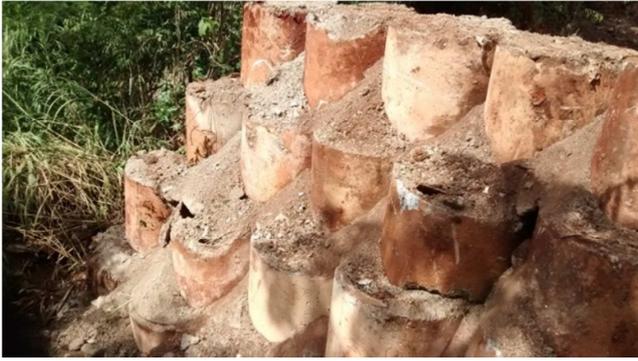
Figure 6. Anchoring.

The construction of the palisades was taken downstream of the gully with sewage or rainwater shackles no longer usable available in town, as shown in Figure 6.

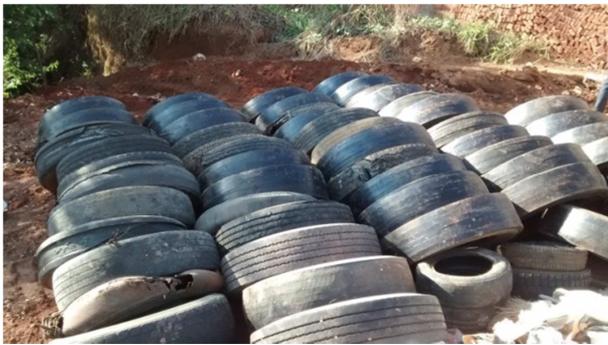
Figure 7. Tire use.

To fix the palisades were held drainage lines of the gully. They were then accommodated tire to absorb the impact of the water passing through the palisade. The use of tires prevents water make a drag (hole) after the stockade, compromising its structure, as shown in Figure 7.

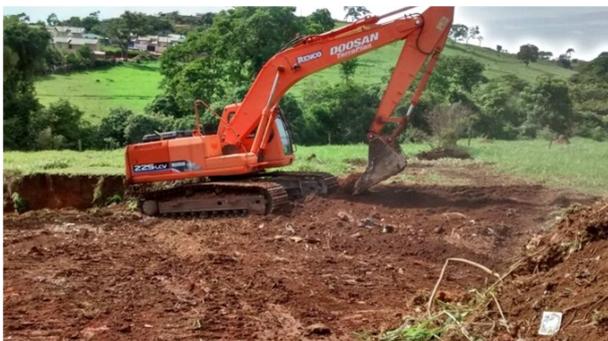
Figure 8. Use of machines for conformation.

The area voçorocamento presents part with ravines and unstable slopes, conducting reshaping is necessary to ensure stability and allow the planting and establishment of vegetation. This work was carried out with the use of machines in the dry season in order to have the area ready to accommodate planting at the beginning of the rainy season, as shown in Figure 8.

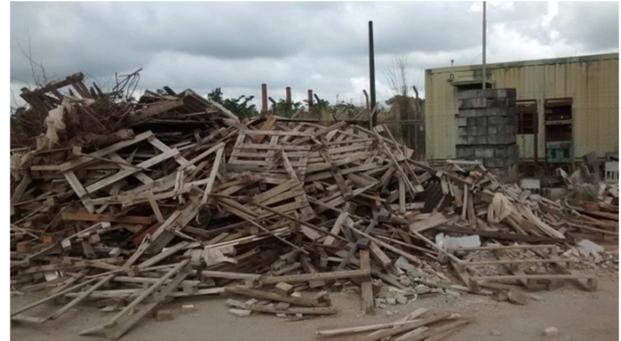
Figure 9. Used woods.

After performing the mechanical practices, construction of palisades and the reshaping of slopes and ravines, passed to the application of plant remains for the formation of mulch

on the eroded surface until the herbaceous, shrub and tree implanted to establish and ensure good protection to the soil. For this, we used the residue of vegetable origin such as straw, bark, sawdust, wood and other materials available in town, as shown in Figure 9.

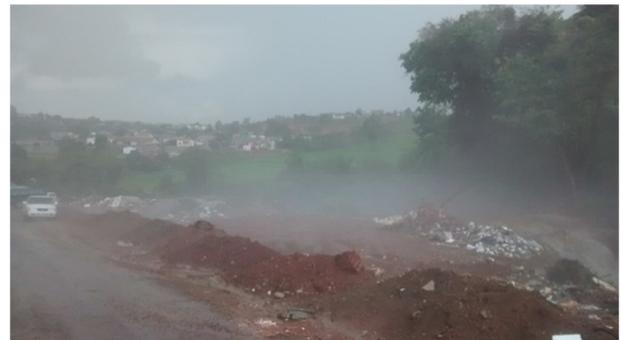
Figure 10. Result of the composting of organic matter.

It was directly applied to the right surface completely biodegradable product (Embiotic - Throttle composting) to speed up the composting of organic materials that contribute to the recovery of the biota in the soil, control erosion and stabilization of slopes and embankments, Figure 10 shows the result during rain after application of this product.

The application of the composting accelerator immediately protected conserving soil moisture for a long period of time. Besides that after certain period it initiates composting providing nutrients to the soil which is absorbed by the root system of the plants and keeping the freshness of vegetables.

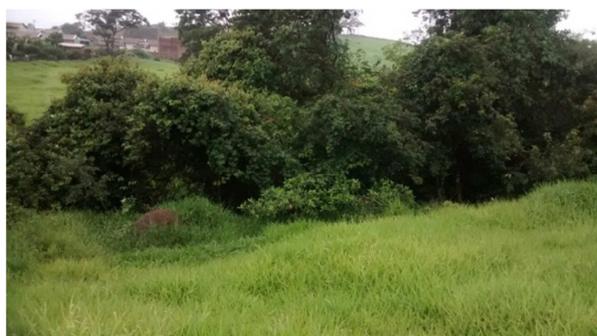
Figure 11. Downstream of the recovered gully.

Periodic inspections were carried out the excavation, erosion containment terraces and picks up the seedlings that were inserted into the area of interest. And carried out periodic maintenance on replanting to prevent the loss of grass layer formed on the surface thus accelerating the retreat of the attacked area. In Figure 11 is shown downstream of the gully recovered and restored vegetation.

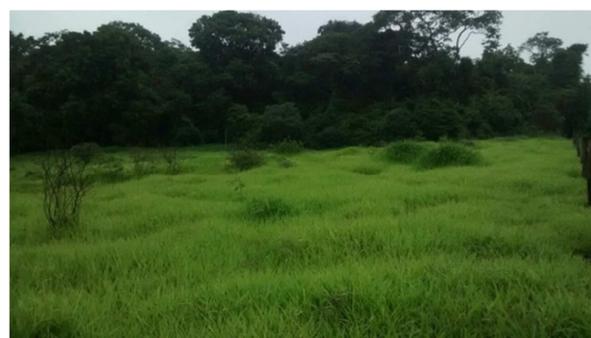
Figure 12. Front view of the recovered gully.

Figure 12 provides a front view of the gully recovered and restored vegetation cover (quarantine area).
