Cause Analysis of the Secondary Mountain Disaster Chain in Wenchuan Earthquake

Ranran Pei, Zhenqiang Ni, Zhaobo Meng, Baoliang Zhang, Yuanyuan Geng. Cause Analysis of the Secondary Mountain Disaster Chain in Wenchuan Earthquake. *American Journal of Civil Engineering*. Vol. 5, No. 6, 2017, pp. 414-417. doi: 10.11648/j.ajce.20170506.24

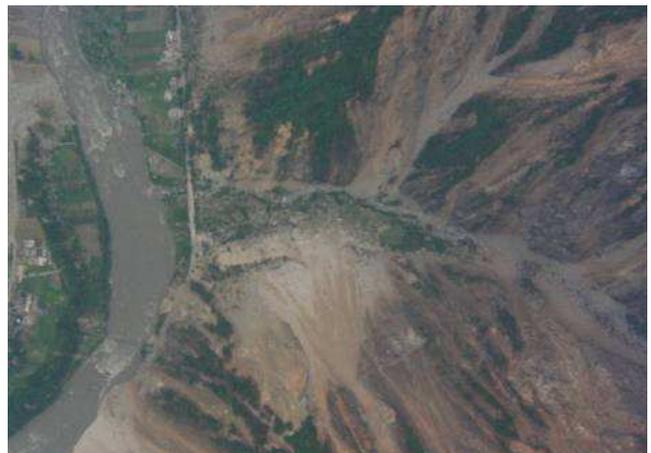
Figure 1. Mizoguchi earthquake aerial remote sensing images (2008. 05. 26).

A large number of beng accumulations have been accumulated in the channel after the earthquake gully. In December 2008, the situation was studied, and the average thickness of Mozigou accumulation of debris flow fan is about 30 meters. The accumulation body side is about 1 million and 500 thousand m^3 (Figure 1). A large number of deposits decline in water, resulting in river blockage, the formation of lake.

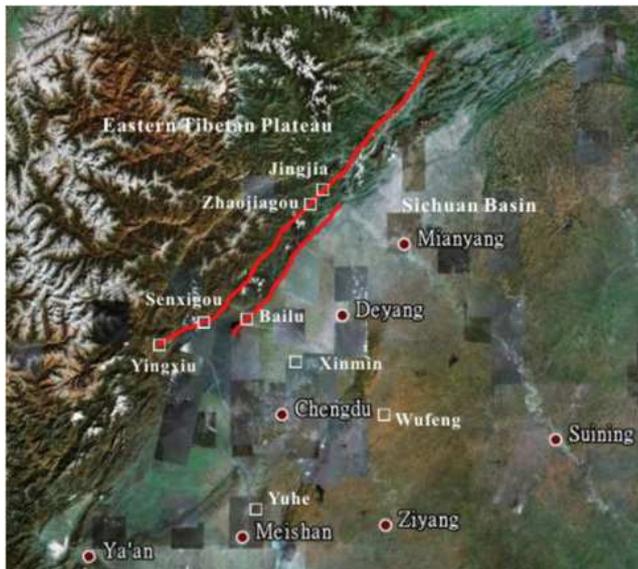
Figure 2. Regional river basin distributions (Jianjin Cao, *et al.*, 2017).

A typical landscape is located in the mountains around the basin. Longmen mountain area is mainly composed of a mountain near the North West to the east. The Jiaoziding peak is elevation of 3045 m, and the lowest point is in the South Fujiang River confluence of 700 m dam. The vertical is height of 2256 m, and the maximum distance is 16.94 km. Located in the tributary of the left bank of river, the shape of the basin is a typical pattern of the plume. The basin area is 158 km², and the confluence of the catchment area is large (Figure 2).
