Research/Technical Note

Evaluation of Sewerage System Sustainability Technically Around Condominiums Areas: A Case Study in Debre Berhan, Ethiopia

Department of Civil Engineering, University of Debre Berhan, Debre Berhan, Ethiopia

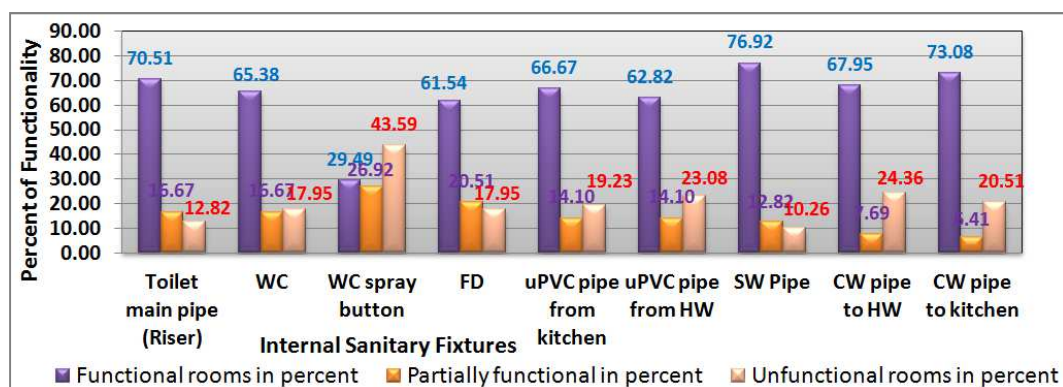
Figure 2. Functionality status of fixtures in internal sanitary system.

The physical status of fixtures installed in study buildings varies on different buildings as observed on figure 2 above. As

can be seen on figure 2 among 58 toilet riser (truck pipe) only 41(70.51%) are functional; 9 (16.67%) are partially functional

and the rest 8 (12.82%) are not functional as required. In the same manner the functionality status of all fixtures are indicated on figure 2 above in percent.

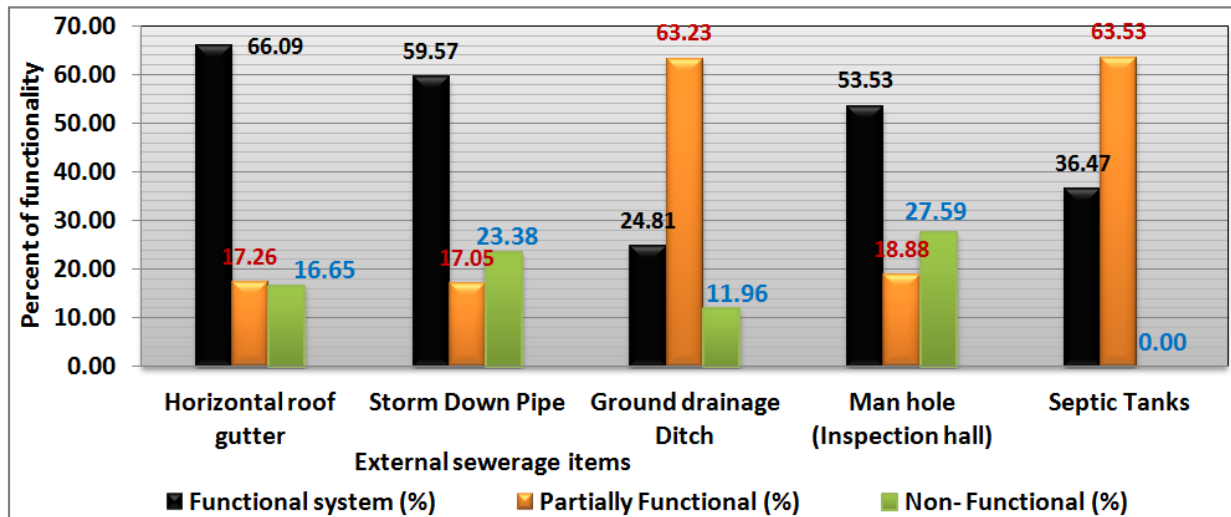
Figure 3. External Building sewerage scheme functionality status.

As indicated on graph above, around 74% of drainage ditch constructed around building could not give required function. This is the main cause observed for poor waste flow collection to dispose area. Around the area of buildings the numbers of surcharged sewers are high.

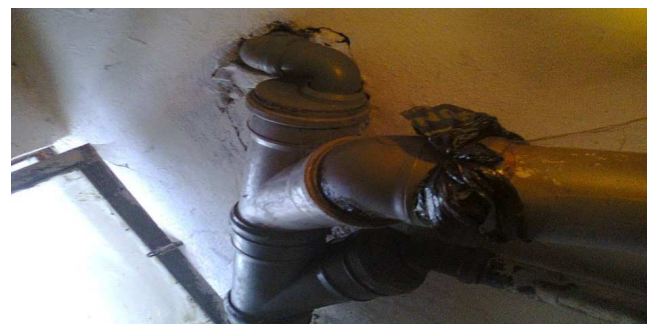
Figure 4. Leakage on main track (soil pipe).

Leakage of pipe at fittings: During construction/installation sewer lines and fittings on the sewer line are not appropriately installed. This implies that the two line which connect each other is not fitted correctly even by using any other fixture liquids such as solvent cement 500mg and fibers.

- A regular checking of the sewerage system, manhole cleaning and application of dilution are essential in order to ensure safety of community health.
- Giving maintenances for fixtures which leak flow and replacing fittings which show any rupturing and break.

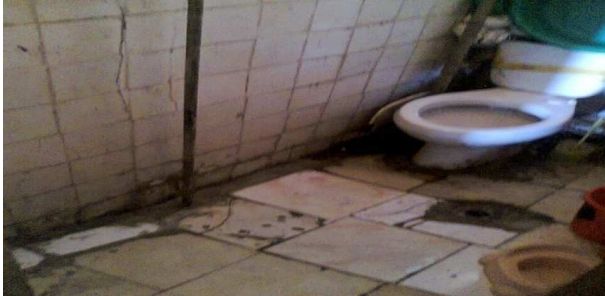
Construction problem: miss of necessary construction item in building.

Figure 5. Missed shower tray from construction.

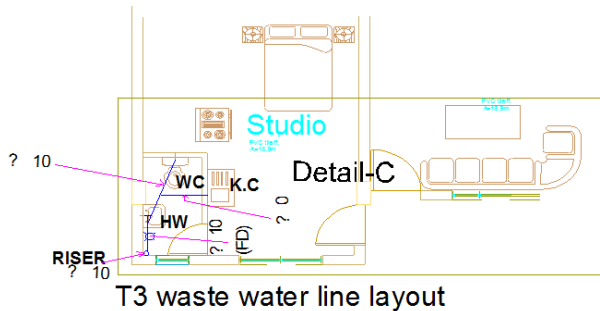
Figure 6. Design problem observed on sanitary line layout.

The alignments of line and fixture sit are loosely planned, during design. The line of sanitary sewer takes large space in the room (for eg, in T3 typology, studio room, the line of sanitary sewer takes large space in the room).

- For those the sanitary alignment seen sever problem regarding space and material quality realignment is preferable based on the willingness and cooperation of households, who the line coincide their room.

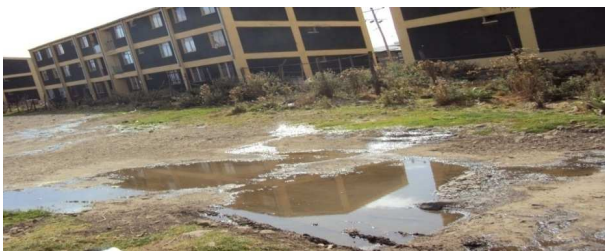
Figure 7. Leakage and over flow of sewage from septic tanks.

There is no periodical suck way implemented as per design, there is lateral inflow through the soil. Due to this, the flow from septic tank is simply leak to external road, side ditch without any secondary treatment which is the cause of health problem to communities. Eg Kebele 2 (site 3) and Kebele 7(melikt academy area).

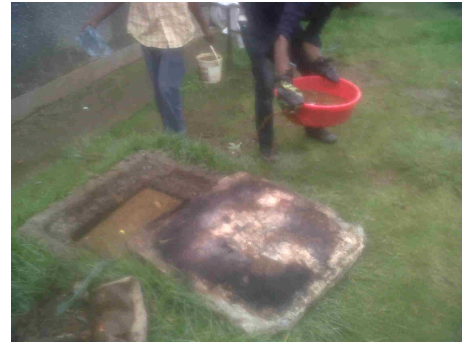
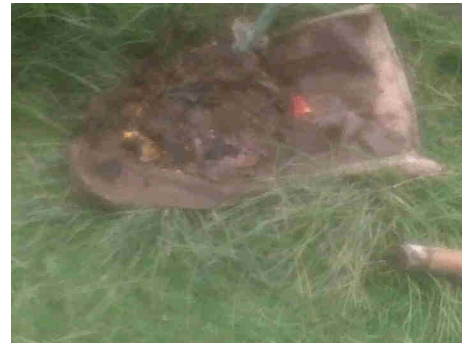
Figure 8. Community collects solid wastes from manholes manually which blocks sewers.

Solid wastes deposited on sewer line, in drainage ditches, manholes and septic tanks. Due this there is surcharge of wastes and over flow to the ground surface. In addition composite of solid waste around sewer, makes very difficult for sewer supervision.

- The initial task has to be make awareness between the communities; how to use sanitary fixtures, way of

dispose solid waste.

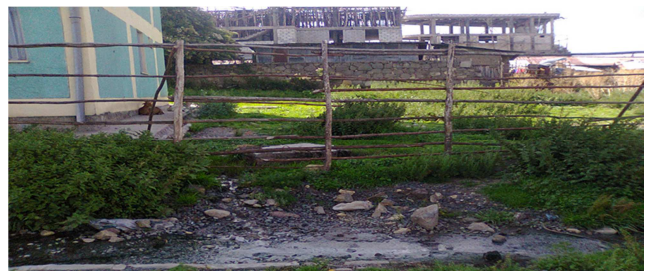
Drainage ditches, manholes and septic tanks are totally buried under solid wastes (i.e., Stones, animal bones, and different garbage's) easily enter to the box and block the out let pipe frequently and fill manholes and block the flow line. Due this there is surcharge of wastes and over flow to the ground surface. In addition composite of solid waste around sewer, makes very difficult for sewer supervision.

Figure 9. Overflow of sewage from manholes due to solid wastes filled in holes.

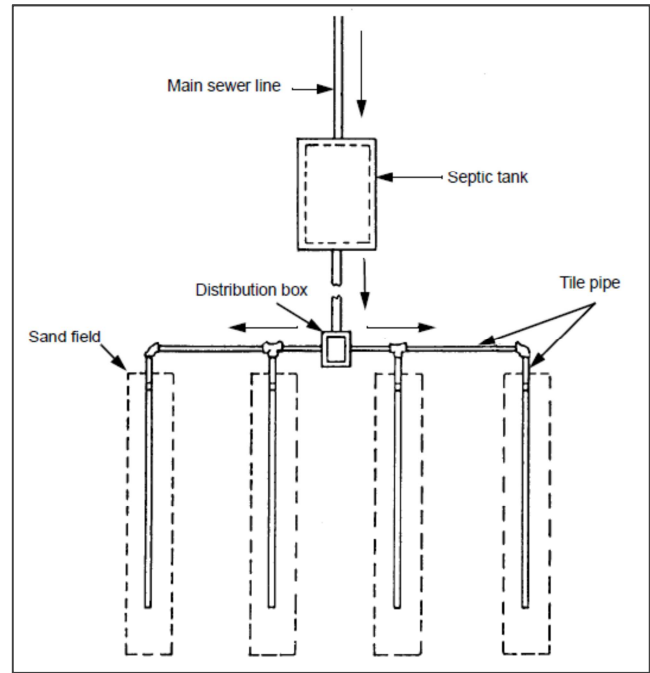
Sand Filter Media and Soak away pits (based on soil percolation and topography of the area)[7].

According to laboratory result, soil type of Kebele 1,2,4 and 9(site1,site3,site4 and site7) show us sand and gravel which have greater percolation capacity than other types. So we can use such type disposal method in these a sites.

Figure 10. Sand Filter Media.

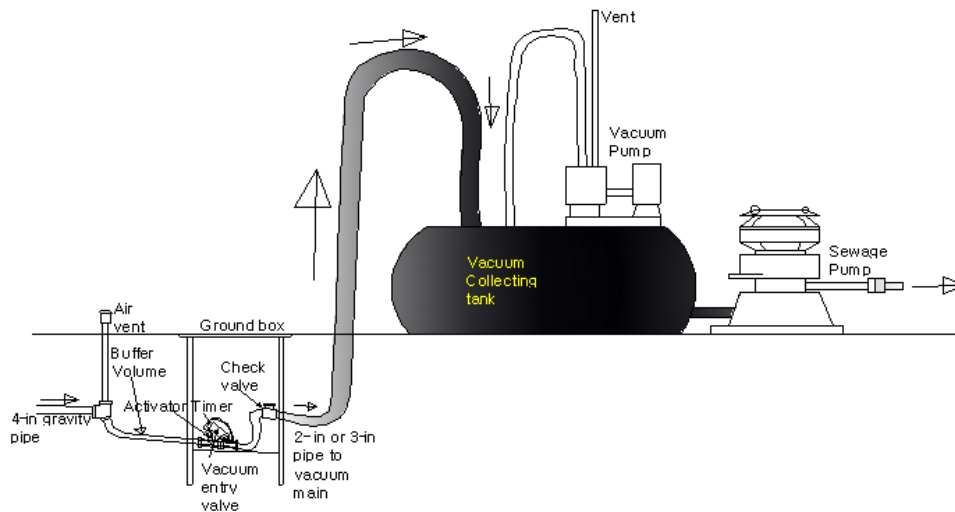
Vacuum Systems: 50 to 150 mm (2 to 6 inch) plastic pipe is buried deep in a vacuum, the source is connected to the vacuum through entry valve which opens automatically when a sufficient volume of sewage has accumulated and recloses when time interval reach to be drawn into the main. Then the vacuum is maintained by pumps at a central collecting tank [18].

Figure 11. Vacuum system.
