Restoration Efforts of Degraded Land, Challenges and Prospects: The Case of Soro Wereda, Hadiya Zone, Southern Ethiopia

Eyasu Estefanos Shanko. Restoration Efforts of Degraded Land, Challenges and Prospects: The Case of Soro Wereda, Hadiya Zone, Southern Ethiopia. *American Journal of Environmental and Resource Economics*. Vol. 7, No. 3, 2022, pp. 77-86.
doi: 10.11648/j.ajere.20220703.13

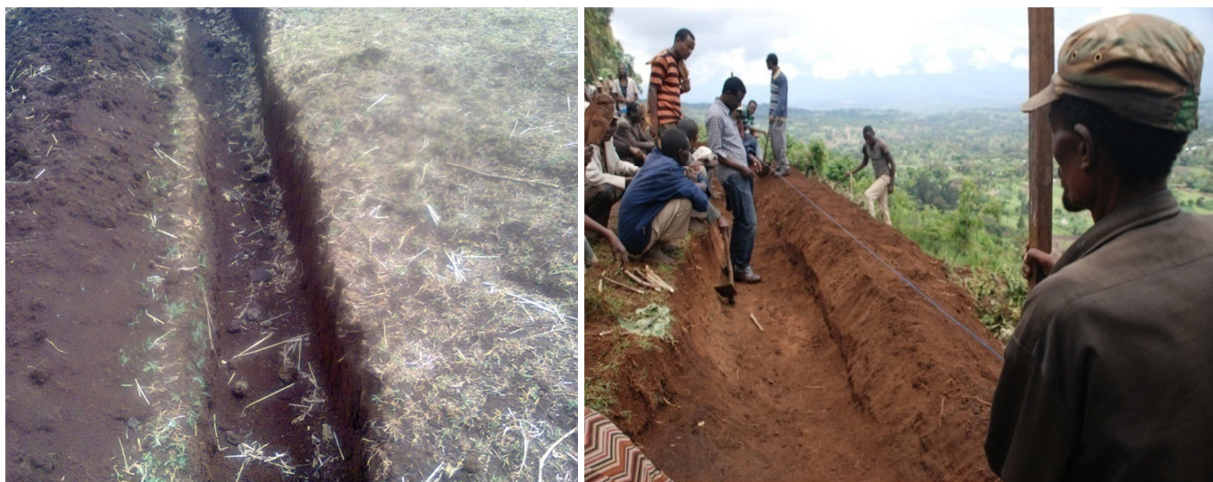
suitable mostly in moist areas of the country with medium to high rainfall. This safely diverts the run-off to a waterway, river, gully and the like [14]. Based on field observation, study area is found at the steep slope and this contributed to degradation of land and currently the rural community is involved in participatory watershed development program in order to rehabilitate the degraded land that is found at the bottom (See figure 3).

Figure 3. Practice of cut off drain in study area, Photo by Researcher, 2015.

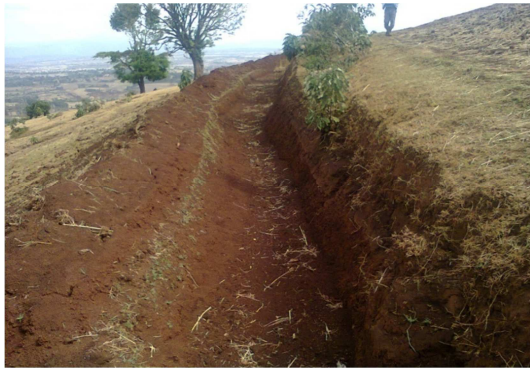
along the steepest slope on in a valley to receive accommodates runoff from cut-off drains and graded terraces/ bunds. This measure was used to carries the run-off to rivers, reservoirs or gullies safely without creating erosion [14] (See figure 4).

Figure 4. Practice of water way Photo by Researcher, 2015.

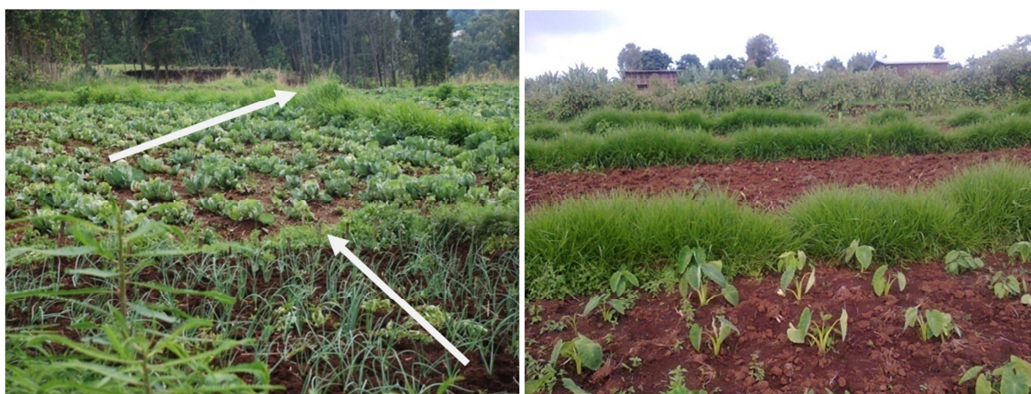
Figure 6. Grass strip by the local farmers at 1st Hankota Kebele Photo by Researcher, 2015.

Grass strip has been practiced by 35.1% of the sample households. The grass is either planted or naturally grow in narrow strips along the contour at intervals across the slope of a field for the purpose of reduce runoff, nutrient loss and for the improvement of the fertility of soil. This measure also involves the growth of natural grasses between croplands across the contour and planted grasses between the crops across the contour line (See figure 6).

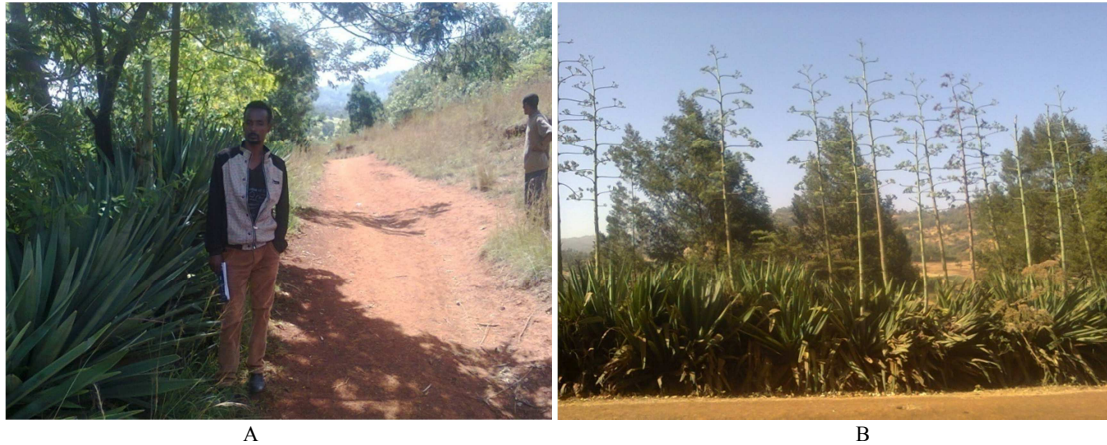
the soil and water conservation measures (See figure 7). The zero management makes it also the cheapest method for rehabilitation of degraded areas. Nonetheless, in a few cases, enclosures are supplemented with enrichment planting of native and/or exotic species as well as soil and water conservation measures to speed up the recovery process.

Figure 7. Live fencing to protect closure areas from human and livestock interference for restoration purpose A and B at Shara and Hirche Uyaya Kebeles respectively (photo by Eyasu Estefanos, 2015).

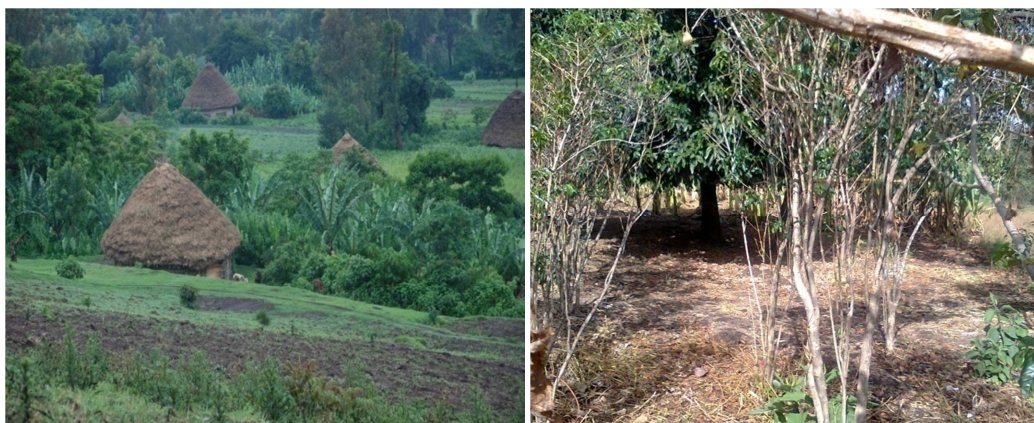
Based on the field observation in the study area the rural community practiced the agroforestry through planting of trees and shrubs and besides of that they plant coffee (*Coffea arabica*) and edible fruits such as mango (*M. indica*), apple (*Malus domestica*) and avocado (*P. Americana Mill*) with combination of enset (*Ensete Ventricosum*) and other crops like maize, teff and sorghum on their farmlands with the aim of, to minimize the soil erosion from land (See figure 8). This measure has also contributed to rehabilitation of degraded land through reducing soil erosion and increasing the fertility of the soil.

Figure 8. Practice of Agroforestry by local community at 1st Hankota Kebele (Photo by Researcher, 2015).
