Our Water Mains Contaminate Us with E. Coli, Lead and Copper – Preventable Illness and Death Follow

Robert Allan Leishear

Robert Allan Leishear. Our Water Mains Contaminate Us with E. Coli, Lead and Copper – Preventable Illness and Death Follow. *American Journal of Water Science and Engineering*. Vol. 7, No. 2, 2021, pp. 72-96. doi: 10.11648/j.ajwse.20210702.15

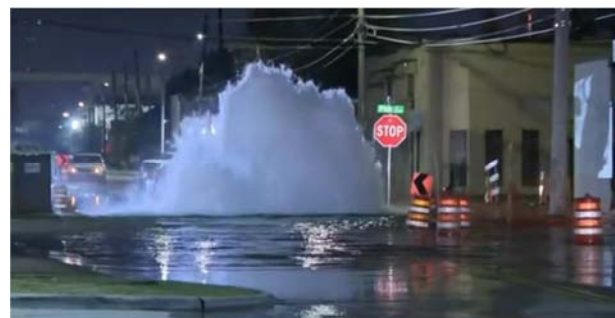
Figure 6. Houston Water Main Break, February 2, 2021 (Adapted from Click2Houston.com).

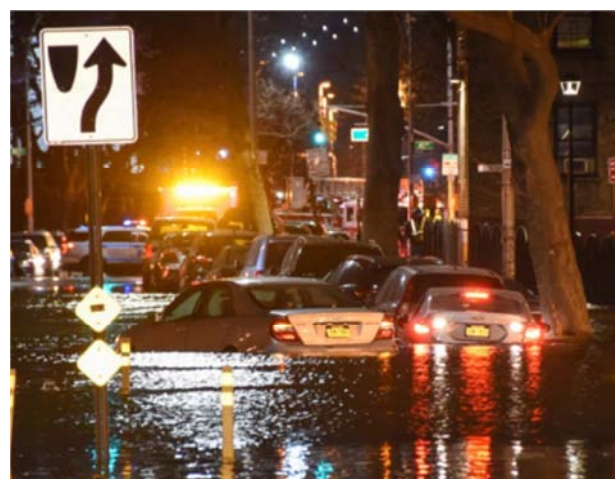
Figure 7. New York Water Main Break, January 28, 2021 (Adapted from The New York Post).

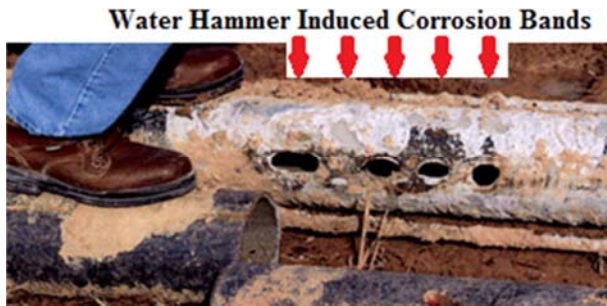
Figure 19. Evidence of Pressure Bands and Fatigue Induced Corrosion (Adapted from Leishear [3]).

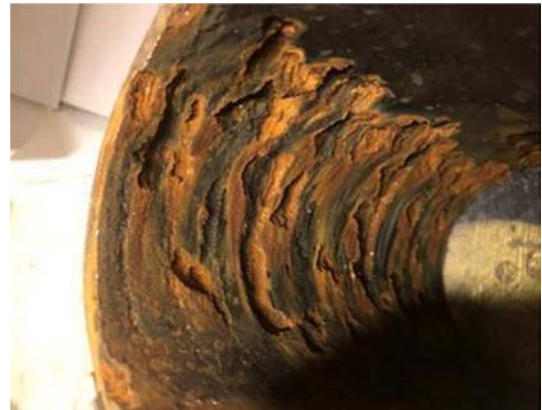
Figure 22. Bands of Fatigue Due to Water Hammer Pressure Waves.

process of fatigue corrosion is unique to the literature. Figures 22 and 23 show bands of corrosion that mimic the fluctuating stress patterns that are observed during the transmission of pressure waves in piping. These observations also fit the data collected in Figure 18.
