# Summary of Color Difference on Exterior of Stainless Steel Buildings

Zhenglin Luo, Yaoheng Wang, Lin Huang

China Construction Shenzhen Decoration Co., Ltd, Shenzhen, China

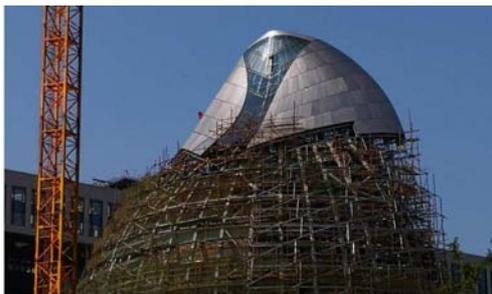
After the installation of the top stainless steel plates of the Science and Technology Museum, color difference between the top stainless steel plates installed around the building was found in the distance. The color changed with different viewing angle. The color difference was also different when observed in the morning and evening, or on sunny, cloudy and rainy days.

Figure 3. Stainless steel color difference (illuminated face).

The on-site installation was suspended immediately; the plate production in processing plant was stopped [1].

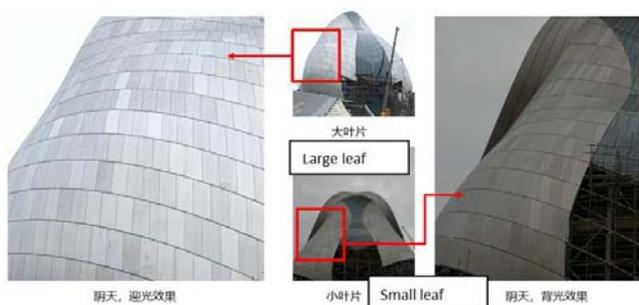
The stainless steel building is in hyperbolic physical shape. There is stress in the curved plate due to plate deformation caused by external force. The stress will emit different colors in the visible light spectrum [8]. There is also a slight color difference in the external surface of a plate due to the different amount of sunlight received by the curved surface in the same plate

Figure 8. Effect of illuminated face in cloudy day. and effect of shady face in cloudy day.

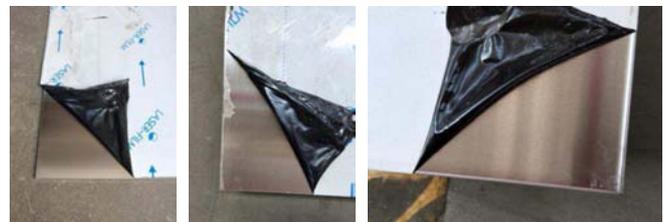
(1) The raw material plates of three furnace numbers were marked with Furnace A, Furnace B, Furnace C and grain direction of plates respectively, and cut into six pieces of 1000mm×1000mm by laser. The surface films were torn apart to compare whether the raw plates have color difference.

Figure 10. Raw plates of three furnace numbers.

(2) Six plates of different furnace numbers (2 plates for each furnace number) were sandblasted in the direction marked on the sandblasting machine (old machine). According to actual observation, there is no color difference between plates with different furnace numbers using the same sandblasting machine.

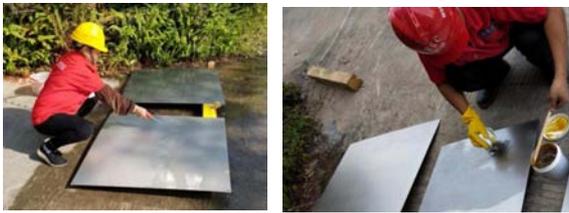
**Conclusion of Test 2:** The raw material plate with furnace number of Furnace C was marked with grain direction of plate and cut into four pieces of 1000mm×1000mm by laser. Polishing was carried out first. Two pieces of plate were sandblasted in the direction marked on the newly purchased small sandblasting machine (new machine); the other two were sandblasted in the direction marked on the original large sandblasting machine (old machine). According to the observation of samples, it was found that the sandblasting of small sandblasting machine (new machine) is relatively rare with sandblasting lines. The sandblasting color of large sandblasting machine (old machine) is darker. A piece of plate sandblasted by the small sandblasting machine (new machine) and a piece of plate sandblasted by the large sandblasting machine (old machine) were taken for pickling [9].

Figure 11. Pickling on outer surface of stainless steel.

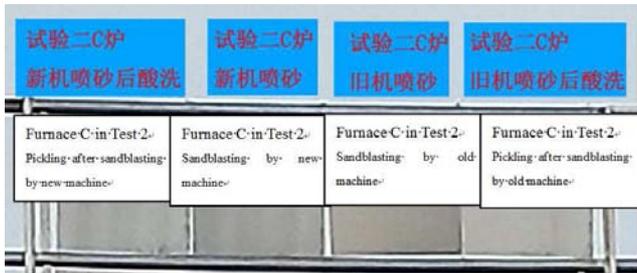
Figure 12. Comparison after pickling.

Discoveries in the test: The acid concentration, acid's duration of stay on the stainless steel surface and the sun's temperature obtained on the stainless steel surface will change the color difference after pickling significantly. The color of stainless steel surface will be inconsistent under slightly different pickling conditions.

According to the test, pickling on stainless steel surface should be eliminated first. There will be obvious color difference between the surface colors of plates after pickling. The uniform color of stainless steel surface of entire building can only be achieved by immersive pickling, but it cannot be implemented. If large-area pickling is carried out in situ, there is a hidden danger of liquid flow marks, which will cause secondary color difference.

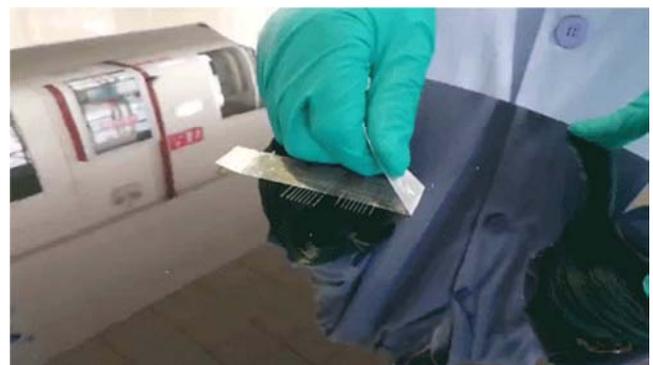
Figure 15. Schematic diagram for adhesion testing of fluorocarbon coating in testing report.

Conclusion: In the surface coating testing, the adhesion is 0 without peeling.

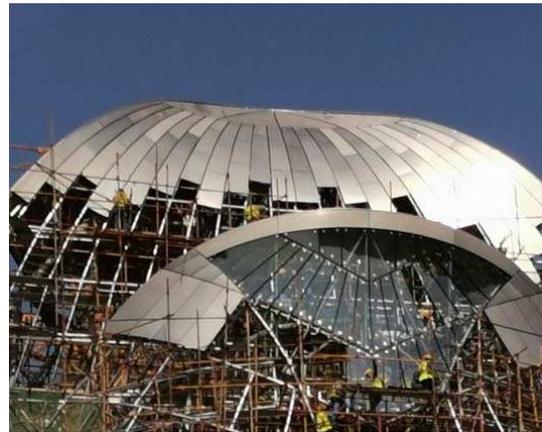
The installation of stainless steel took four months. In field observation, it was felt that as time went by, the overall outer surface color of stainless steel was more consistent with reduced color difference compared with the previous period [12].

Figure 17. Photo taken on a sunny day on August 29.

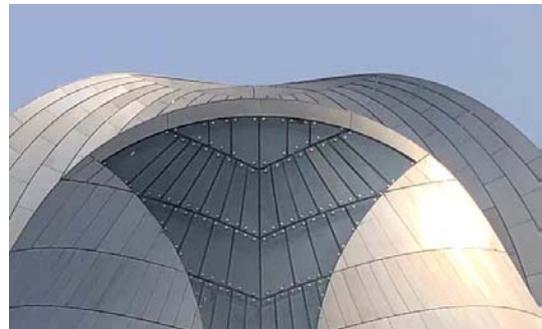
Figure 18. Photo taken on a sunny day on December 22.

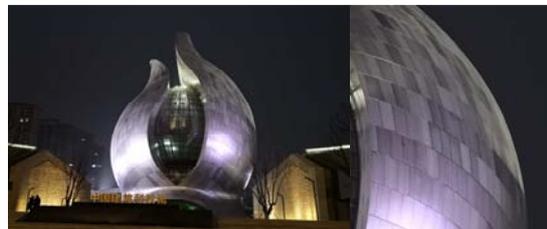
At night, lights around podium building irradiated the outer surface of stainless steel building with white bright cold light, the stainless steel surface showed obvious color difference.

Figure 19. Stainless steel color difference under cold light at night.

It is recommended to replace bright white lights around podium building with spotlights of different colors to irradiate the building exterior to form reflection on stainless steel surface. The building exterior will form a colorful visual effect with dynamic light irradiation, which will be an extraordinary visual appreciation [13].

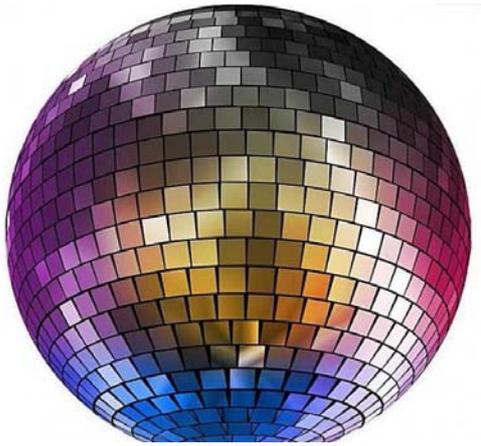
Figure 20. Schematic diagram of laser ball

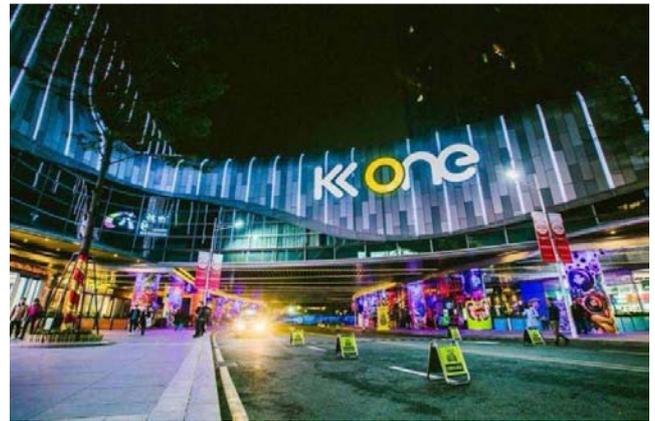
Figure 24. Stainless steel color difference of kkone Shopping Plaza in Shenzhen Binhe Shidai (light effect at night).

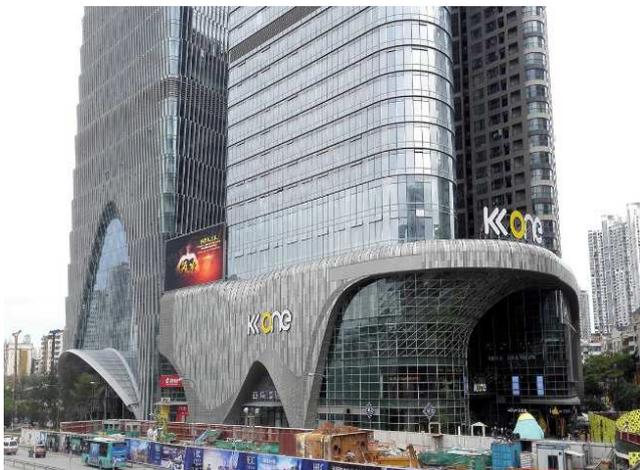
Figure 23. Stainless steel color difference of kkone Shopping Plaza in Shenzhen Binhe Shidai (daytime).

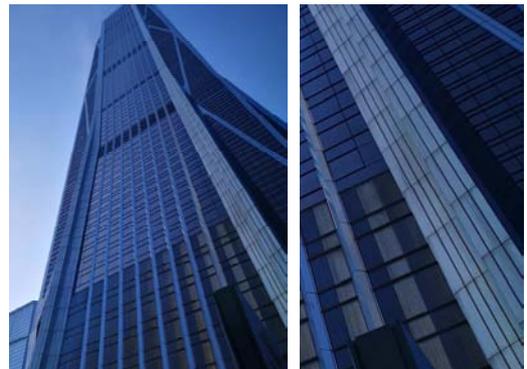
Take Shenzhen Ping An Centre as an example. Its facade is decorated with stainless steel plates, and there was a similar stainless steel color difference before, as shown below:

Figure 25. Stainless steel facade of Shenzhen Ping An Centre (white part in the picture).

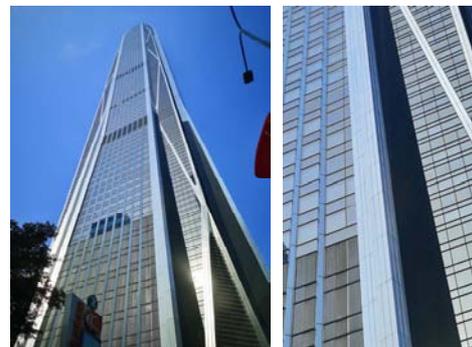
The stainless steel panels were completely cleaned with passivation cleaner. After the six months of natural passivation, the overall color tended to 95% consistency.

Figure 26. Stainless steel facade of Shenzhen Ping An Centre (effect of six months of natural passivation after cleaning).

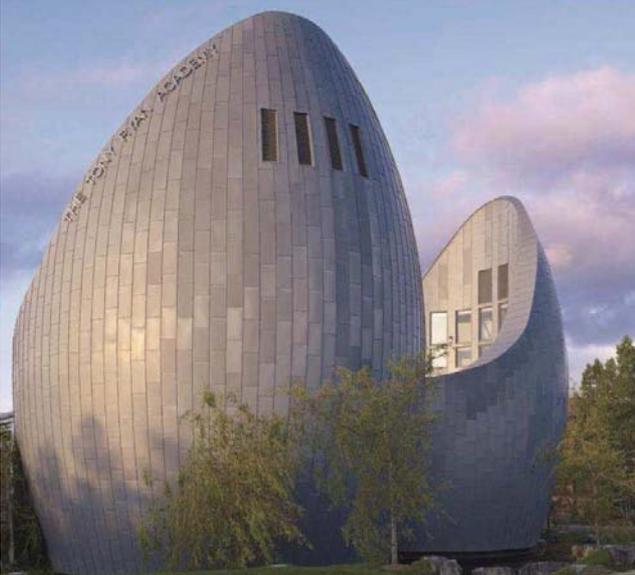
**Figure 27.** Color difference on stainless steel building exterior of Tony Ryan College in Dublin, Ireland.

The obvious contrast between bright and dark colors of stainless steel on shady face can be seen from the picture. The visual color difference is lighter on illuminated face, with no obvious color difference on convex curved parts. Some plates in concave parts have obvious color difference [14].

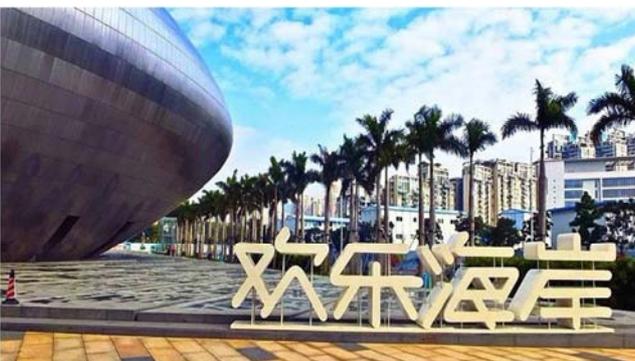
**Figure 28.** Color difference on stainless steel building exterior of Shenzhen OCT Harbour.

The stainless steel surface of Shenzhen OCT Harbour in above picture has similar color difference.
