# The Inspection and Appraisal of the Yonghemen Structure of the Qing Dynasty in Beijing

**Abstracts:** Beijing has concentrated many of the excellent wooden structures of ancient architecture, but some of the ancient buildings are inevitably damaged by natural and human factors because of the time passed by. Therefore, the regular inspection of the wood condition and the analysis of the safety performance of the wooden structure have become an indispensable work for the protection of ancient architecture. The Lama Temple is an outstanding example of the wooden structure of ancient architecture in Beijing. This research introduces the inspection and appraisal of the Yonghemen, which is one of the buildings in the Lama Temple, representing this kind of structures. First, surveying and mapping of the structure were completed, and detailed investigation and measurement of the stress and deformation states of the bearing member and the primary node were carried out to check structural safety. Meanwhile, several nondestructive inspection technologies were adopted during testing. For instance, radar was used to detect the foundation, Impulse tomography and resistograph were used to dete

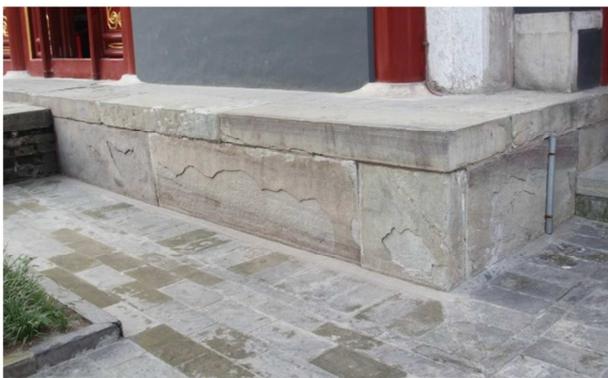
Figure 6. Photo of the foundation.

The foundation of the building is rectangular, and its top and four sides are made of stones. The height of foundation is 1.05m.

According to the on-site detection, the stones of foundation are basically intact, and only a small part of the stones desquamate and fracture due to weathering. The photo of foundation is shown in Figure 6.

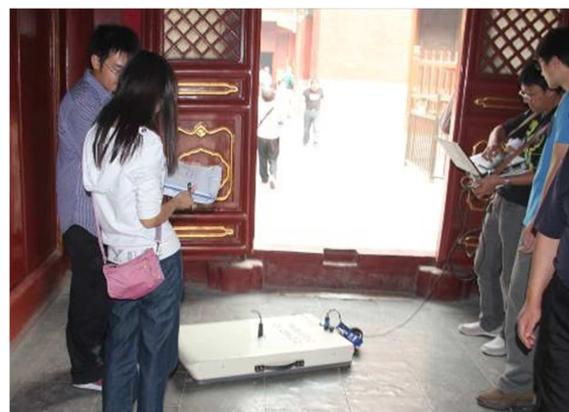
Figure 7. Photo of radar test.

In this research, Zond-12 geological radar with an antenna frequency of 300MHz was used to scan and detect the ground outside the apron and inside the building. (The photo of radar test is shown in Figure 7, and the plots of test results are shown in Figure 8-9). Through the detection, it was found that there was no cavity in the ground outside the apron but the water remained inside some parts made the reflected wave decline quickly. Meanwhile, no obvious defect was found inside the indoor ground. The detection results of radar could provide references for future inspection.

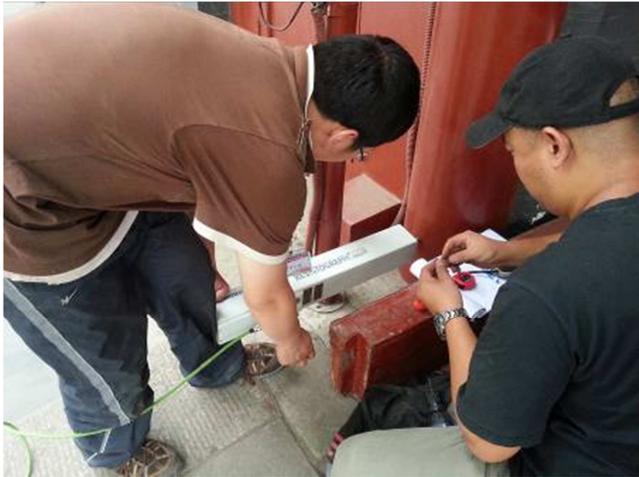
Figure 10. Photo of resistograph test.

Resistograph is a kind of wood small-destructive testing equipment which drives a micro-probe (with diameter about 1.5mm) into the wood at a constant speed with the help of a motor so as to measure the relative resistance of the wood. The resistograph will transmit the resistance parameters to the internal data acquisition card and then displays the resistance curve image after conversion. Since there is a positive relationship between the test values and wood density, namely, the wood density will change along with the resistance, it is possible to work out the relationship between the test values of the resistograph and the physical and mechanical properties

(density, elastic modulus, etc.) of wooden components. Besides, the plan and stereograms of defects can be obtained by driving the micro-probe into different part of the wooden components [8]. The photo of resistograph test is shown in Figure 10.

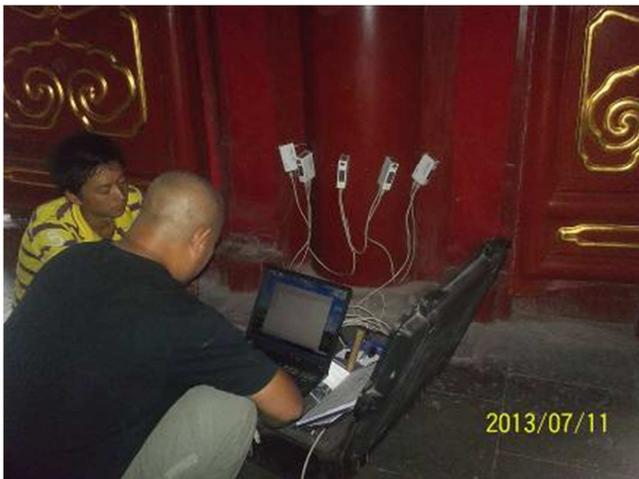
Figure 11. Photo of stress wave test.

Stress wave scanner is mainly composed of sensors and a computing system. The scanner works like this: strike the sensors installed on the wooden components to be tested to produce stress wave, and the propagation speed of the stress wave will then be processed by a computer, and reflected on an image showing the defects of the wooden components so as to determine the wood quality[9]. The photo of stress wave test is shown in Figure 11.

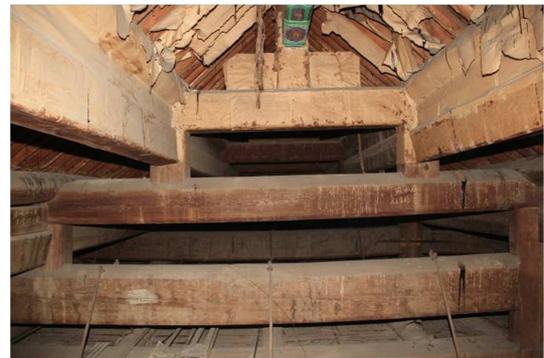
Figure 17. Photo of timber beam.

A typical timber beam is shown in Figure 17, while some defects are shown in Figures 18-19.

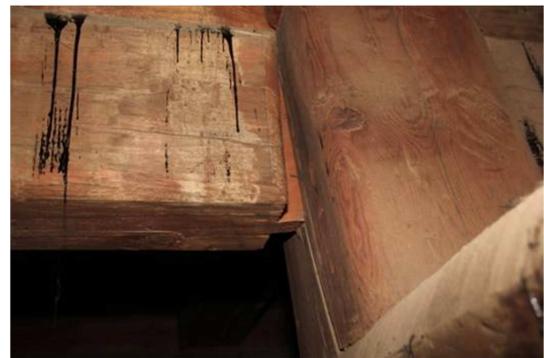
Figure 18. Photo of mortise extraction.

- 2) The ends of some beams fractured due to the action of forces.
- 3) The joints between beams and columns became loose, and some tenons were pulled out from mortises, which was commonly seen in the both sides of the C-axis hypostyle column on the north side, and the joints among hypostyle columns, 6-purlin beams and one-step cross beams. In addition, there were splits on the mortises of many king posts and short columns, and the length of some tenons pulled out of the mortises was more than 2/5 of its total length. And all of these are the defects mentioned in the *Technical Code for Maintenance and Strengthening of Ancient Timber Buildings* (GB 50165-92).  
Base on the above analysis, the reasons are as follows: There are 9 purlins in the beam frame, namely, a 6-purlin beam, a one-step cross beam and a two-step cross beam. The hypostyle column divides the beam frame into two parts, which are connected by mortise-tenon joints between the one-step cross beam and two-step cross beam, Baotou beam and central column. Due to the poor connection effect of the mortise-and-tenon joint, the tenons are likely to be pulled out from the mortises under external force, thus making the structure appear loose.

- 4) No obvious damage to the bucket arch was found.
- 5) The one-step cross beam and 6-purlin beam have already been strengthened by flat steel while other defects remain to be dealt with.
