Assessment of Structural and Conservation Practices on Vernacular Houses of Axum, Ethiopia

Gebremeskel Teweldemedhn Desta

School of Architecture & Urban Planning, Ethiopian Institute of Technology, Mekelle University, Mekelle, Ethiopia

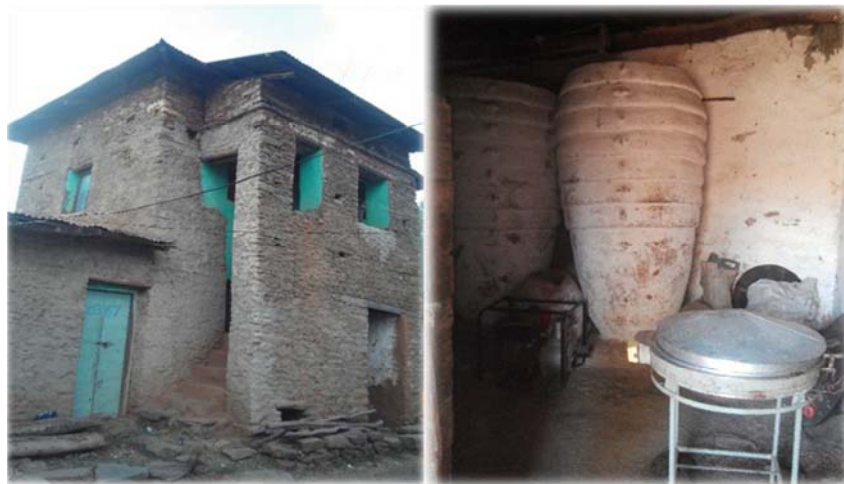
Figure 5. The building and grain storage “*Kefo*” in ground floor (by the author).

The building wall is constructed by stone and mud with 50 cm thick and 6.5 m high. Its floor is constructed by wooden materials and mud (earthen floor) which is 30 cm thick.

The ceiling is bamboo and wooden materials. The wall internal structure is plastered by mud and local lime mixes.

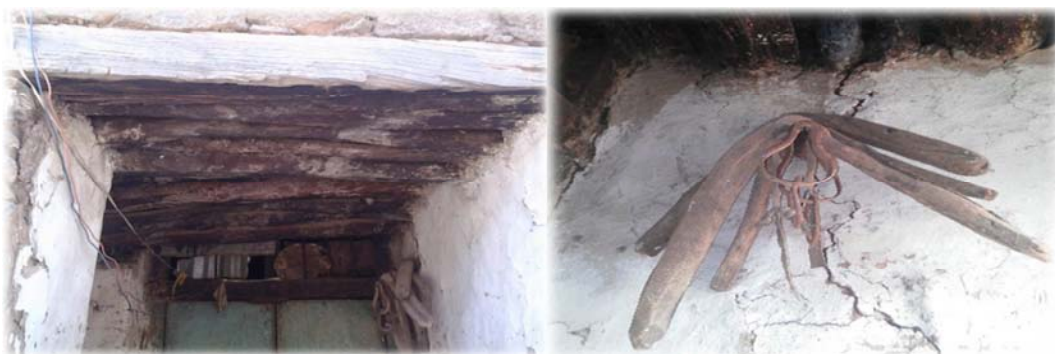
The wooden materials of the floor and ceiling are deteriorated. Its wall and plastering's has cracks especially in ground floor as in the picture below shown.

Figure 7. Deteriorated floor and cracked wall (by the author).

In 1992 G.C the external wall has plastered partially by cement material to protect from external wall cracking and to protect from erosion of mud, which is adhesive material of the stone masonry.

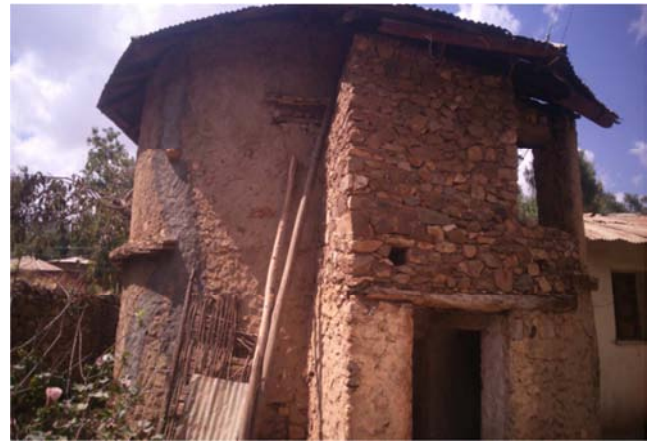
Figure 8. Kegnazmach Abreha Meshesha building (by the author).

The building is circular two story stone masonry building with a radius of 3 m internally and its wall height is 5 m with 60 cm thickness. Currently its roof is galvanized sheet cover but, previously it was thatched roof.

The floor is constructed by wooden and mud or earthen floor. Its ceiling is decorated by bamboo. The wall is constructed by thin and small stone and mud; internally it is plastered by mud.

The building has massive semicircular stone masonry external stair to upper floor. And its door and window are constructed and decorated by wooden materials.

In the middle of the wall, in the floor level, it has flat and thin stone called “Katsela” inserted to the wall to protect dampness. But, still it has cracks in the stone masonry wall and the wooden floor has deteriorated and decayed. It is in a bad condition

Before 60 years the thatched roof removed and changed by

galvanized sheet roof cover. In 2004 G.C the external wall has plastered partially by mud to protect from external wall crack. In 2009 G.C the vertically cracked part has plastered by cement in order to repair the cracked part.

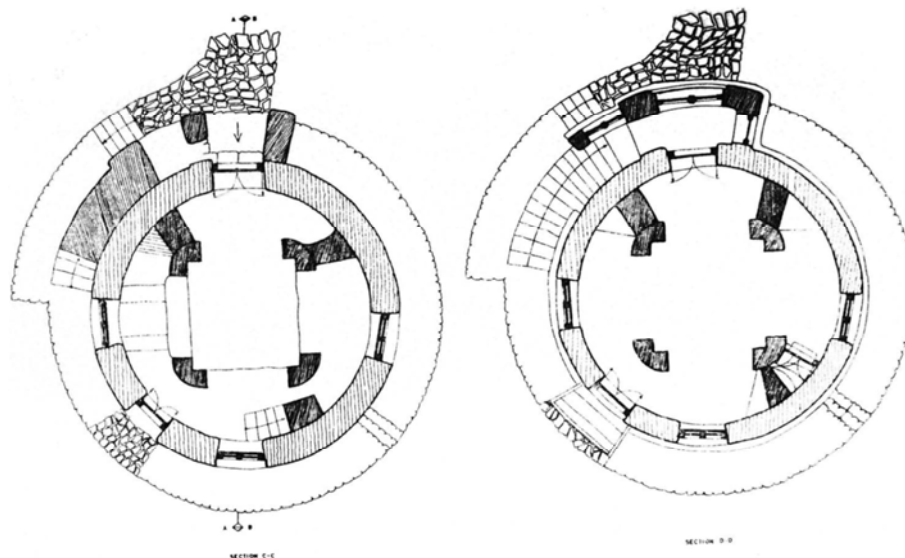
Figure 10. Ground and First floor plan of the building respectively [17].

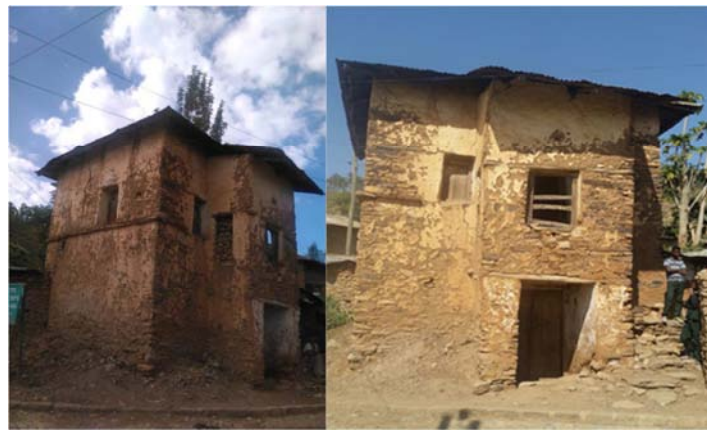
Figure 11. Ato Weldegebriel Meshesha building (by the author).

The building is rectangular two story or “*Debri*” stone masonry building with wall height of 6 m and 50 cm thickness. Currently its roof is galvanized sheet cover but, previously it was thatched roof.

The floor is constructed by wooden and mud or earthen floor. Its ceiling is decorated by bamboo and wooden elements. The wall is constructed by thin and small stone and mud; internally it is plastered by mud.

The building has massive L-shaped stone masonry external stair to upper floor. And its door and window are constructed and decorated by wooden materials.

The first and the only practice of conservation in the building is mud plastering of the external wall and galvanized sheet cover of the roof from thatched roof, before 40 years to protect the external wall erosion.

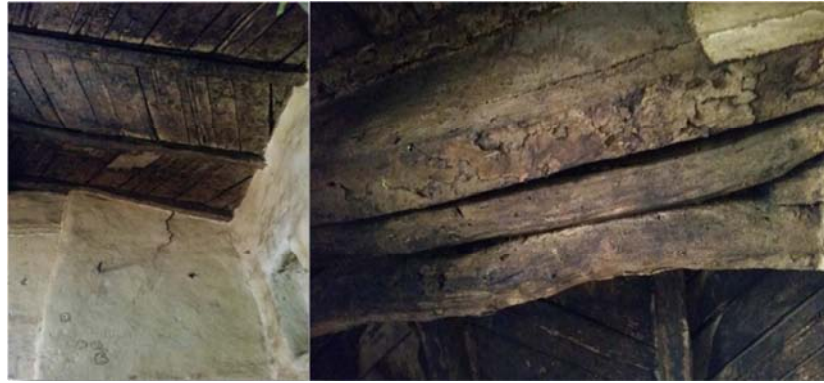
In the middle of the wall, in the floor level, it has flat and thin stone called “*Katsela*” inserted to the wall to protect dampness. But, still it has cracks in the stone masonry wall and the wooden floor has deteriorated and decayed. It is in a bad condition.

Figure 13. Cracked wall and the deteriorated wooden beam and ceiling.

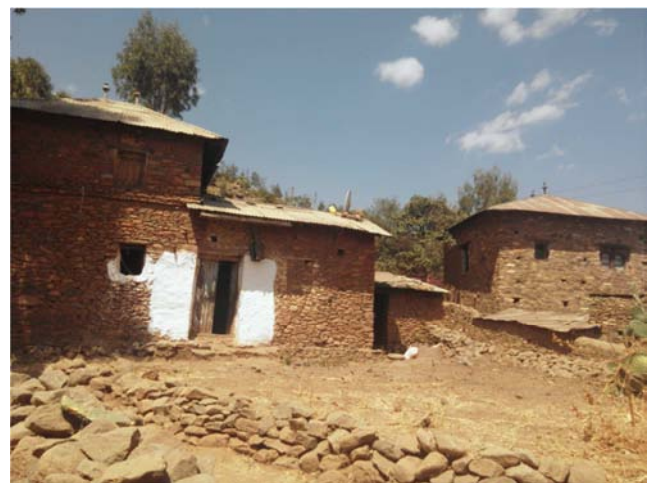
Figure 14. Ato Yared Hailemariam building (by the author)

The building is rectangular two story or “*Debri*” stone masonry building with wall height of 6 m and 50 cm thickness. Currently its roof is galvanized sheet cover but, previously it was thatched roof.

The floor is constructed by wooden and mud or earthen

floor. Its ceiling is decorated by bamboo and wooden elements. The wall is constructed by thin and small stone and mud; internally it is plastered by mud and lately by lime.

The first and the only practice of conservation in the building is lime plastering of the internal wall and galvanized sheet cover of the roof from thatched roof, before 40 years to protect the external wall erosion.

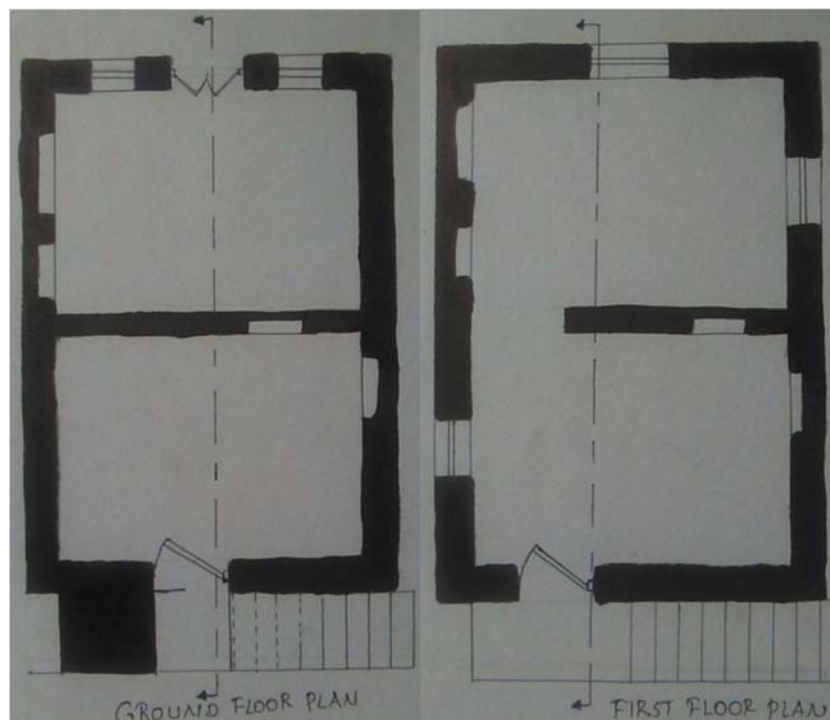
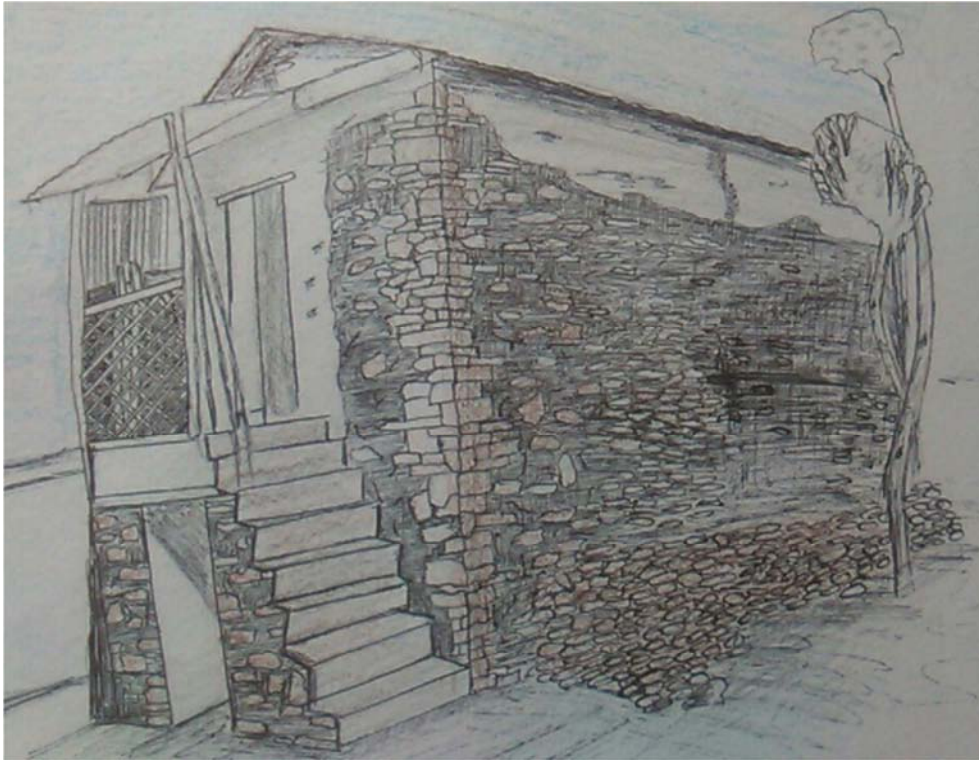
Figure 15. Plan of Ato Yared Hailemariam building (by the author).

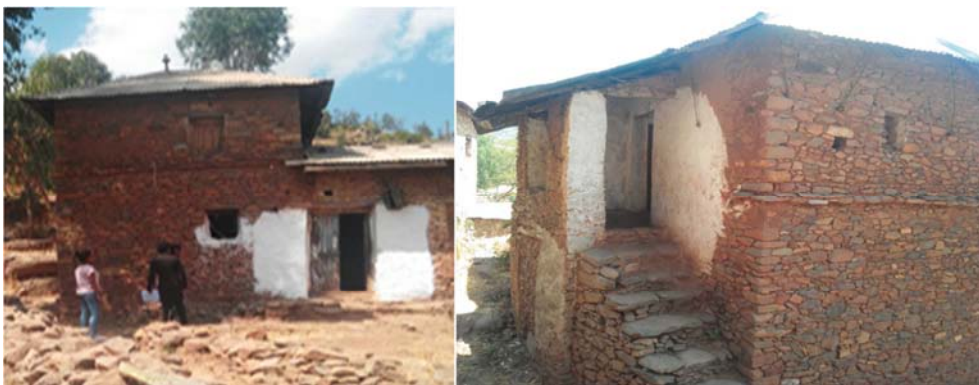
The building has massive one flight stone masonry external stair to upper floor. And its door and window are constructed and decorated by wooden materials.

Figure 16. External view of the building; the stair, the door and window etc. (by the author).

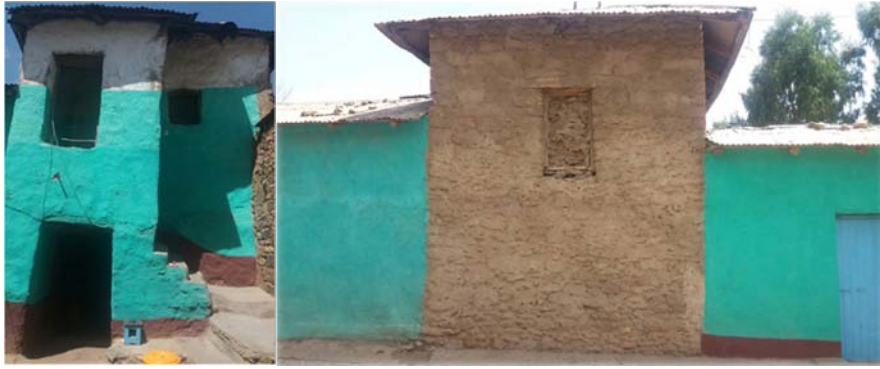
Figure 17. Front and rear view of Basha Gebrehiwot building (by the author).

The building is rectangular/square two story or “Debri” stone masonry building with wall height of 6 m and 50 cm thickness. Currently its roof is galvanized sheet cover but, previously it was thatched roof.

The floor is constructed by wooden and mud or earthen floor. Its ceiling is decorated by wooden elements. The wall is constructed by thin and small stone and mud; internally and externally in partial, it is plastered by mud and lately by

lime and newly introduced chemical paint.

The building has small steps by stone masonry like external stair to upper floor. And its door and window are constructed and decorated by wooden materials. Some of the windows are closed by stone in the time of rooms’ expansion and the street side windows. As shown in figure 17.

The first practice of conservation in the building is lime plastering of the internal wall and galvanized sheet cover of the roof from thatched roof. Secondly, the external wall has plastered by cement before 23 years to protect the external wall erosion and finally the internal wall and some external part of the wall has painted by new chemical paint before 15 years.

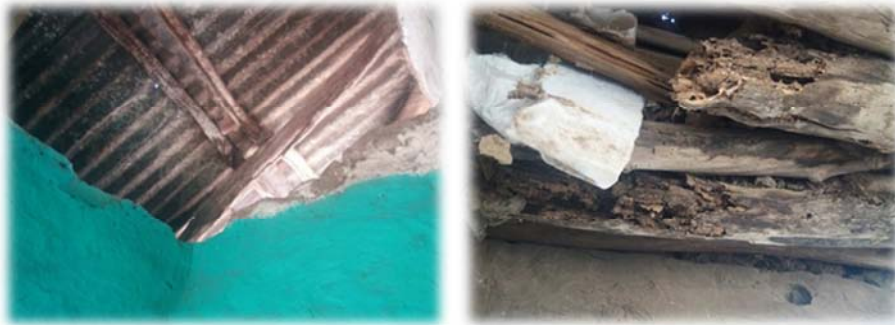
The wooden elements of earthen floor/slab have deteriorated and create floor height difference on ground floor. The wooden beam is supported by new pillars.

Figure 18. The deteriorated wooden beams and ceilings (by the author).

The floor and ceiling; the wooden elements of the flooring and ceiling are deteriorated by different reasons and some of the wooden beams are supported by additional pillars

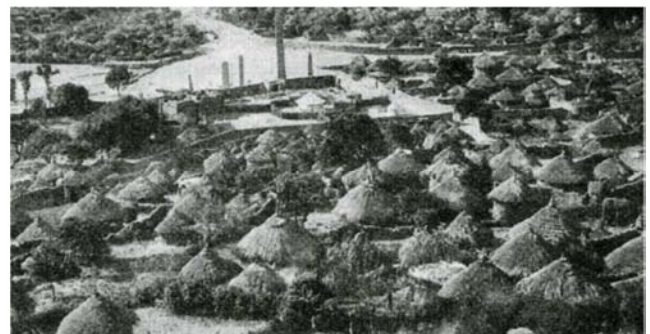
The roof; the roof of all case studies has changed from thatched roof to galvanized sheet cover and it is possible to compare with figure 19, view of Axum before 113 years. All roof covers was thatched roofs.

Figure 19. View of Axum on 1906 [18].
