Participatory Identification of Major Natural Resource Constraints and Potentials Under Koka-Lewate Watershed, Tembaro Woreda, Kambata Tambaro Zone of Southern Ethiopia

Abstract: Koka-Lewate watershed is located in the Tambaro district of Southern Ethiopia and it is about 328 km and 185 km far from Addis Ababa and Hawassa respectively. It was selected by a virtual team (team of researchers from a natural resource, crop science, livestock, and socioeconomic departments) organized from Areka Agricultural Research Center, Southern Agricultural Research Institute (SARI). It was selected for its high level of degradation, minimal intervention and high amount of sediment load contribution on the Gibe III hydroelectric power dam. This study aimed to identify and prioritize natural resource constraints of the watershed and to document reports as baseline information for comparison after project implementation. Data for this study were collected from primary and secondary sources. The study catchment is characterized by intensive. The study revealed, soil erosion is severe and caused damage to house, inputs, and farmland fragmentation. Human and livestock damaged by a flood during the heav

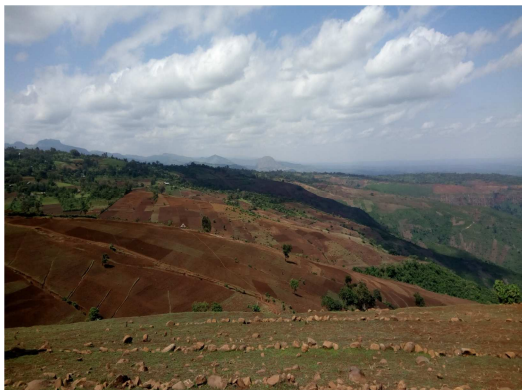
Figure 2. Dominant land use type of the study area (Source; field survey, 2017).

The study result revealed the watershed is intensively cultivated. From the total catchment area, the proportion of land use of respondents is about 34.36, 4.89, 0.77, and 3.18 ha cultivated, grazing, outcrop, and woodland respectively. The study indicated, there is land shortage per HH and most farmers under study area engaged in converting forest and fragile lands to cultivated land particularly at downstream of the catchment. All respondents dictated the study area has a history of a dense forest; however, due to deforestation and agricultural land expansion, it is seriously devastating. The result shows, deforestation, intensive cultivation, and agricultural expansion to fragile lands are the main factor contributing to accelerated soil erosion, land degradation, migration of wild animals, a hindrance to production and productivity.

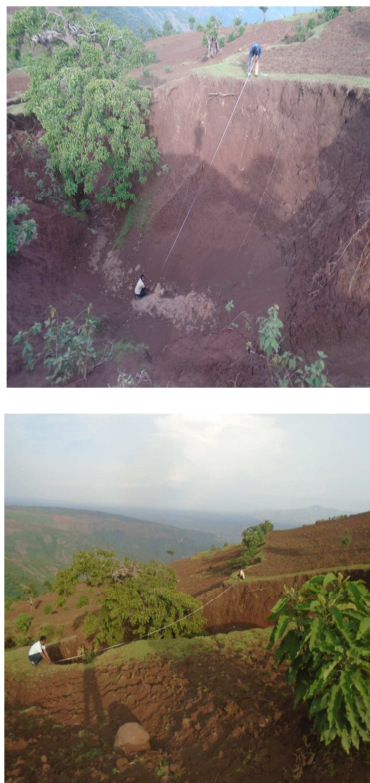
Figure 3. Soil erosion and land degradation under Koka-Lewate watershed (Source; field survey, 2017).

Soil erosion is a significant environmental problem affecting agricultural productivity of study catchment. Discussion held with farmers and extension agents revealed that due to undulated topography, cultivation of steep slope and marginal lands, intensive rainfall with erratic nature, free grazing, and deforestation; soil erosion frequently occurs in the watershed. From field observation, researchers perceived that sheet and rill erosion which are caused by intensive rainfall coupled with cultivation of sloppy and marginal lands are dominant types of soil erosion in the area. In some parts of the catchment, deeper and wider gullies were also observed. Farmers were well acquainted with the negative impact of soil erosion on their lives. They pointed out that, the level of erosion is severe and caused several hazardous. Among these, damage to the house, damage to crops and fertilizers, road break, farmland fragmentation, drought and drying of spring are common ones. Damage on animals and humans by flood during a heavy rainstorm is also reported. Severe downstream siltation and deposition were identified as soil erosion problems in the study area. Shortly, this may pose a harsh impact on Gibe III hydroelectric power dam [13]. Although soil erosion has a severing effect, the use of physical conservation measures are not carried out by farmers' initiative but initiated by government organizations. As a result, constructed conservation structures failed to serve the planned reason. Besides, inappropriate design, wrong structure selection, and construction, damage by heavy runoff, human activities and animal (grazing), lack of follow-up and maintenance are observed problems under study catchment. As cited by respondents, currently the soil needs extra inputs and labor to provide them satisfactory products because of fertility degradation caused by soil erosion. Respondents also reported workable soil depth is decreasing year to year.

The finding depicts that, indicators of soil erosion perceived by farmers were formation of rills and gully, poor in crop and grass growth, change in soil color, roots and subsoil exposure, difficult of land preparation, and sediment deposition at depressions 97.9%, 83%, 72.3%, 63.8%, 44.7%, and 34% respectively. Almost all respondents were aware of soil erosion impact on the food security of their household.

Farmers manage soil erosion problems using both physical and biological conservation measures. Tree plantation, plantation of banana and desho grass, contour plowing, soil bund, stone bund, fanya juu terrace, and cutoff drain are common in the area. Experts revealed that the use of biological conservation measures is very limited in type and area coverage. In general, lack of adequate and effective soil and water conservation measures coupled with poor management of the existing conservation measures have led the problem of soil erosion to continue.
