# Solution to the Breach of the Dike of Keur Bara KAIRE, Located in the Commune of Notto Diobasse in the Department of Thiès, Senegal

This article studies the rupture of the Keur Bara KAIRE dike, located in the commune of Notto Diobasse in the department of Thiès in Senegal. The village is crossed by a stream which collects rainwater from the west to the east, following a natural slope. The overflow of this stream causes serious flooding, leading to the total cutting of the road and the isolation of the population. These floods had tragic consequences, resulting in two losses of human life. To regulate the water level, prevent flooding and protect agricultural and urban areas from overflows, the Senegalese authorities initiated the project to build the Keur Bara KAIRE dike in 2004, unfortunately the latter gave way in 2017. The geotechnical analysis was carried out on samples taken from various points on the site, revealing that the terrain is mainly composed of fine sand and the embankment is made with clayey sand. Morphometric and hydrological investigations highlight that the watershed of the Keur Bara KAIRE dike covers an area of 3.72 km<sup>2</sup>, with a projected flow of 5

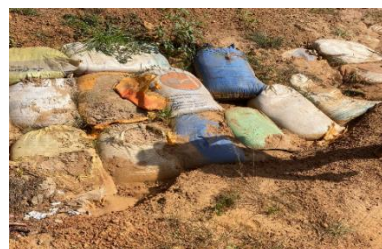
Figure 8. Sandbags stored on the track ditch.

Figures 8-9-10 and 11 illustrate the current state of the Keur Bara KAIRE dike.

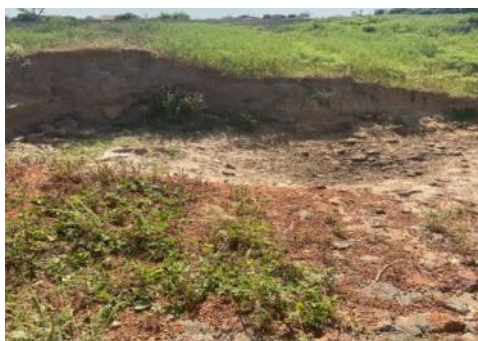
**Figure 11.** Rupture at the spillway.

The resizing showed that the dimensions of the dike are acceptable except for the length of the spillway. The calculation results for the LANE rule check are shown in Table 19.

The sizing is acceptable except for the length of the spillway. Also, the overturning stability is not checked, which can be a cause of breakage.
