# Method for the Rapid Replacement of the Travis Spur Rail Bridge over I-278 Highway

**Abstract:** Rise in traffic volumes of urban highways over the last decades has led to an increasing need for widening both highways and access roads. The present case study deals with the replacement of the Travis Spur Rail Bridge to allow for larger width of roadways that lead to and away from the New Goethals Bridge, which connects Elizabeth, New Jersey, to Staten Island, New York, in the United States. The main objective of the project was to apply a rapid method for the replacement of the existing bridge, which was performed during the Columbus Day weekend (7-9 October 2017). Considerations of all existing constraints, which include high traffic volumes and limited space for material laydown and equipment positioning, are presented first. To respond to these challenges careful planning of the construction steps of the substructure (cap beams supported on circular piers) and the superstructure of the bridge (two-span steel deck) had to be carried out both temporally and spatially before the replacement weekend, which is described in the second part of the paper. The final part presents the d

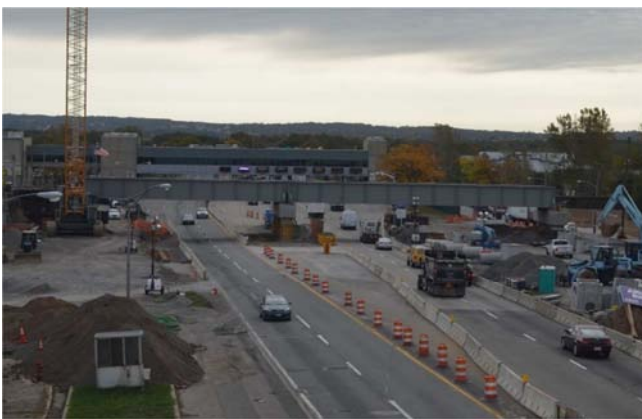
**Figure 1.** New Travis Spur Rail Bridge after the replacement weekend.

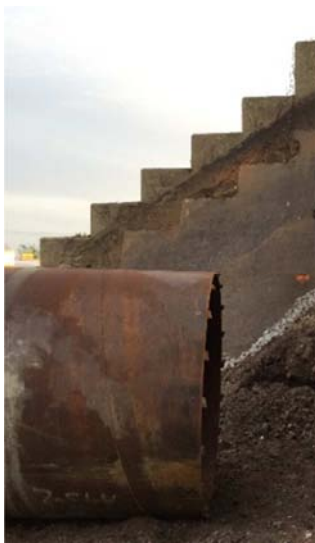
**Figure 2.** Teeth welded on casing.

After examination of various alternatives for the foundation system of the new RC piers, the engineering teams opted for the solution of drilled shafts rather than massive footings, as the shaft footprint is rather small, while reuse of the existing foundation members [9] was not possible. This choice minimizes the disturbance to the existing members that are in proximity. On the same time, drilling is a much faster process compared to works associated with excavation, provisional soil retaining and footing formwork. After the completion of excavation works at both north and south abutments, the drilled shaft construction commenced. In total, ten shafts were drilled for the new rail bridge, each measuring 1.83 m (6 ft) in diameter. With regard to the casing geometry, a wall thickness of 19 mm ( $\frac{3}{4}$ " ) and length varying from 10.36 m (34 ft) to 12.80 m (42 ft) were selected. Cutting teeth were welded on the casing bottom and a 0.3 m (1 ft) driving band of 19 mm ( $\frac{3}{4}$ " ) thickness was positioned around the top of each casing (Figure 2). When the equipment was brought to the field, 2 holes were cut in the casing top in order to fit a shackle. In addition four twister slots were cut around the top of the casing. A device was fabricated and attached to the drill rig to guarantee that all four twister slots would work together during the drilling process and to ensure that no shearing would occur under the applied load.

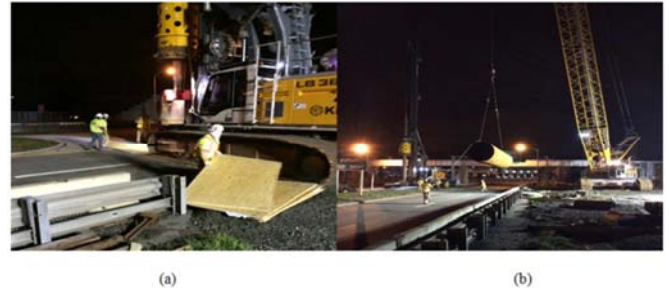
**Figure 3.** (a) Mobilizing the drill to median and (b) Casing transportation over I-278 WB to the median strip).

All ten shafts were installed by the LB-36 drill rig shown in Figure 3. The crane had to move at off-peak traffic times in order the traffic flow to be maintained on I-278. In order to provide access for the drill rig, the existing wing walls had to be demolished, adding extra time and cost to the operation. The shafts of the north pier were positioned first (median strip of I-278 - Figure 3b). The LB-36 drill rig and an 895 crane were used for this operation during a graveyard shift. The casing was relocated by the drill and the twister slots were engaged. The casing was then spun into the ground at the correct location (Figure 4).

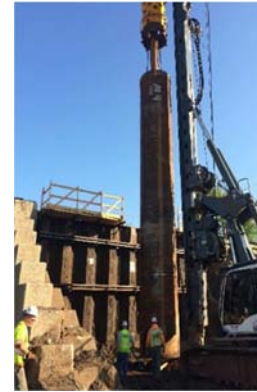
**Figure 4.** Aligning twister attachment into slots.

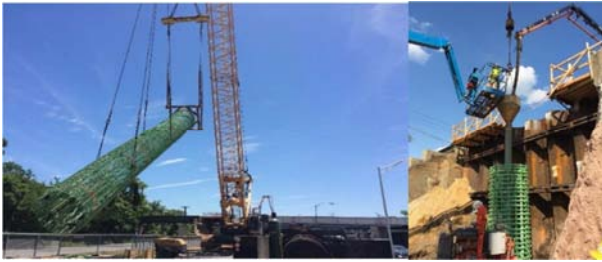
**Figure 5.** Transportation of the rebar cage with picking ring (left) and placing tremie with pump truck (right).

After the SID was removed, the casing was cut to the definite elevation according to the plans. Once the shaft passed the SID test, the 895 crane would pick and transport the rebar cage and set it into the casing (Figure 5). The shaft rebar included the rebars of pier to be cast above. The same crane was also used to assemble the tremie pipe and hopper and the tremie mix was pumped by a pump truck provided by Precision Concrete Pumping until concrete of good quality was overflowing the casing top (Figure 5). As the tremie was placed, a 10.2 cm (4") hydraulic pump was used to pump the water off the top of the shaft back to the water treatment plant. During some of the placements, the pumps malfunctioned making dewatering difficult, which resulted in some additional laitance on the shafts. Cross-hole Sonic

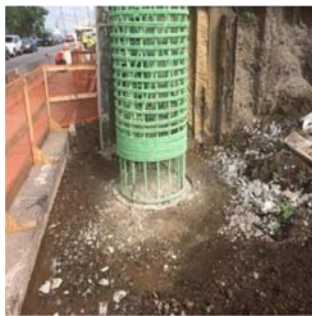
**Figure 6.** Rebar on top of the shaft.

The new bridge was supported on 6 piers, measuring 1.68 m (5.5 ft) in diameter in order to fit to the drilled shaft diameter (see Section above). This choice resulted in rebar installation during the shaft operations (Figure 6), the remaining work for the piers being the touch up of the epoxy paint coating and the installation of a plywood shoe and EFCO type formworks [13] (Figure 7).

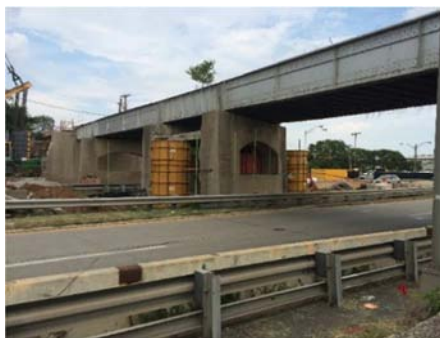
**Figure 7.** Formwork set around the rebar cage.

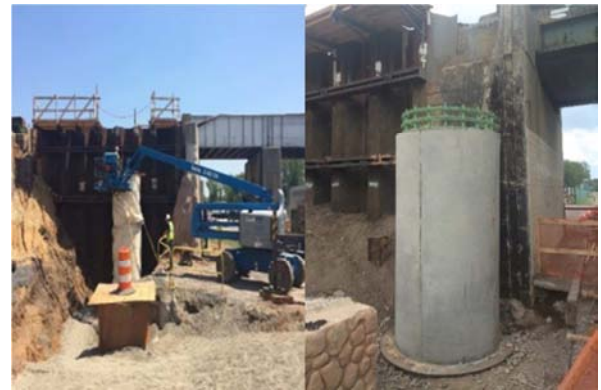
**Figure 8.** Wrapped forms for concrete thermal control (left) and completed pier (right).

brought to the site from EFCO [13], so that works would proceed simultaneously for all piers. Once the thermal cure period (7 days) passed, the formworks were removed. The work following the formwork removal was the joint preparation on top of the piers. This included bush hammering of the pier top in order to expose the aggregates and clean off any loose concrete. The exposed part of the rebar cage was again touched up with epoxy (Figure 8) and the exact center of each bar was surveyed.

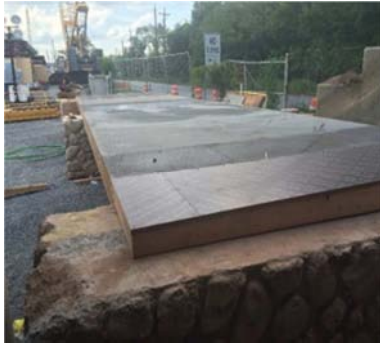
**Figure 9.** Soffit set on 3 supports.

Concurrently with the pier works, the construction of the 3 cap beams of different dimensions commenced near the side of future installation. The specificity of these works was related to the need of monolithic cap beam-pier connection after construction of both components. To achieve this goal, 18 vertical rebars were protruding from the concrete mass of each pier. To achieve perfect connection, the cap beams would receive 36 grouted couplers in the bottom, where the 36 protruding pier rebars would be fixed. Tight space tolerances regarding the difference between the rebar diameter and the coupler opening had to be respected. The cap beam form was a standard EFCO system and was built on top of 3 concrete supports to facilitate rebar coupler inspection and cleaning (Figure 9). The space between coupler and rebar was filled with hard polymer to achieve rebar centering into the coupler. Once the couplers were positioned on the rebars sticking out of the piers, a mini-cage rite was used as a template (Figure 10), allowing everything to be locked together. The couplers were tied to the cage rite and rebar hoops were installed around the exterior of the couplers to increase the stiffness (Figure 10). Banding of the couplers offered additional security. Once full assembling was achieved, the template and couplers were removed from the pier and placed on the steel form. After the templates were set in place, the pin setters were tightened and the couplers were locked into position. Each coupler had two ports, for the grout inflow and outflow, the latter one receiving a PVC sleeve which was extended through the forms. In addition to the grouted couplers, anchor bolt sleeves were used for the future cap beam bearings.

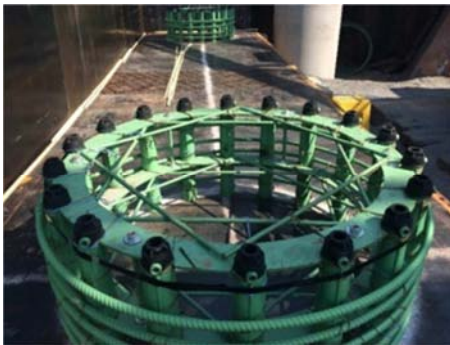
**Figure 10.** Rebar hoops placed around the couplers.

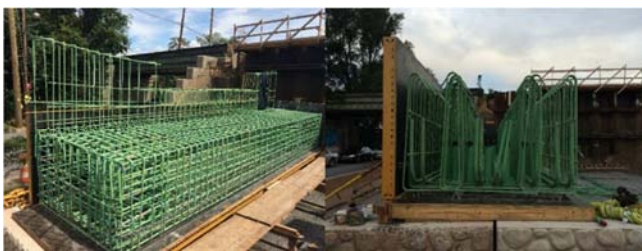
**Figure 11.** Tied on soffit rebar.

To support the rebar cage load on the elevated soffit in the temporary location, 3 posts were installed along the unbraced side of the form. Half of the soffit was supported on the long steel form spanning the entire cap length, while the other half was supported on these posts. Since positioning of the long horizontal bars on the formwork bottom was obstructed by the template (Figure 11), the couplers were dismantled and the cage rite was cut so that rebar and stirrups could be accurately placed. After tying together the reinforcement cage the forms were closed up and a walkway was installed around the top to provide access for pedestal work and casting (Figure 12).

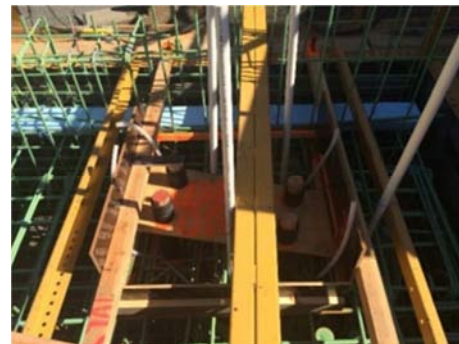
**Figure 12.** Pedestal forms with anchor bolt sleeves.

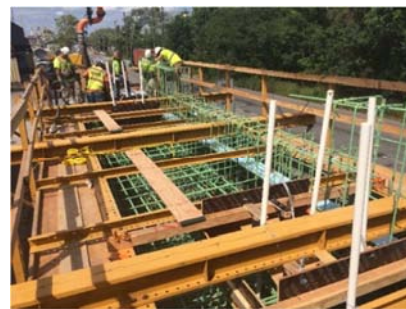
**Figure 13.** Casting of the cap beam using a pump truck.

beam and the pier. Each pier location received 4 38.1 mm (1.5") sleeves to make sure the entire area would be covered with grout. To control the concrete placement, a pump truck was used (Figure 13). The location of each PVC sleeve was marked, allowing the constructors to track the exact sleeve locations and prevent sleeve-vibrator contact resulting in sleeve damage. Verticality during pouring was guaranteed by a rebar passing through each sleeve. Once the cap beam was casted, a 4% wash was finished on the top. The smaller pedestals (76.2 mm or less) were constructed monolithically during grout pouring, while the larger ones were poured the following day.

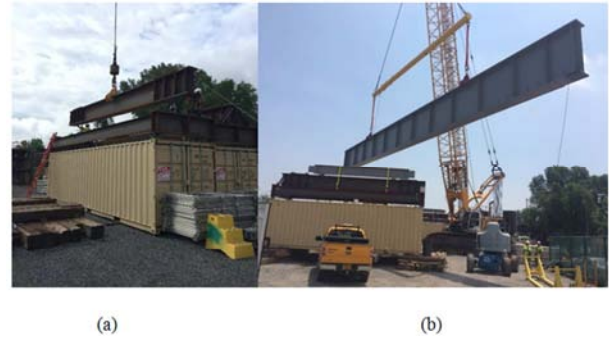
**Figure 14.** (a) Grillage steel positioning on connex box, and (b) setting of the first girder for span 2.

Placing the girders onto the shoring involved its own set of space challenges since the tail end of the beam had to swing out over the highway as the crane swung into position. For this reason, setting of the girders was planned to take place during the morning following the transportation in the same time frame (4:30 to 5:00). The Port Authority police provided assistance in shutting down the bridge for all required closures. Once the girder was positioned on the grillage steel, traffic circulation was again allowed and the ironworkers secured the girder in the new temporary position. The pick plan called for the 895 crane to have 37.49 m (123 ft) of boom and 5 parts of line. The rigging consisted of two 15.24 m (50 ft) 6.35 mm (1/4") wire rope slings attached to a picking beam with 80 tones capacity (Figure 14b). From the picking beam, there were two 3.05 m (10 ft) ENR 13 round slings to a Crosby beam clamp. Then, the ironworkers raised the shoring towers to

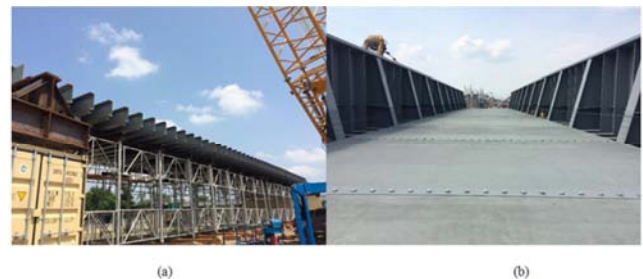
**Figure 15.** (a) Floor beams before receiving second girder, and (b) view of span 2 with all knee braces installed.

After the first girder was positioned and secured, the deck panels were set and fastened to the girder. Each deck panel consisted of 4 floor beams running perpendicular to the span length and a welded deck plate. Each floor beam was bolted to the girder's stiffener. To minimize the risk of fall during installation, a lifeline was placed along the girder's top so that the crew members could tie off during the operation. During the positioning process, the beams had to be shimmed to the shoring towers in order to keep the camber and allow the bolts to fit up. In order to release the initial girder bracing, 4 floor beams had to be 100% bolted (2 on either side of the centerline of the girder). After the girder bracing removal, the second girder was set in a similar manner to the first one, with only exception the fact the second girder had to be fixed to each floor beam prior to setting down (Figure 15a).

Once both girders and all the floor beams were set and bolted, the knee braces were placed (Figure 15b). The knee brace spacing corresponded to the distance between four floor beams and was connected to the girder and deck panels using bolts that were fixed tightly and inspected. Afterwards, the side and curb plates were installed in the same way. Prior to their rigid fixation to the existing structure, the shoring below the new span was removed in order to facilitate the access to the workers for bolting up.

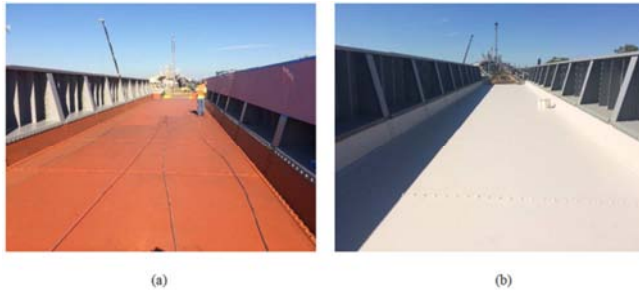
**Figure 16.** Waterproofing works on top of span 2: (a) primer coat, and (b) finish coat.

SSPC-SP 10. Then, a primer coat was applied to all blasted surfaces (Figure 16a). Afterwards, a cold “Eliminator” waterproofing membrane was applied twice to get the desired thickness (Figure 16b). The procedure schedule was dictated by the steel temperature and was often performed during early evening. Finally, the touch up painting of the bolted connections and any scratches occurred during installation was accomplished over approximately one month.

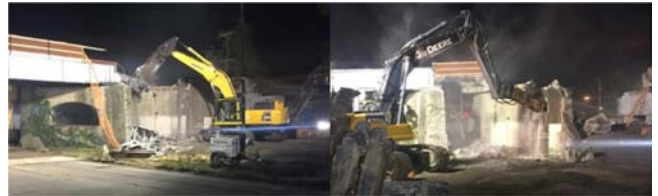
**Figure 19.** Demolition process: Shearing down the existing TSR Bridge deck (left) and Hammering out the existing abutments (right).

After all security measures were in place, the demolition started, with 3 excavators with shears demolishing the steel spans, 2 excavators with hammers demolishing the concrete

piers (Figure 19), and one excavator with grapple and one loader being used to load out steel material into container trucks that would be directed to the scrap yard. Concrete debris was loaded into dump trucks and directed to the main Goethals Bridge project site for later testing. At the same time, DGA was being transferred from the satellite yard, spread to the I-278 eastbound lanes and then compacted to reach the yard height (range between 0.30 m and 0.91 m) and then gradually sloped down to the elevation of the roadway to create a path for the SPMTs.

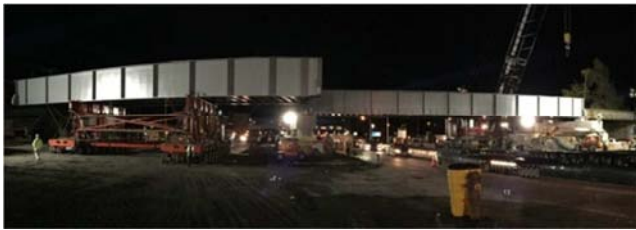
**Figure 20.** Rolling Span 1 on north abutment and north pier cap beams using SPMTs.

After the traffic switch, the anchor bolt sleeves in the north and south piers were grouted and the four new bearings were set on the north pier and north abutment to support the next span. The welding of the bearings under span 2 was also performed at this stage. The DGA ramp and road plates were then rebuilt on the I-278 westbound lanes in the same way as previously completed on the eastbound lanes. Afterwards, once the new span was fastened tightly, the shoring boxes were removed, and the SPMTs rolled the new span into its final location (Figure 20). Then, the SPMTs staged out of the way and the roadway was cleaned up and restored normal traffic flow in both eastbound and westbound directions.

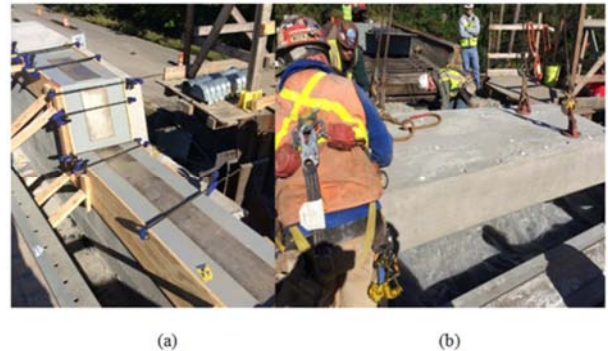
**Figure 21.** (a) Bent plate grouted into the backwall, and (b) Placing the approach slab on the backwall studs.

On the north side connection, a bent plate with studs on its lower side was picked and positioned in the keyway within the backwall (Figure 21a). The plate was shimmed up and the formed gap was then grouted. Afterwards, the form was removed in order to place the precast approach slab (Figure 21b). The slab was then grouted in place and the sliding plate
