Assessment of Drainage Structure by Using ArcGIS Software: The Case of Bale Robe Town, Ethiopia

Gutema Wakjira, Garuma Negasa. Assessment of Drainage Structure by Using ArcGIS Software: The Case of Bale Robe Town, Ethiopia. *Journal of Civil, Construction and Environmental Engineering*. Vol. 6, No. 5, 2021, pp. 149-160. doi: 10.11648/j.jccee.20210605.14

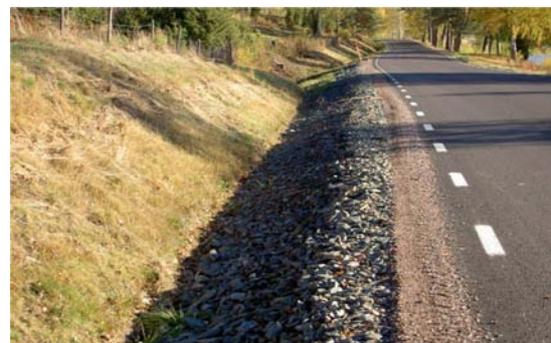
Figure 1. Surface drainage system, photo.

Roadside ditches are an agent of hydro modification and in many cases discharge into natural streams, effectively increasing the drainage density of a landscape [11]. A surface drainage system or ditches (Figure 1) collects and diverts storm water from the highway surface and surrounding areas to avoid street flooding. It also prevents damage to sub-surface drains, water supplies (wells) and other sensitive adjacent areas. It decreases the possibility of water infiltration into the highway and retains the pavement bearing capability [10].

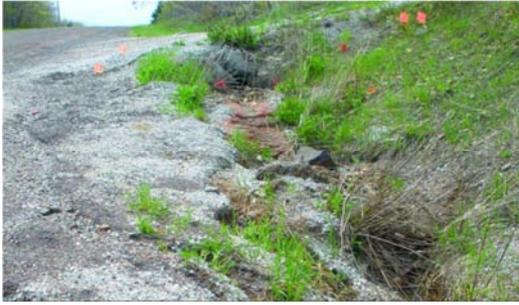
Figure 2. Unstable ditch. Source (Faisca et al., 2012).

The main purpose of a roadside ditch is to protect the integrity of the highway. Highways are designed to drain rain and snowmelt away from the pavement surface, toward the lower elevation of the roadside ditch. Once the water reaches the ditch, it can flow along the ditch and eventually away from the roadway, protecting the stability of the road subgrade. A ditch may respond to changes such as: increased water flow, blocked channels, removed vegetation and increased sediment load. When its flow is blocked, water seeks a new course. It might carve a new path causing banks to erode or a channel to deepen. As the channel deepens and the banks become near vertical, the upper bank soils might slough to create a shallower slope see Figure 2.

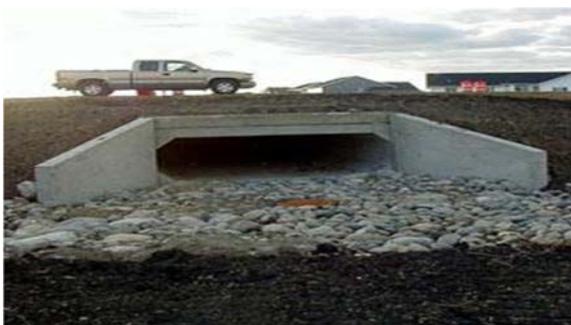
Figure 3. Culverts source [13].

Culvert is a closed conduit for passage of runoff from one open channel to another. One example is a corrugated metal pipe under a roadway. Subsurface drainage systems drain water that has infiltrated through the pavement and the inner slope but also groundwater. Subsurface drainage systems are directly linked to surface drainage systems [10]. According to the SRA handbook, culverts are road constructions with a theoretical span of 2.0 m. Culverts or subsurface drainage system have an open inlet and outlet and conduct water underneath a road. Particular care in both design and maintenance is required to prevent obstruction of water flow by obstacles [13].

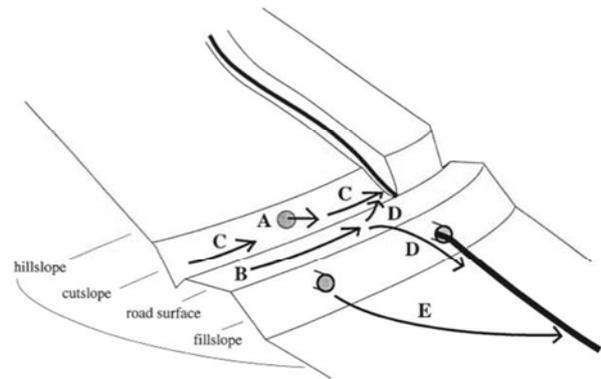
Figure 4. Types of water flow on a road Source: [16].

Highway structure development in floodplains changes the floodplain hydraulics and affects the related aquatic ecosystems [15]. Figure 4 shows the interactions that can occur between road segments and flows of water or sediment. Roads surface may act as corridors for flows of water on it (A and B in Figure 4) or in roadside ditches (C in figure 4). And roads may be sources of water for stream networks through subsurface drainage structure or culverts (D in figure 4) or gullies (E in figure 4). The interaction between highway and rivers may modify the magnitude and direction of water flow and debris, and water flows may transform into debris flows or vice versa [16].

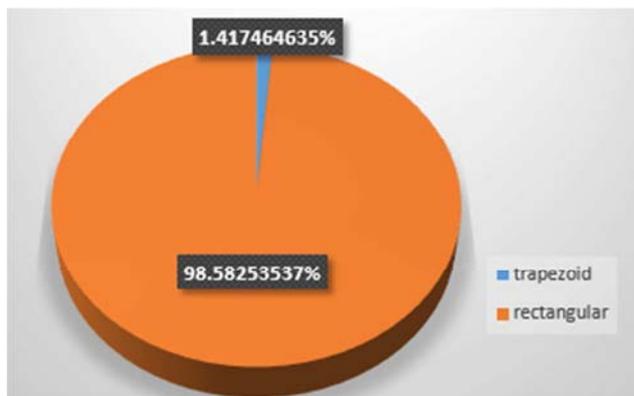
Figure 6. Types of EDS based on their shape.

The existing drainage structures were categorized according to their type based on their shape. These types were identified during field observation, and the observed types were rectangular and trapezoidal. As it was shown in Figure 6 only 1.42 percent of existing drainage structure were trapezoidal while 98.58 percent of these drainage structure were rectangular. Both types, rectangular and trapezoidal have their own advantage and disadvantage. Trapezoidal drainage structure require higher space than rectangular drainage structure. Rectangular drainage structure have lower capacity than trapezoidal drainage structure.

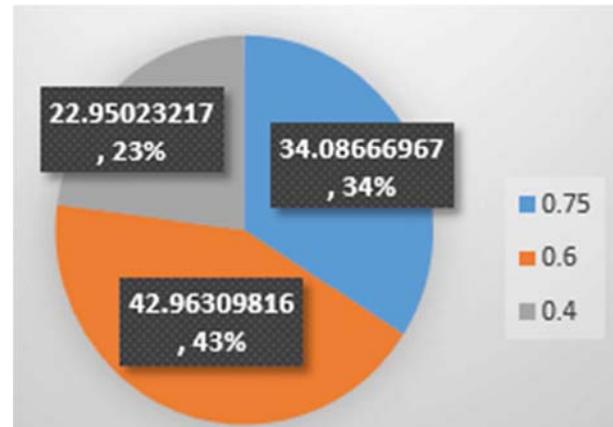
Figure 7. Types of EDS based on its depth.

To identify the general characteristics of existing drainage structures the researcher was also measured their depth during field survey. The depth of those EDS ranges between the intervals of 0.75m to 0.40m. As it was shown in Figure 7, about 23 percent of these drainage structure have a depth of 0.4m, 34 percent of them have a depth of 0.75m while 43 percent of them have a depth of 0.6m. As [12] states, the exact dimensions of the side drains are dependent on the expected amount of rainwater and the distance to the next exit point where the water can be diverted away from the road. As [18] standard indicates the depth of rectangular drainage structure must be at least 0.75m; but, in Bale robe town some drainage structure have a depth less than 0.75m which do not achieve the ERA manual standard.

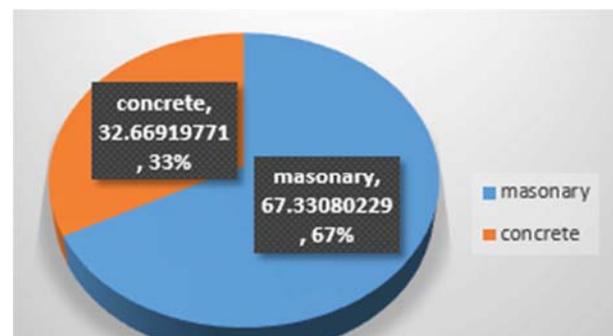
Figure 8. Classes of EDS based on construction materials.

During the computation of discharge value, to know the capacity of drainage structure it is mandatory to know surface material from which they were constructed since different construction material have different rainfall runoff coefficient. So, during the study the researcher was identified the type of those construction material from the report of the town's administration and also through observation. As it was indicated in their report and identified during field observation 33 percent of those drainage structure was constructed from concrete while 67 percent of them were constructed from gravel with mortared at their bottom and masonry at their sides and it was shown also in Figure 8.

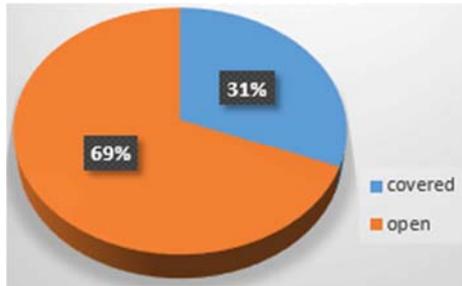
Figure 9. Classes of drainage structure.

During field observation the researcher was categorize the existing drainage structure as closed and open drainage structures. In the Bale Robe Town 69 percent of the EDS are open while 31 percent of EDS are closed as shown in Figure 9. In urban areas especially commercial and residential areas the drains should be covered with concrete slab or small block for easy inspection and cleaning [12]. The deposition of wastes are higher in open drainages structure than in closed drainage structures; because any individual can throw whatever they need in it easily. Those open drainage structures have no good pleasant to the appearance of the town. At some areas it is difficult to cross especially for elders and disabled persons.

The terrain category of the town was classified based on the standard by using ArcGIS software. These classifications were based on the variation of slope the study area. During this classification DEM of the town was extracted from DEM of Ethiopia, and this DEM was 30mx30m.

In Bale Robe Town, as stated above in Figure 9 of this document, about 69 percent of the existing drainage structure is open drainage structure. There is also no garbage or gunge nears the roads. So, the road users and the surrounding society are using this existing drainage structure as garbage. Therefore, the existing open drainage structures were blocked by dry waste including very small waste like plastic to some large crap like dead animals. Construction materials were also deposited in drainage structures.

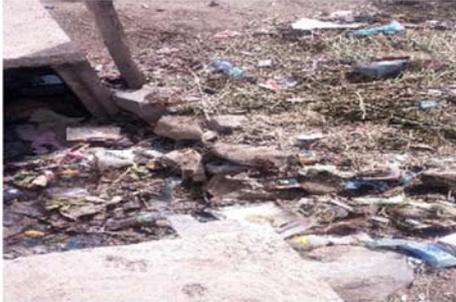
Figure 12. Water released to some facilities.

Water from existing drainage structure of the town are released to some structure and farm lands of the surrounding society at some parts of the town. At some areas, it was released to collector roads and it is damaging these roads. At other parts of the town, it releases water to farmland and

damaging these farms by erosion and formation of gullies. So, the surrounding society block these drainage structures to preserve their farms from the expected damage. Those blocked drainage structures are damaging drainage structure itself, hazard to surrounding society, affecting appearance of the town and damaging the other structures.

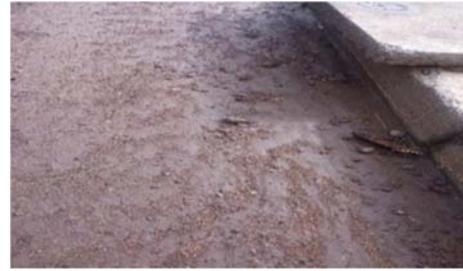
Figure 13. Sedimentation of road surface and drainage structure

During field observation deposition of sediment in the existing drainage structure was also identified as another defect. The study of [12] was indicating, if the longitudinal gradients less than 2 percent silting occur easily. While with gradients steeper than 5% the ditches will easily erode. As the researcher indicate in the computation of slope of existing drainage structure all drainage structure's longitudinal slope is less than 2 percent, it is one of the factors that causing siltation in this town.

Since some wastes and construction materials deposited in drainage structure, outlets of some drainage structure were closed and plants are highly growing in the drainage structure water cannot flow as fast as proposed speed. As this speed decreases the sedimentation increases, and fill up some parts

of drainage structure and causes street flood.

vegetation that growth in drainage structure, properly cleaning of drainage structure before and after rain, early maintenance of drainage structure based on the severity of defects.
