Structural Integrity Assessment of Office Building Development in FCT-Abuja, Using Non-Destructive Testing Method

Abstract: This paper present structural integrity assessment of the remodelled office building for the National Directorate of Employment (NDE), Abuja. Structural and the architectural drawings were reviewed. Visual inspections, soil investigation, and in-situ concrete testing were carried out. However, to identify structural flaws and the type of reinforcement bar used; structural elements were measured, photographed were taken, Ground Penetrating Radar (GPR) was used to assessed the reinforcement in all the structural elements (columns, beams and slabs). A total station survey of the structure utilizing structural Non- Destructive Test Unmanned Aerial Vehicle (NDTUAV) was used to create the as-built plan for the building. The elevations inside the construction area were surveyed to determine the slope's orientation in order to assess the effects of wetting on the building foundation. There was no indication of structural fatigue on the structural components at the time of the visit. The structural members' in-situ compressive strength tests were satisfactory. The geo

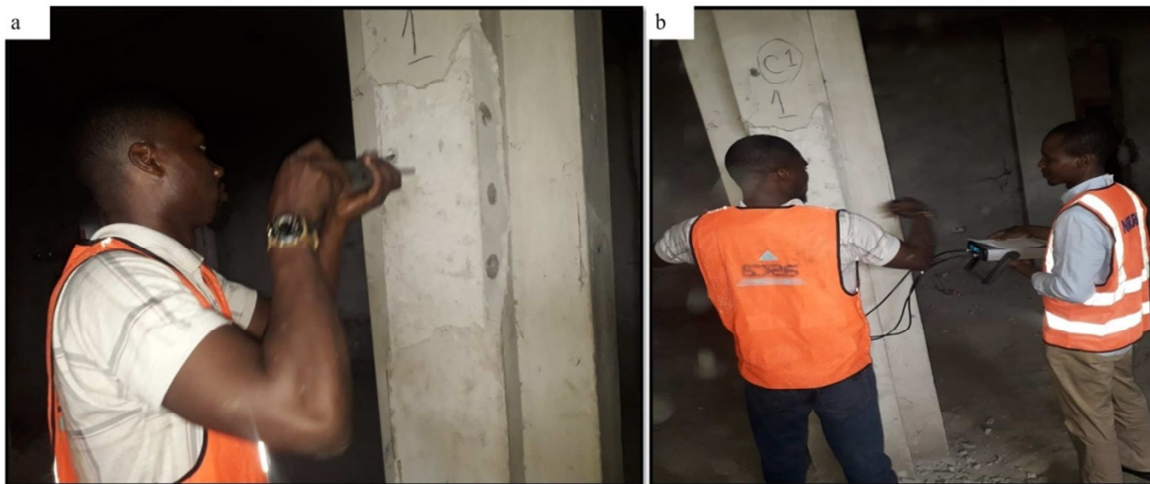
Figure 2. (a) Testing one of the internal column using Rebound hammer (b) Testing the internal column using Ultrasonic Pulse Velocity.

The Rebound Hammer Test was carried out with the view of assessing the in-situ strength of the structural members. In practice, the results from these tests are dependent upon the surface condition and moisture content of the concrete as well as the ratio of aggregate to cement paste. Prior to testing, a grinding stone was used to smooth the test surface, and then a rag is used to remove all dust from the tested area. Figure 2 (a) shows how the test was carried out. The test procedure based on ASTM C805/C05M [17] for Rebound Hammer was adhered to for accurate result.

Ultrasonic scanning is a recognized non-destructive evaluation to qualitatively assess the homogeneity and integrity of concrete. The test was based on the EN-12504-4 [18] specification. With this technique, the qualitative assessment of concrete strength and its gradation at different locations of the structural members can be assessed. Figure 2 (b) shows how the test was carried out.

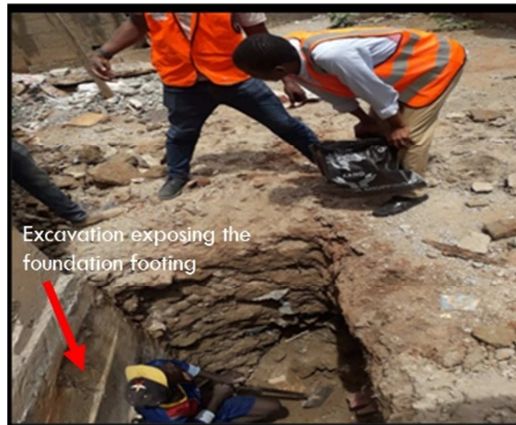
Figure 3. One of the Excavated pit for soil sample.

An underground investigation was conducted to evaluate the condition of the foundation soil. Three (3) trial pits were carefully excavated to collect soil samples for laboratory tests (See Figure 3). Disturbed soil samples were obtained using a special coring machine and transported to the Nigerian Building and Road Research Institute material testing laboratory in Abuja.

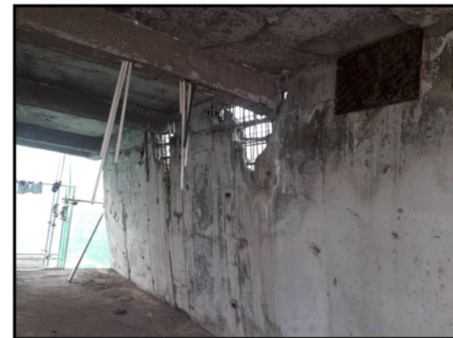
Figure 4. Exposed reinforcement bars at the last floor of the building.

The building is relatively in stable condition at the time of the visit. No cracks were seen on the walls, as well as structural elements of the building, except around the slanted wall section at the last floor of the building that showed exposure of reinforcement bars due to poor formwork as shown in Figure 4.

1. All exposed reinforcement should be covered to avoid further deterioration.
2. Areas with poor concreting should be amended.
3. The roof slab should be adequately protected.
