Case Report

Assessment of the Causes of Pavement Failure Due to Sub-Base and Sub-Grade Materials Along Nekemte-Bedele Road

Department of Surveying Engineering, College of Engineering and Technology, Wallaga University, Nekemte, Ethiopia

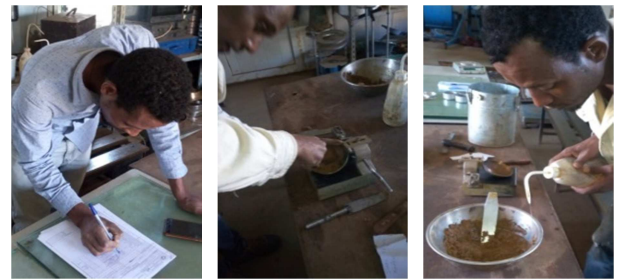
Figure 4. Atterberg's Limit (photo taken by Kasahun 10.10.2020@10:40AM).

The liquid limit test is the water content corresponding to the behavioral change between liquid and plastic state. The In the laboratory, the liquid limit is determined using specific devices. It represents the water content at which a part of the soil is cut by a groove of standard dimensions with 25 blows. The plastic limit, on the other hand, is the water content at which silt or clay will just begin to crumble when rolled into a specific diameter. The plasticity index is calculated by subtracting the plastic limit from the liquid limit. (i.e., $PI = LL - PL$).

For determination of the LL, the soil sample passing through a 0.425 mm sieve, weighing 200 g was mixed with water to form a thick homogeneous paste. The paste was collected inside the Casagrande's apparatus cup with a groove created and the number of blows to close it was recorded. Similarly, for plastic limit determination, the soil sample weighing 200 g was taken from the material passing the 0.425 mm test sieve and then mixed with water till it became homogenous and plastic to be shaped to the ball. The ball of soil was rolled on a glass plate until the thread cracks at approximately 3 mm diameter. The 3 mm diameter sample was placed in the oven at 105°C to determine the plastic limit.

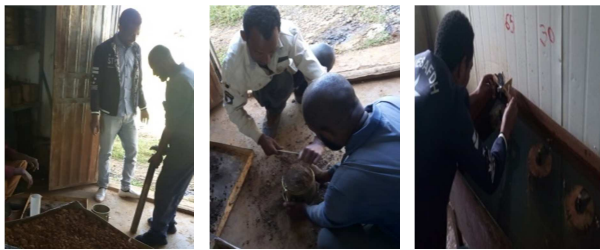
Figure 5. CBR test (photo taken by Imiru 17/10/2020@11:15 AM).

The California bearing ratio (CBR) test is a penetration test carried out to evaluate the mechanical strength of a sub-base, selected fill, and natural subgrade soil material. The soaked method of CBR was conducted to characterize the soil for use as a sub-base and selected fill material. A portion of air-dried soil sample was mixed with optimum moisture content. This was put in CBR mold in 5 layers with each layer compacted with 56 blows using a 4.5 kg hammer (Modified proctor test). The compacted soil and the mold were weighed and placed under the CBR machine and a seating load was applied. Load was recorded at penetration of 0.625, 1.25, 1.875, 2.54, 3.75, 5.08, 7.5, 10 and 12.5 mm.

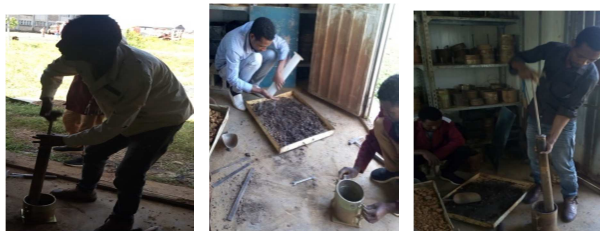
Figure 6. Proctor test (Photo taken by Kasahun 25/10/202).

Compaction tests were performed for sub-base, selected fill, and natural subgrade soil materials based on the AASHTO T-180 test procedure for compaction. The densification of soil with mechanical equipment thereby rearranging the soil particles which makes them more closely packed increasing the ratio of horizontal effective size to the vertical effective stress. The degree of compaction is measured in term of its dry weight and it increasing the bearing capacity of road foundation, stability slopes, controls undesirable volume changes, and curb undesirable settlement of structures. The mold is filled and compacted with soil in five layers of a 4.5 kg rammer.
