Degradation Prevalence Study of Field-Aged Photovoltaic Modules Operating Under Kenyan Climatic Conditions

Keywords: Degradation, Photovoltaic, Field-Aged Modules

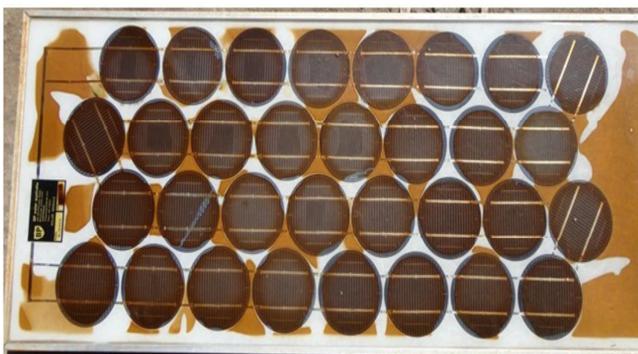
The primary degradation forms observed in the samples were those that affect the encapsulant i.e. delamination and encapsulant browning. Module delamination occurs as a result of the disintegration of bond between the encapsulant and other material layers that make up the PV module [12].

Figure 1. Destruction of laminate by water ingress.

Most of the delamination observed in the field has occurred at the interface between the encapsulant and the front surface of the solar cells in the module. A common observation has been that delamination is more frequent and more severe in hot and humid climates (Temperature zone 3 and Precipitation Zone 1).

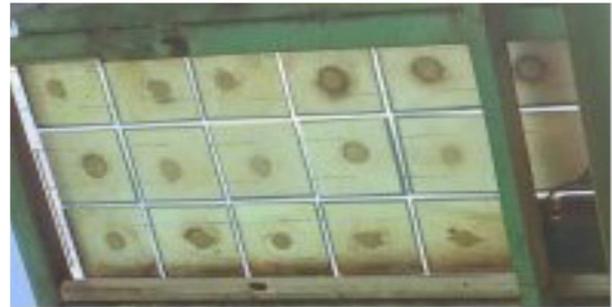
Hotspots were also observed as a common degradation form in many of the sample modules investigated. No climatic relation can be conclusively associated with the hotspots observed in the samples investigated in this research. However, the severe hotspots, for example those shown in Figure 2 below, were observed on panels which had not been ideally located and allowed some form of partial shading to the panel during the day.

Figure 2. Hotspots on PV Module.

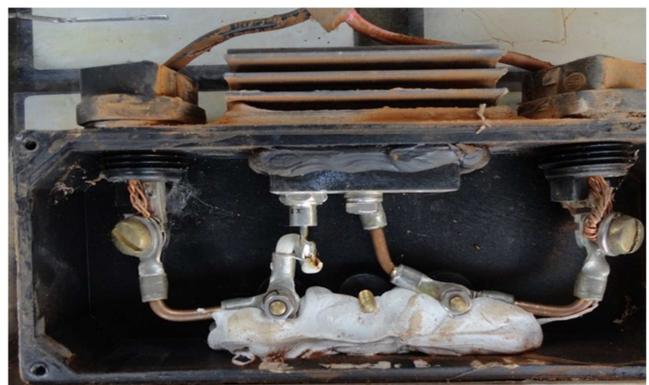
Figure 3 shows junction box from one of the sample which had undergone warping of the cover, probably due to the high temperature conditions of the region. It was also installed directly on the corrugated iron sheets without allowing flow of air. As such, the junction box was exposed to elevated temperatures which consequently weakened the plastic cover

Figure 3. Junction box defects.

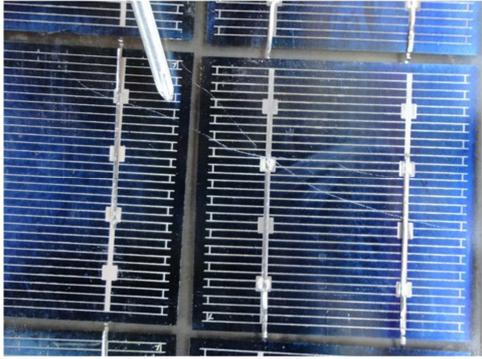
Glass breakage is an important degradation factor of PV modules. They occur in most of the cases during installation, maintenance, and especially during the transportation of modules to their installation sites [14].

Figure 4. Cracked front glass of a solar module.

The broken modules or with cracks may keep functioning correctly. However, the risk of an electrical shock and of a moisture infiltration increases. Breakages and cracks are usually followed by other degradation types such as corrosion, discoloration and delamination [12].

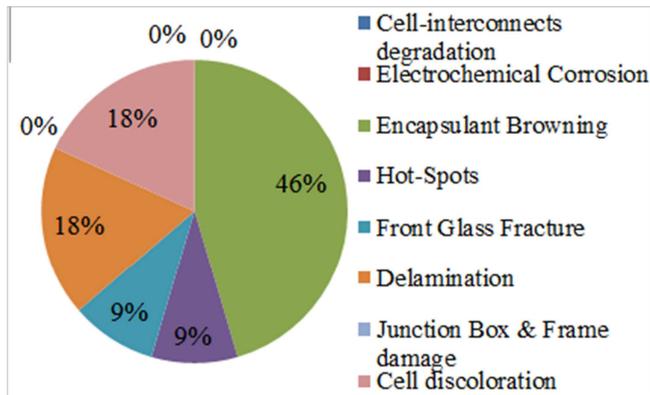
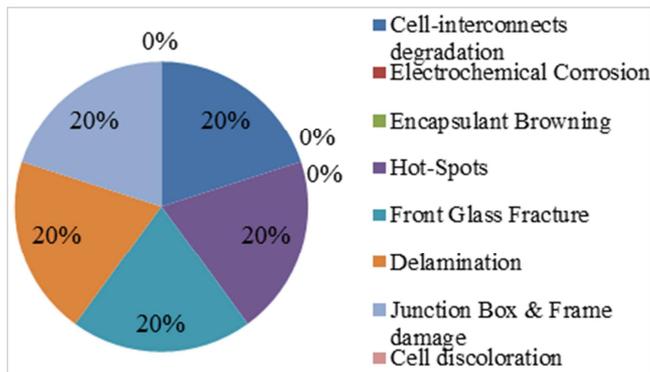
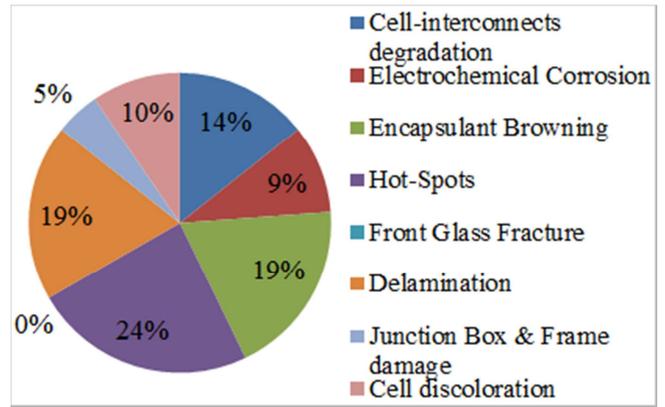
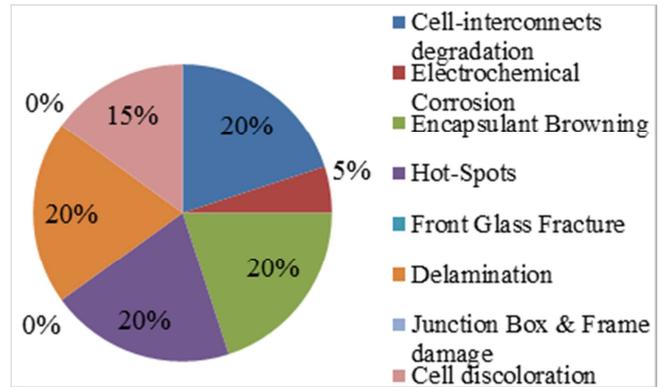
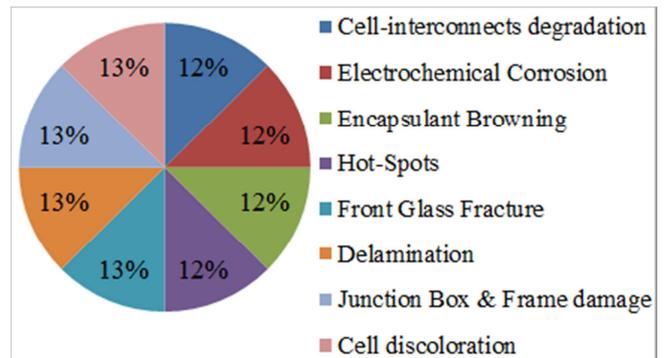
Figure 5. Correlation between Degradation prevalence and age of solar panels.

Analysis was done to show the prevalence of each degradation form in each age cluster of the samples studied. Figure 5 (a-e), illustrates the results observed. Encapsulant browning was seen to be the most prevalent form of degradation in the 9-12 Years age clusters as illustrated in Figure 5(a). Figure 5(c) and 5(d) indicates that hot spots were observed to take place more commonly in the 17-20 and 21-24 Years age cluster. As only one panel existed in the 25-28 age clusters, the severeness of deformations in this group could not be determined. This panel exhibited all the forms of deformations observed in all the other panels.
