Participatory Integrated Low-Cost measures Gully Rehabilitation and Reclamation for Sustainable Land Management in Ilasa Watershed of Goba Distinct Bale Zone

Mulugeta Eshetu, Daniel Abegeja, Tesfaye Ketama, Girma Getachow, Regassa Gosa. (2024). Participatory Integrated Low-Cost measures Gully Rehabilitation and Reclamation for Sustainable Land Management in Ilasa Watershed of Goba Distinct Bale Zone. *Science Research*, 12(1), 1-8. <https://doi.org/10.11648/sr.20241201.11>

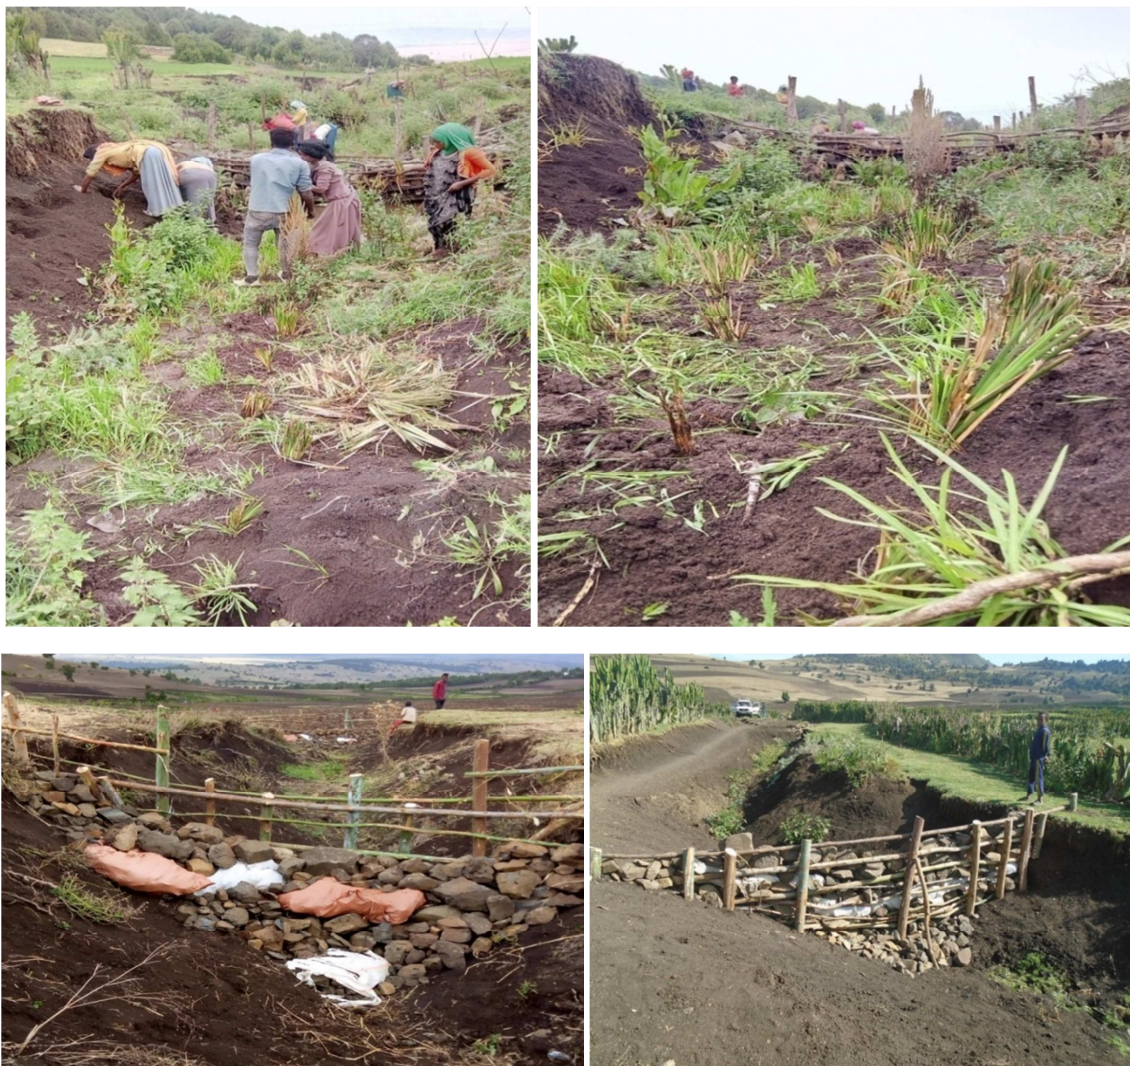
Figure 3. Interventions implemented points.

Check-dams: To prevent channel/bed erosion, check-dams were constructed across the gully bed. Check-dams reduce runoff's erosive force and water flow velocity by lowering the gully channel's initial gradient (Figure 3).

Stone Check-dam: Based on minimum standards for soil and water conservation measures different stone Check-dams were constructed such as spacing estimated on the safe side using $S \text{ (spacing)} = \frac{\text{Height (m)} \times 1,2}{\text{Gradient (in decimals)}}$; Side key: 0,7-1 m inside gully sides, Bottom key & foundation: 0,5m depth x width of check dam; Height: min 1m and max 1,5 m excluding foundation; Base width: min 1,5 and max 3,5 m (Figure 3).

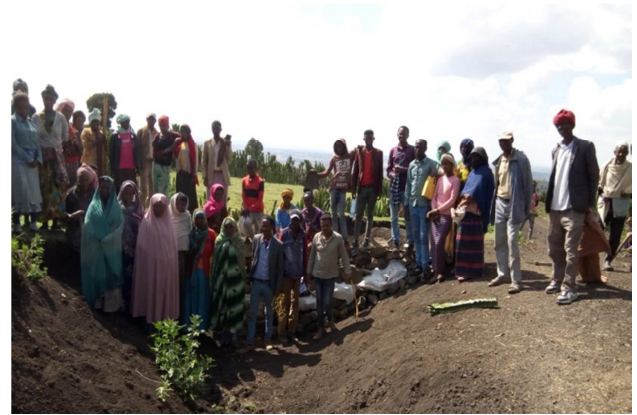
Figure 4. Picture during community based participation rehabilitation work at Ilasa watershed.

Out of the total 306 male participants and 167 female participants, respectively, were mentioned in Table 3 and figure 4. Farmers were encouraged to participate in watershed management and household skill improvement, and the role and connections of women in these intervention

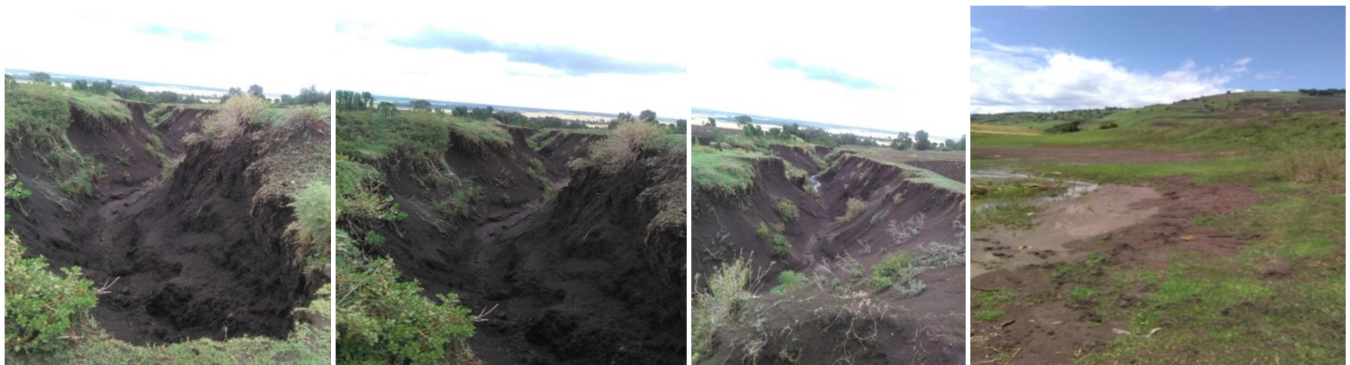
Figure 5. Status of land degradation and gully severist at Ilasa watershed before intervention.

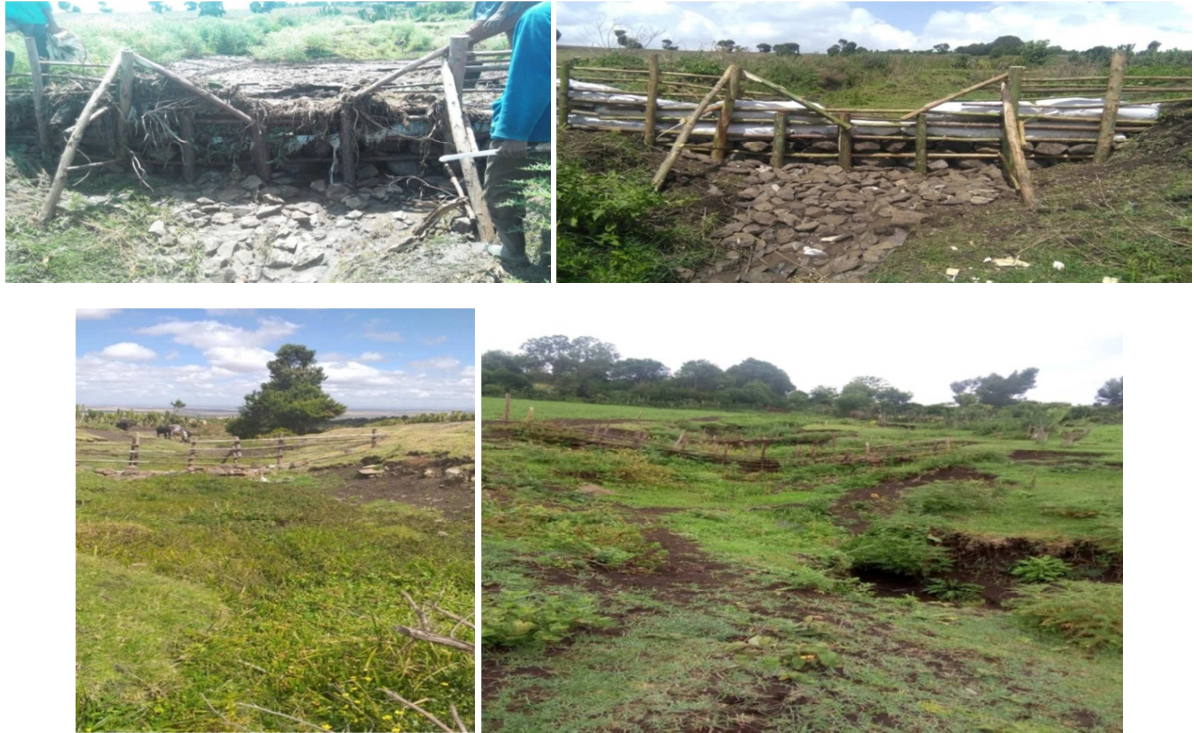
Figure 6. Illasa watershed status after innervations.

The gully reshaping, stone and wooden check dam, and cut-off drain supported with biological measures reduced sediment loss and further extension so that more efficient ways to mitigate gully erosion. Participatory approach and use of low-cost locally available materials to restore gullies are the efficacy and affordable gullies measures strategies.
