# Utilizing the Taguchi Method to Optimize Slope Stability and Analyse Parameter Sensitivity in Road Cuts: Insights from Southern Ethiopia

Aklilu Shitu<sup>1,\*</sup>

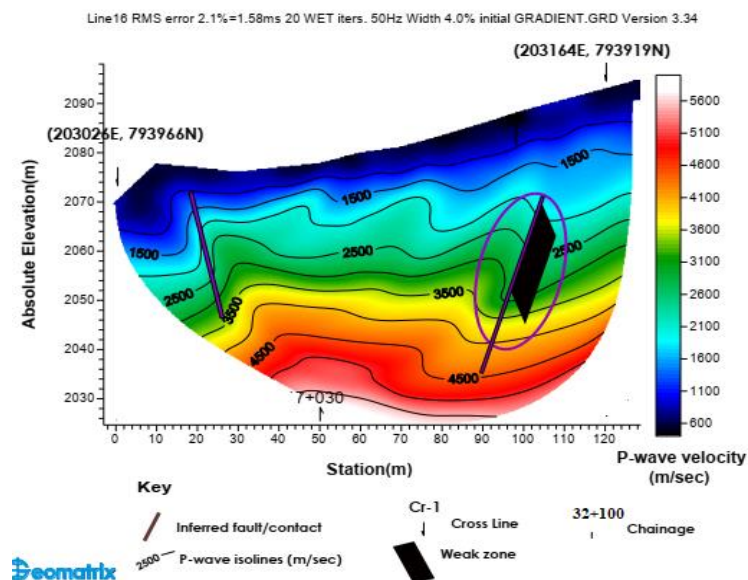
Figure 9. 2D P-wave velocity tomography, road segment Km 32+120.

Figure 9 shows that the subsurface underlying line Km 32 is formed of clay, clayey silt, and extensively worn decomposed materials, which are indicated by p-wave velocities below 1500

m/sec and thicknesses between 6 and 18 m. The maximum thickness of the line is little more than eighteen meters at its lowest point, which is at the far NW end.

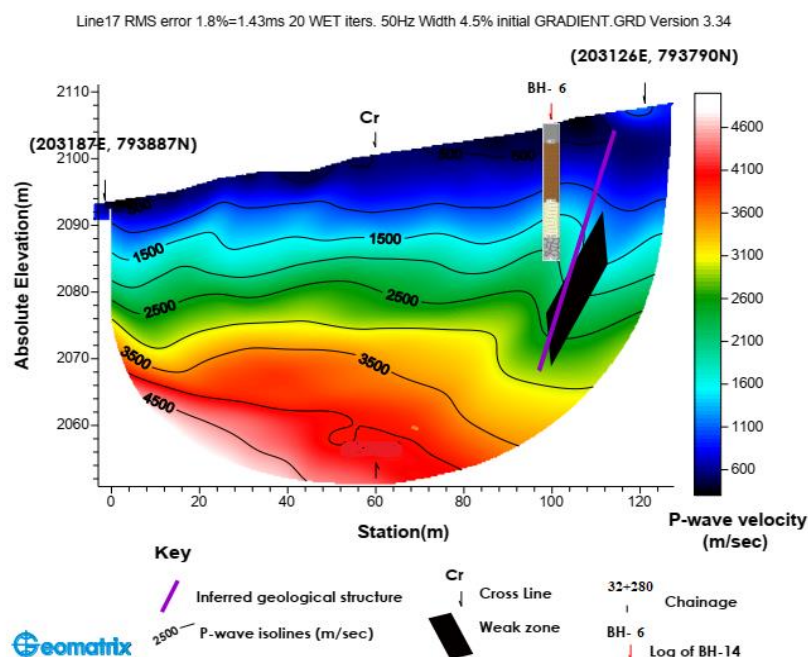
Figure 10. 2D P-wave velocity tomography, road segment Km 32+280.

The 2D-P wave velocity tomography along line Km 32+280 indicates that clay silt and silty clay with gravel are associated with extremely low velocity units that have a thickness of 2.5–12 m and a velocity of 500–1000 m/s. This unit is supported by stiff to hard silty clay and tuff, which have a thickness of

11–17 m and a velocity of 1000–1500 m/sec, Figure 10.

The next unit is interpreted as moderately to slightly fractured basalt (2500–3500m/s) and is generally situated below 2080m a.s.l Figure 10. The substratum is slightly related to fresh basalt characterized by higher velocities (>3500m/s).

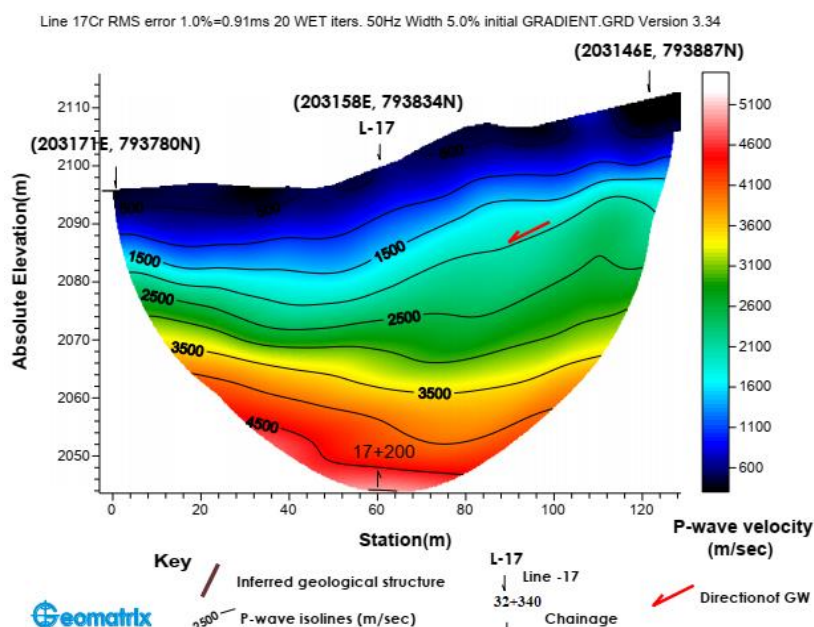
Figure 11. 2D P-wave velocity tomography, across Km 32+340.

According to Figure 11, The sloping slope and the south-east-flowing groundwater are likely to result in shallow groundwater and shallow creep because of gravity. The latter is the reason the local embankments have failed. The inferred

structure beneath the station and shallow groundwater may also be the primary causes of the fracture around stations 32+340 and the structure extends to about 20m.

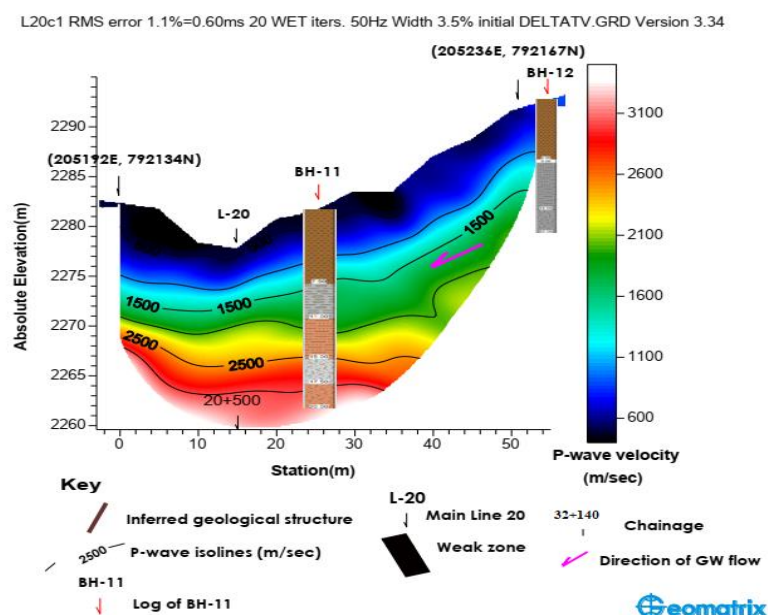
**Figure 12.** 2D P-wave velocity tomography, Cross Line Cr-500.

The upper portion of the bedrock, which is composed of highly to moderately fractured volcanic rock, most likely rhyolite, is expected to have p-wave velocities in the range of 3000-3500m/sec, with a maximum depth in the central part of

the line below ground level (2050m asl), even though there is no borehole log deeper than 20m. Furthermore, fresh bedrock is anticipated to have velocities exceeding 3500 m/sec since rock quality rises with p-wave velocity. Figure 12.

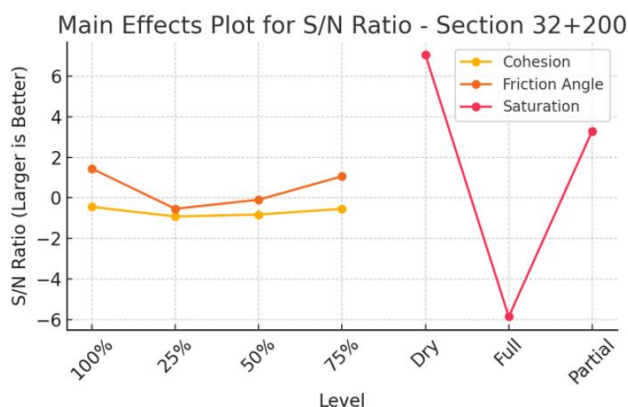
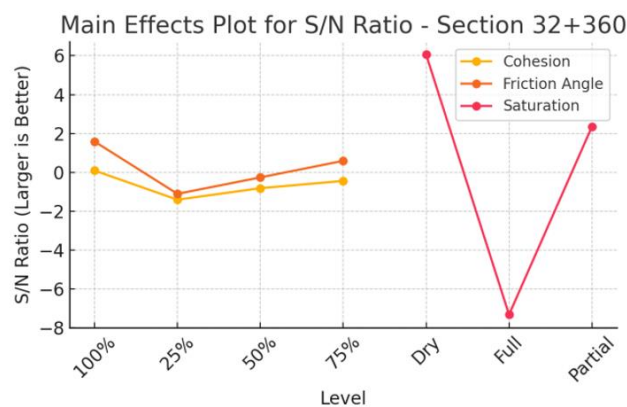
Figure 25. Signal to noise ratio plot for section 32+200 and 32+360.

Figure 25 shows the influence of each parameter on slope stability in Section 32+200 and 32+260. The parameter with the steepest slope and highest S/N ratio has the strongest effect on Factor of Safety.

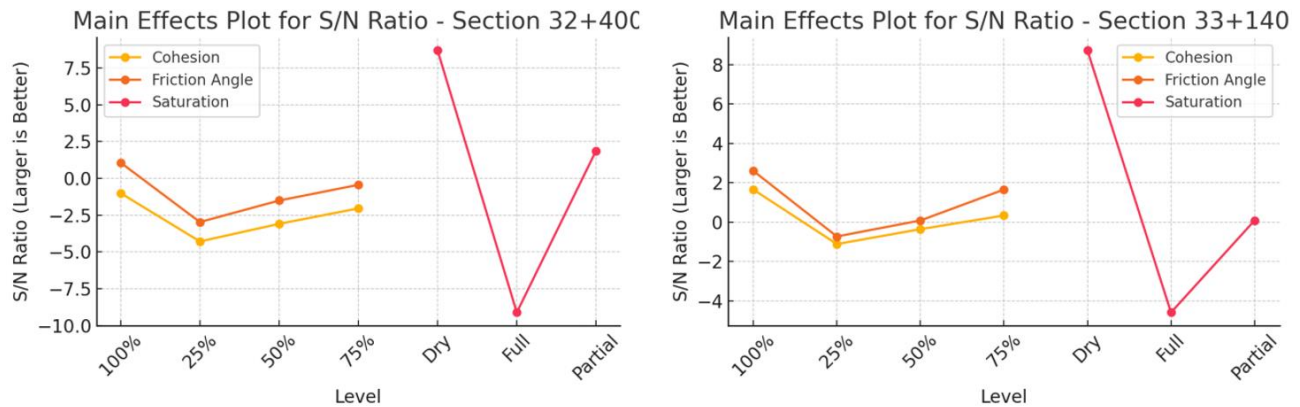
Figure 26. Signal to noise ratio plot for section 32+400 and 33+140.

Figure 26 shows the influence of each parameter on slope stability in Section 32+400 and 33+140. The parameter with

the steepest slope and highest S/N ratio has the strongest effect on Factor of Safety.

compacted rock fill and granular layers. A 1.5–2 meter retaining wall and underdrain on the LHS are also recommended. The slope stability study indicates an enhanced factor of safety of 2.19 with these precautions in place, as illustrated in Figure 26.
