Status of Public Water Supply Facilities in Port Harcourt Metropolis

Geraldine Okwy Ojukwu, Hycienth Ogunka Nwankwoala. Status of Public Water Supply Facilities in Port Harcourt Metropolis.

International Journal of Environmental Protection and Policy. Vol. 10, No. 2, 2022, pp. 31-38. doi: 10.11648/j.ijepp.20221002.13

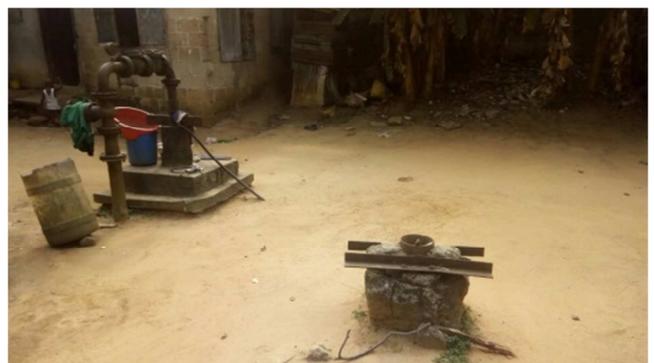
For Borokiri Water Station, at the time of visit the station was locked and access could not be gained to this facility. However, observations made showed that no activity has been going on in the facility for some time and the structures therein are under neglect (Figure 3).

Figure 3. An overhead tank at Borokiri Station.
