# About Some Environmental Consequences of Kerch Strait Bridge Construction

Institute of Water Problems and Land Reclamation NAAS, Kyiv, Ukraine

Vol. 6, No. 1, 2018, pp. 1-9. doi: 10.11648/j.hyd.20180601.11

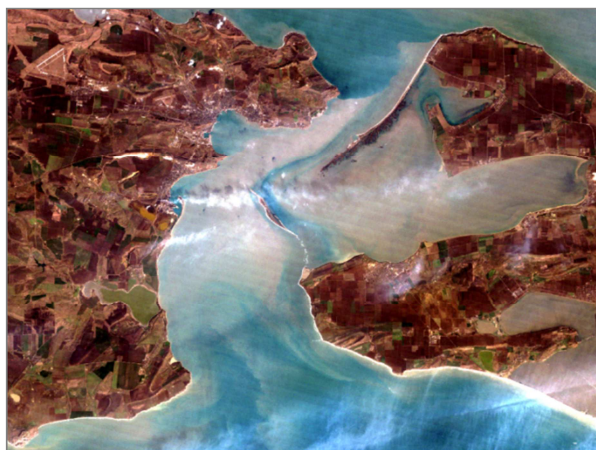
**Figure 3.** Satellite images of the Kerch Strait. Landsat 5 dated 17 Feb 1990.: *a* – false natural colours; *b* – in turbidity values.

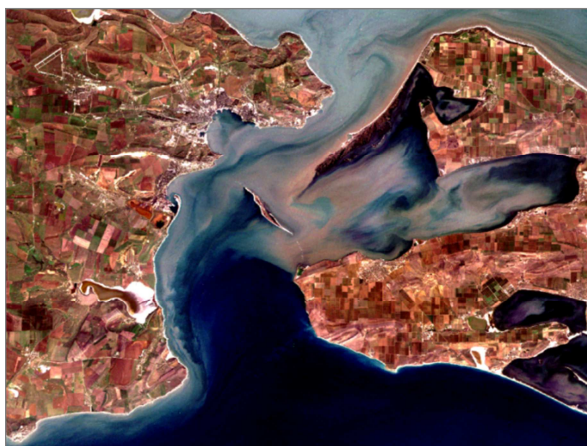
**Figure 4.** Satellite images of the Kerch Strait. Landsat 5 dated 10 Oct 1991.: *a* – false natural colours; *b* – in turbidity values.

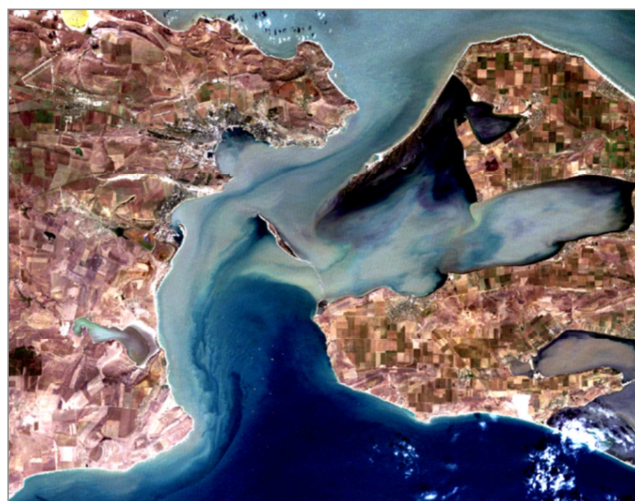
**Figure 5.** Satellite images of the Kerch Strait. Landsat 5 dated 19 Sep 2001.: *a* – false natural colors; *b* – in turbidity values.

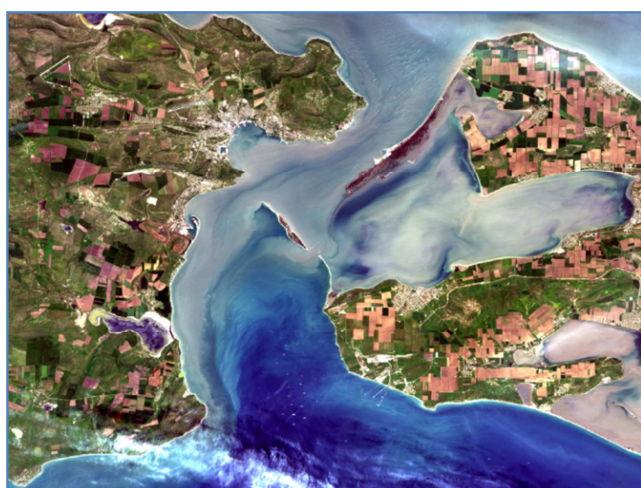
**Figure 6.** Satellite images of the Kerch Strait. Landsat 8 dated 21 May 2015: a - false natural colors, b - in turbidity values.

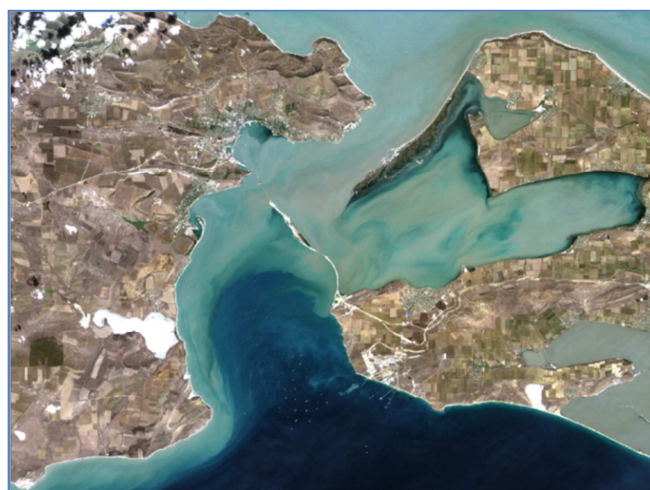
**Figure 8.** Satellite images of the Kerch Strait. Landsat 8 dated 01 Oct 2017: a - false natural colors, b - in turbidity values.

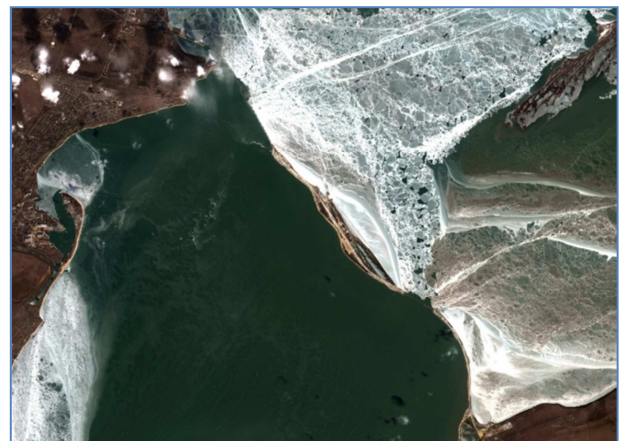
**Figure 10.** Ice spreading in the Kerch Strait according to the satellite Sentinel 2a dated 13 Feb 2017.

days of February 2017, the withdrawal of ice from the Sea of Azov began, and during the next few days almost all of the northern part of the Kerch Strait was covered with ice (Figure 9, 10).

Working bridge constructed across the Kerch Strait caused a stop of the ice drift from the Sea of Azov to Black Sea and caused an ice blocking in the strait. Although the ice is thin (5-10 cm), there is a large amount of it in Sea of Azov with no way out so the hummock formation began.

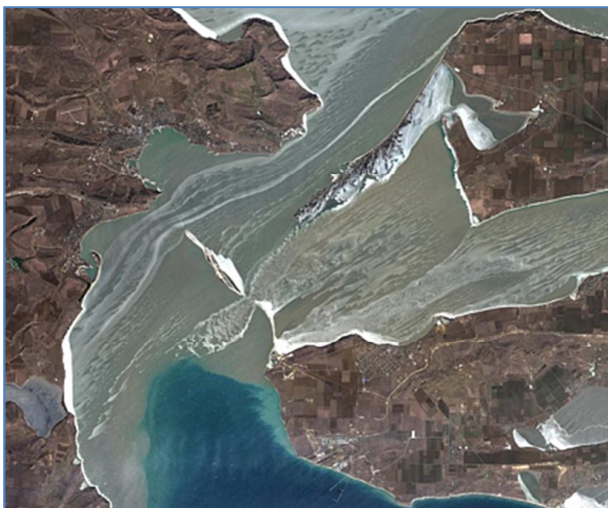
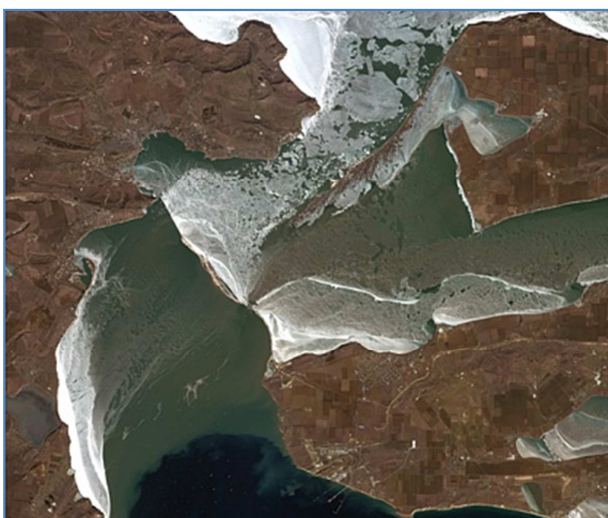
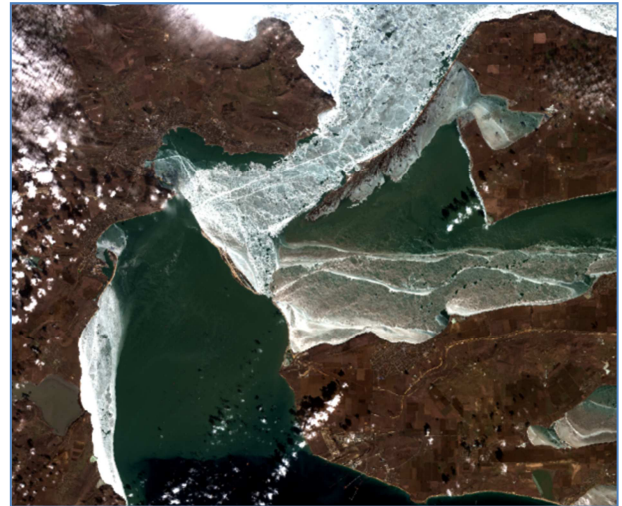
**Figure 11.** The Kerch Strait Bridge became a barrier in the way of ice drifting under the influence of the wind from the Sea of Azov to the Black Sea: a – Satellite image SPOT 7 (AIRBUS Defence & Space) dated 09 Feb 2017; b – Satellite image SPOT 7 (AIRBUS Defence & Space) dated 11 Feb 2017; c – Satellite image Sentinel 2A (ESA) dated 13 Feb 2017.

construction significantly affects the ice situation. The bridge under construction actually plays the role of "dam" that blocks the ice passing through the pillars of the temporary working and main bridge.

Russian specialists also began to write about significant changes within the ice situation influenced by the bridge [6, 7]. The authors of the paper [7] stated that even in the strong north-east wind the ice practically does not pass under the bridge, including its fairway arch. It's worth noting, that it is the case of the most favourable wind for such movement.

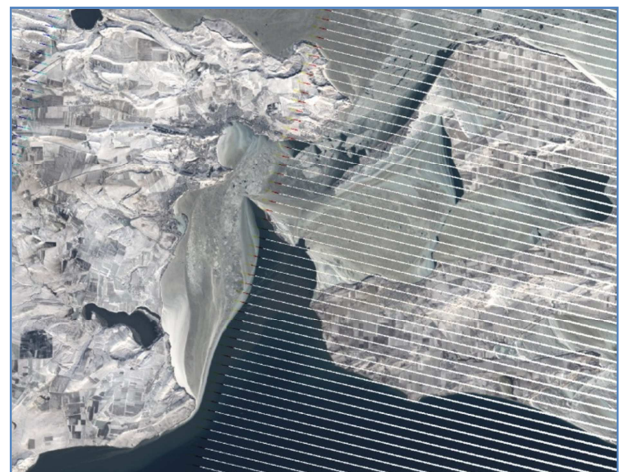
**Figure 12.** Ice situation in the Azov and Black Seas, ice passing to the Kerch Strait according to satellite image from Landsat 7 dated 03 Feb 2014.

We make a point of the fact that the advection of ice in the Kerch Strait from the Sea of Azov is an ordinary situation. The analysis of satellite data collected in this area during the current century and accumulated in the NASA and USGS archives has shown that similar situations emerged, in particular, in January-February 2003, 2006, 2008, 2012, and 2014. At the same time, the ice situation in the Sea of Azov and the ice drift to the Kerch Strait may be much more significant than the situation observed in February 2017 (Figure 11). For example, Figure 12 shows the situation observed in the region on 2-3 February 2014.
